To: Peter Folino, Eagle Environmental, Inc.
From: Martin Brogie
Date: March 20, 2015
Re: National Environmental Policy Act (NEPA) Statutory Checklist

**225 Main St
Bridgeport, CT
Project No. 1403900-17-1000**

NEPA Statutory Checklist
225 Main St
Bridgeport, CT

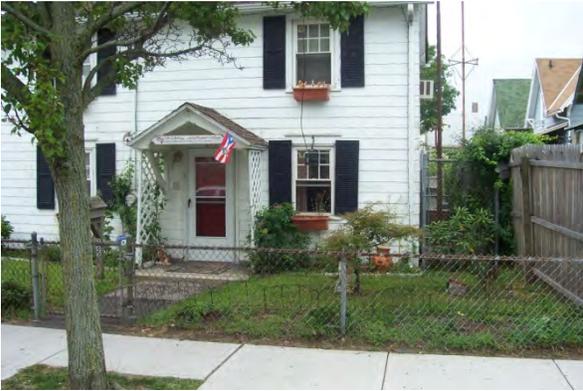
Photo 1: Front view of the property; photograph facing west.

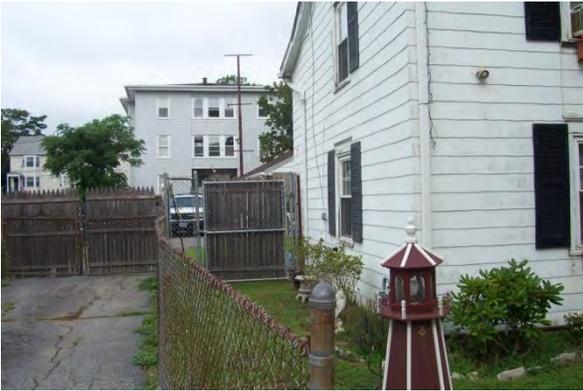
Photo 2: South side of the property; photograph facing west.

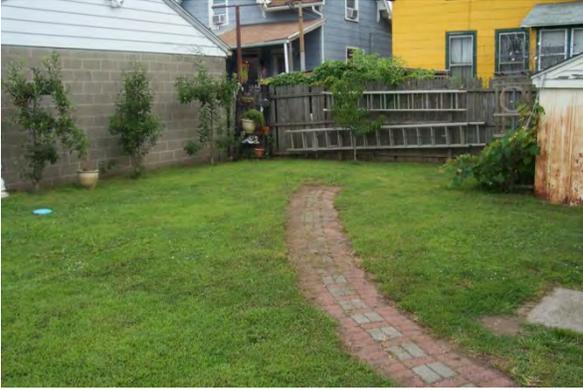
Photo 3: Rear view of the property; photograph facing northwest.

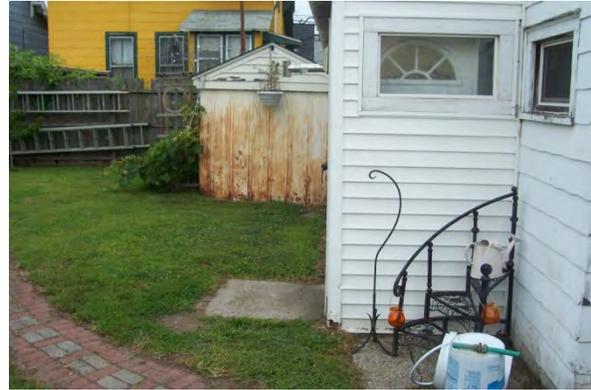
Photo 4: Rear view of the property; photograph facing north.

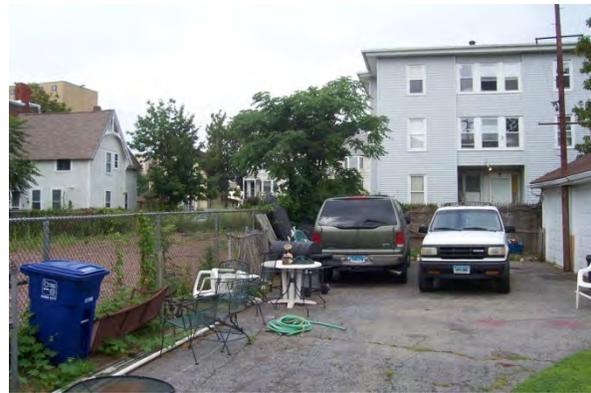
Photo 5: Rear view of the property; photograph facing west.

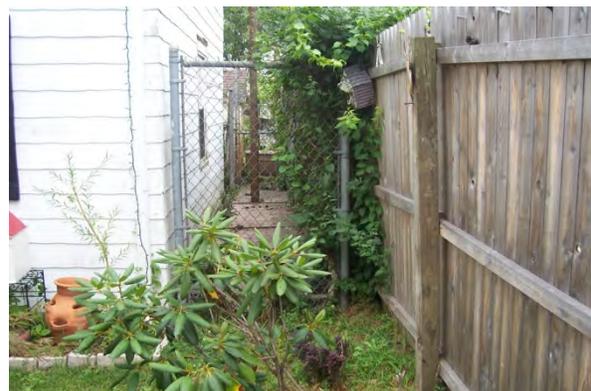
Photo 6: North side of the property; photograph facing west.
