Re: National Environmental Policy Act (NEPA) Statutory Checklist for 888 Ocean Avenue, West Haven, CT

888 Ocean Avenue

West Haven, CT

Please find the attached Environmental Assessment Report conducted at 888 Ocean Avenue located in West Haven, Connecticut (Site). The environmental assessment was performed in support of the planned renovations/repairs to the Site building under the State of Connecticut Department of Housing Community Development Block Grant – Disaster Recovery Program (Program). The assessment focused only on those areas of the building that are scheduled for renovation/repair work with the exception of the comprehensive lead-based paint inspection, which included the interior and exterior of the entire building. The proposed scope of renovation/repair work was provided to Eagle Environmental, Inc. (Eagle) by Capital Studio Architects (CSA).

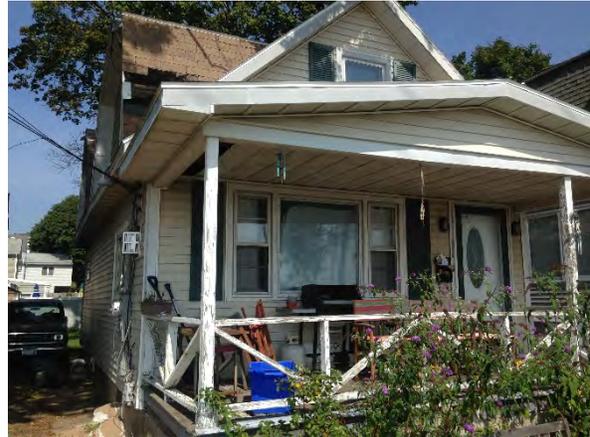
Photo 1: Front of property; facing north.

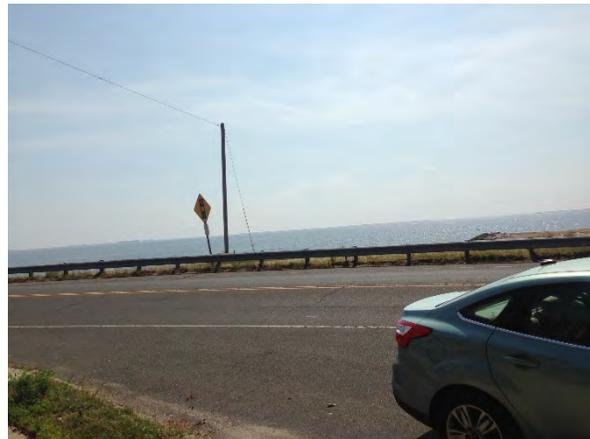
Photo 2: Long Island Sound viewed from property; facing northeast.

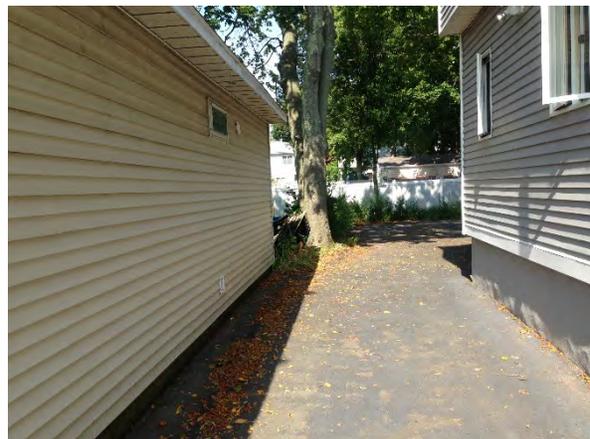
Photo 3: Eastern side of property; facing north.

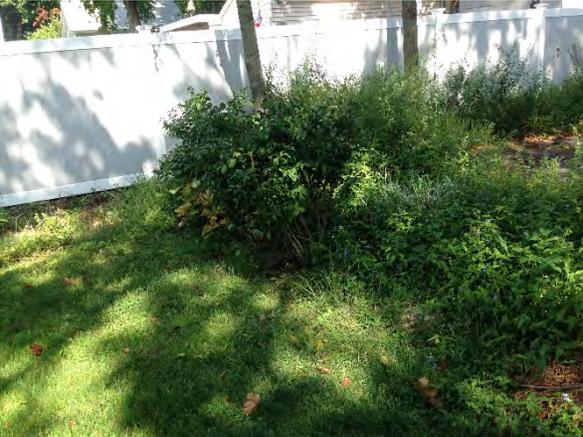
Photo 4: Rear of property; facing northwest.

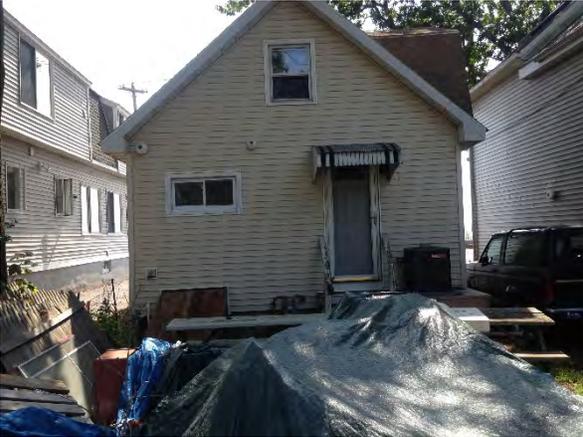
Photo 5: Rear of property; facing east.

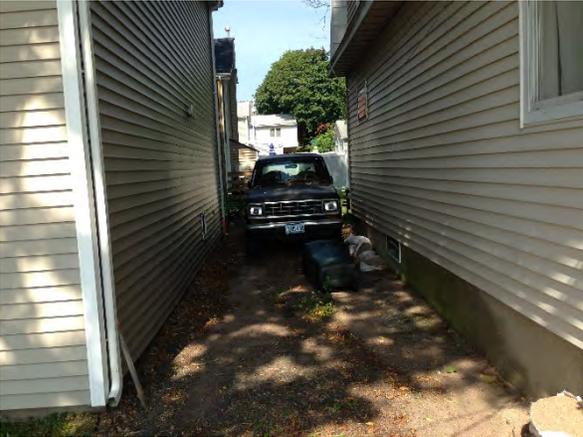
Photo 6: Western portion of property; facing northwest.
