ENVIRONMENTAL REVIEW REPORT

**Community Development Block Grant – Disaster Recovery
Owner Occupied Rehabilitation and Rebuilding Program**

**70 Shell Avenue
Milford, Connecticut**

Limited Hazardous Materials Building Inspection Report

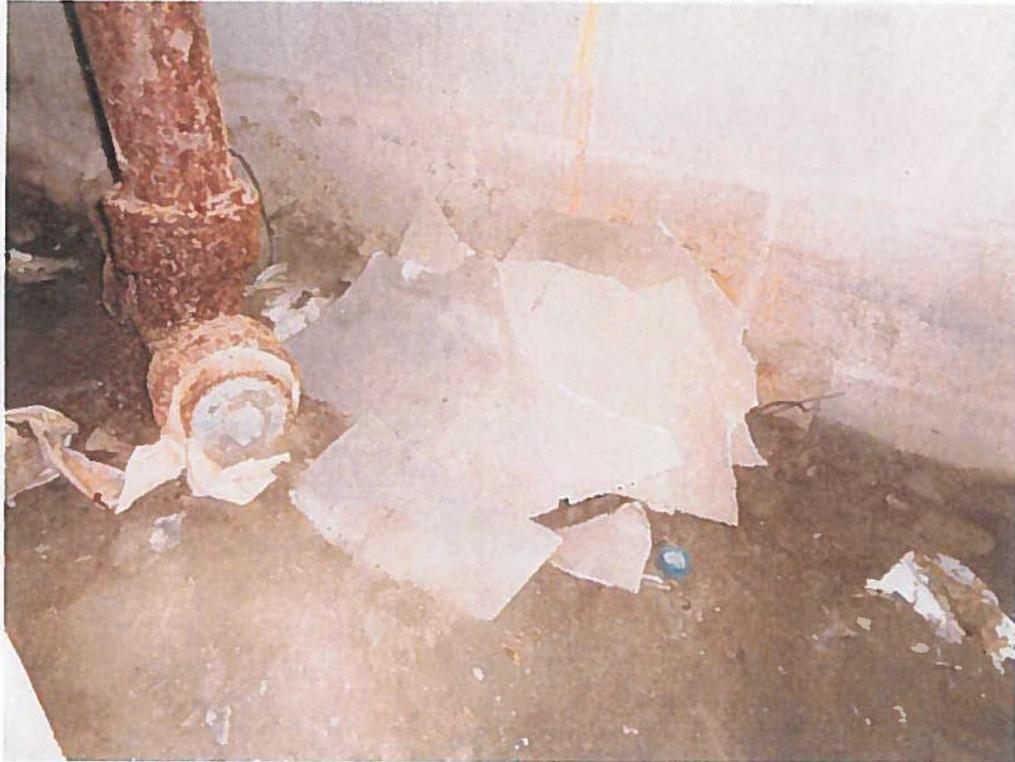
Transite Paneling—Broken/damaged ACM transite panels were observed in the crawlspace area during the time of the inspection. The crawlspace soil ground surface is considered contaminated where the disturbance occurred and shall be disposed as ACM waste.

Damaged ACM Transite Paneling in Crawlspace

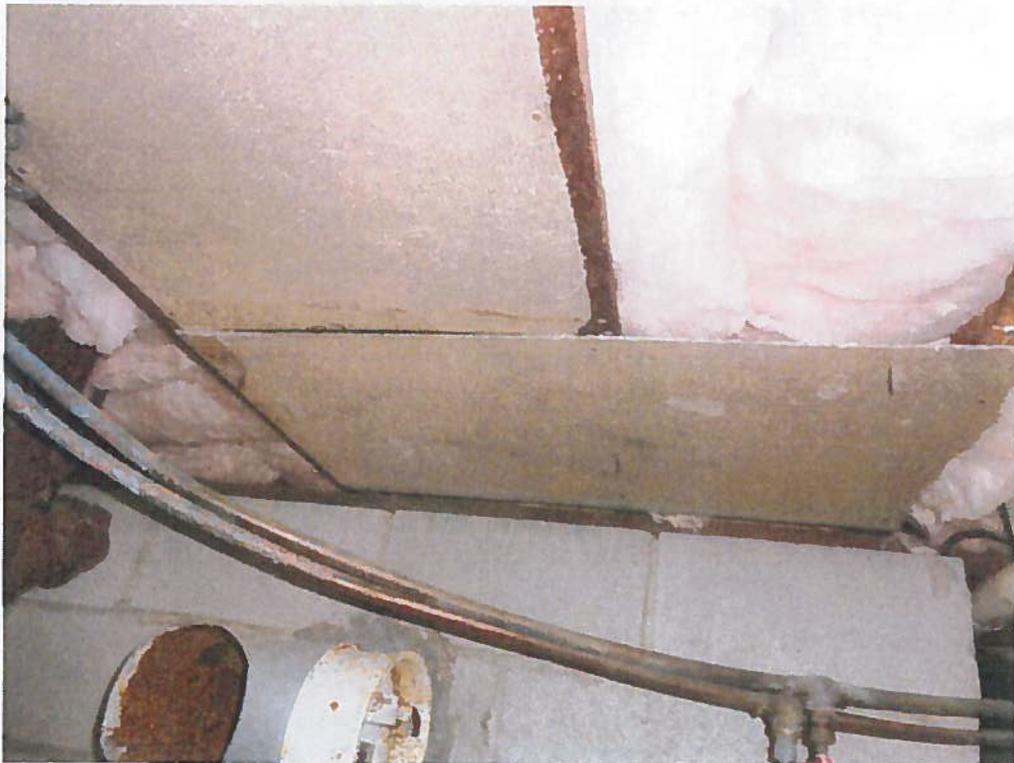
Intact ACM Transite Paneling on Crawlspace Ceiling

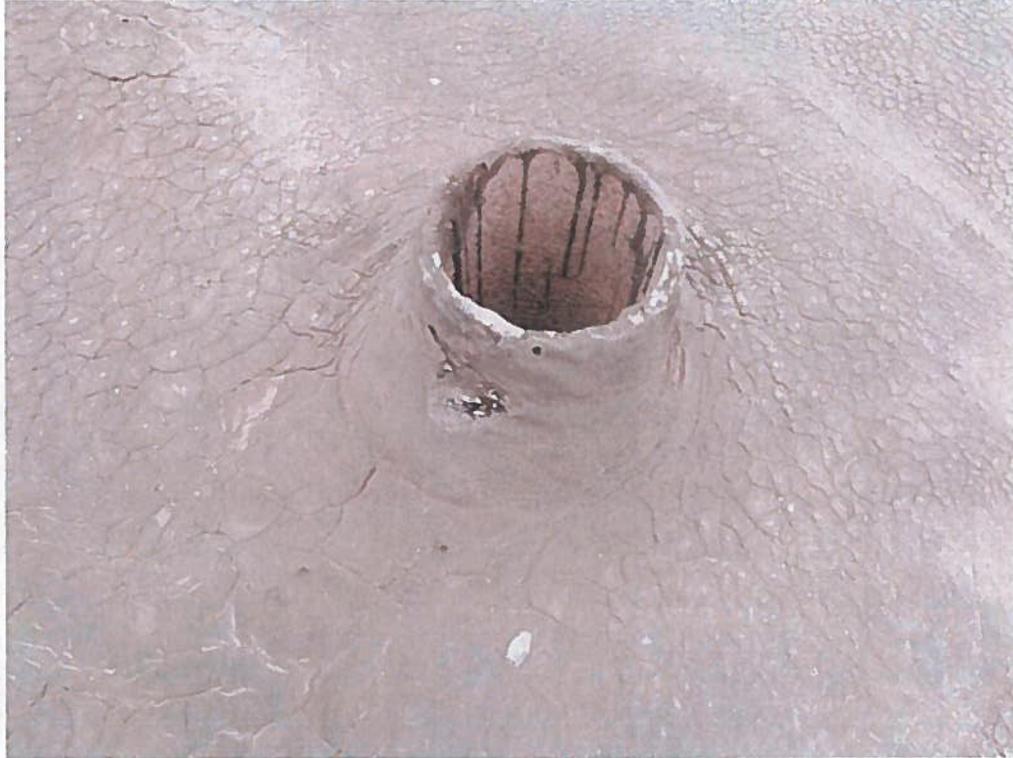
ACM Roof Vent Pipe Flashing

The non-friable roofing materials identified in *Section 2.1 - Table 1* have been de-regulated by the Connecticut Department of Public Health (CTDPH). The identified non-friable roofing materials may be removed by either a CTDPH-licensed Asbestos Abatement Contractor, or by a roofing contractor provided they adhere to all Occupational Safety and Health Administration (OSHA) training requirements and EPA NESHAP regulatory requirements. All asbestos waste must be properly sealed (leak/airtight containers) and disposed in a landfill approved to accept asbestos waste. A CTDPH-licensed Asbestos Abatement Contractor is only required should the ACM be made friable and become a regulated asbestos containing material (RACM) by work activities. If the roofing material becomes RACM, then all applicable CTDPH regulations shall apply.

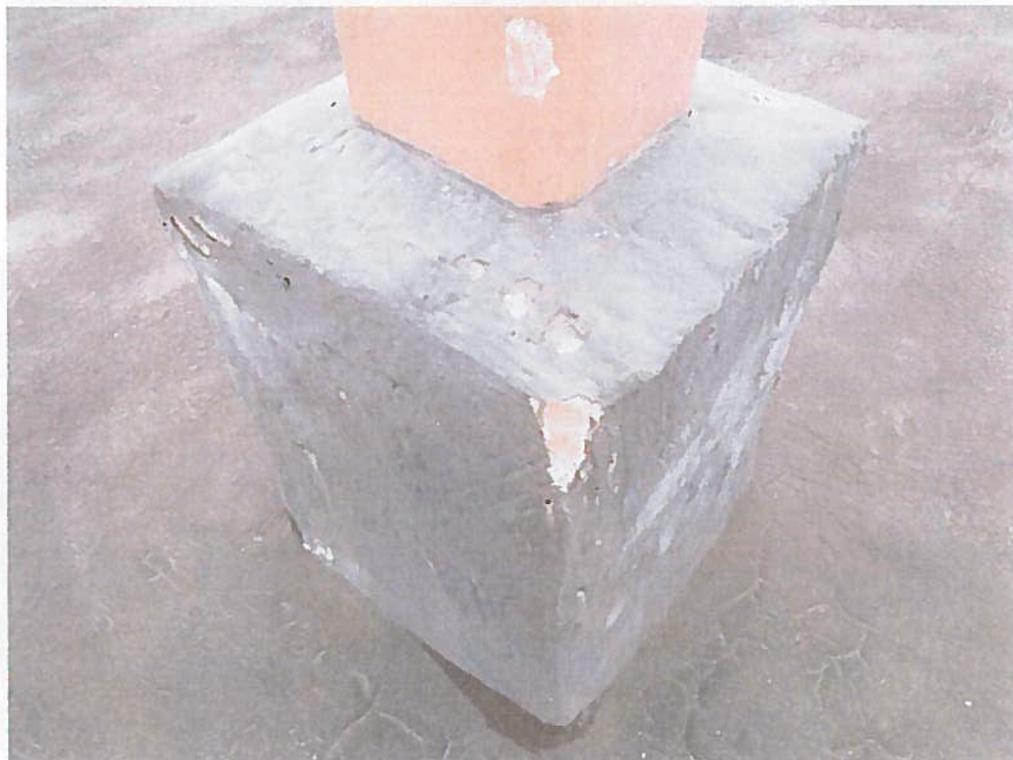
ACM Roof Chimney Grout and Flashing
