ENVIRONMENTAL REVIEW REPORT

**Community Development Block Grant – Disaster Recovery
Owner Occupied Rehabilitation and Rebuilding Program**

**43 Pine Ridge Road
Fairfield, Connecticut**

October 31, 2014

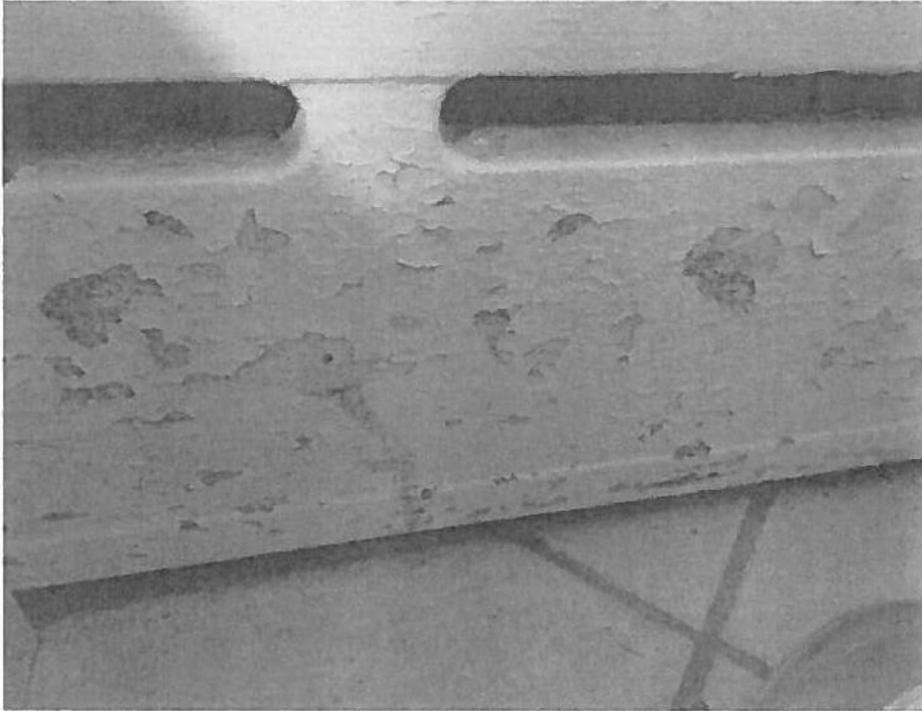
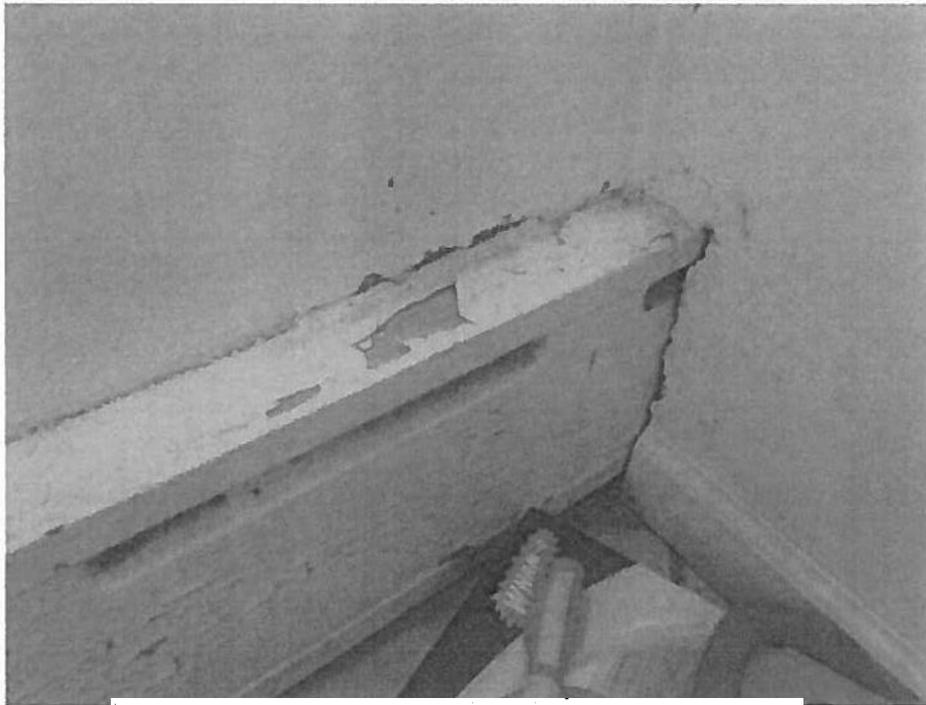
Building Component	Location	Reading (mg/cm ²)	Defective?
	Den/Dining Room		
Metal Radiator (Painted)	Lower Level Den	2.5	Yes
Metal Air Vent	Upper Level Corridor	1.1	No
Metal Door Casing	Garage	1.0	No
Metal Vertical Column	Garage	1.0	No
Metal Baluster	Front Entrance Exterior Stairwell	1.1	Yes
Window Sill and Trim	Exterior of Side A (Living Room)	1.1–1.5	No
Basement Window Frame	Exterior of Side A	1.1	No

Defective Lead-Based Paint on Lower Level Den Radiator

Interior defective LBP identified on the lower level den radiator must be completely abated of LBP. Toxic levels of lead were identified within the matrix of the non-coated radiators, which are not included in proposed demolition during renovation activities. Because the metal radiators are not considered a painted surface, a lead hazard does not exist.
