**BAILIWICK ROAD over
MIANUS RIVER**

ConnDOT Bridge No. 05491 ✓

PRELIMINARY APPLICATION FOR THE LOCAL BRIDGE PROGRAM

**BRIDGE SAFETY INSPECTION
STATE PROJECT NO. 170-2729**

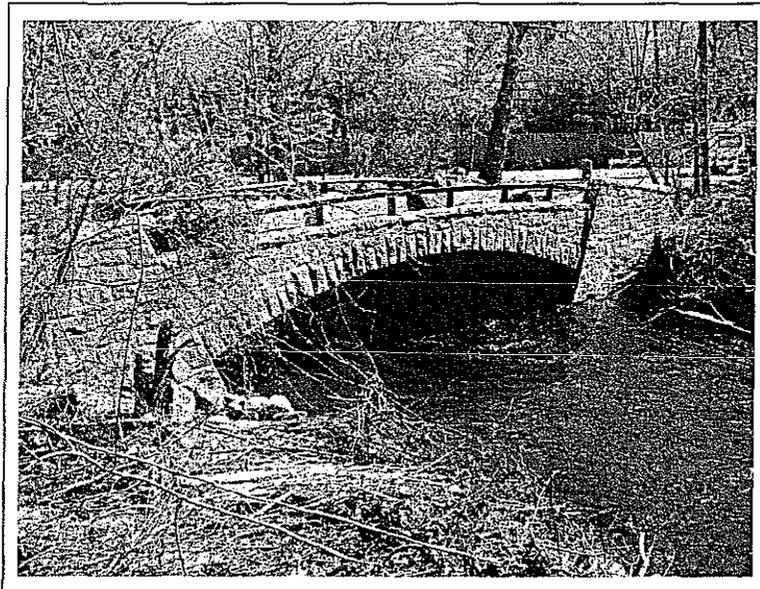
Bridge No. 05491 carries Bailwick Road over the Byram River in Greenwich, Connecticut. The bridge consists of a single span concrete arch deck. The bridge has an overall length of 33 feet and a curb-to-curb measurement of 26.1 feet. The structure was built in 1970. According to information on file at the Connecticut Department of Transportation, the bridge has a load rating capacity of 34 tons based on a judgement rating for an AASHTO HS loading using the load factor design method. Consideration should be given to performing a load rating analysis for this structure.

A routine inspection completed in April 2007, determined the general condition of the bridge to be out of service (Overall Rating = 0). It should be noted that the structure is currently closed to all service due to washout and buckling of the pavement and the washed out north fascia and parapet. The deficiencies found on the bridge and the recommendations for repairs are as follows:
