PROBLEMS TO AVOID

STARTING AT THE ROOF

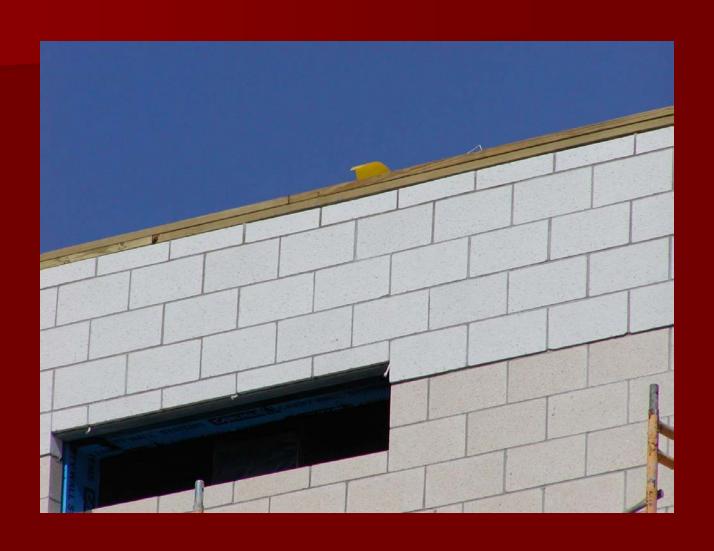
ROOF TIE IN

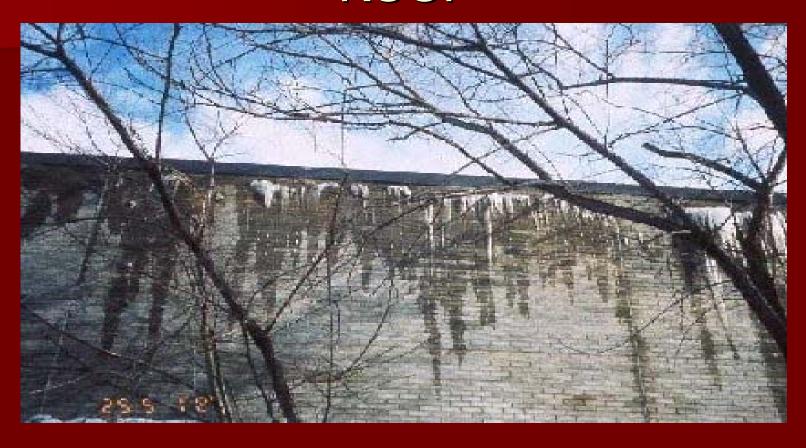
NO AIR BARRIER TIE IN WITH THE ROOF

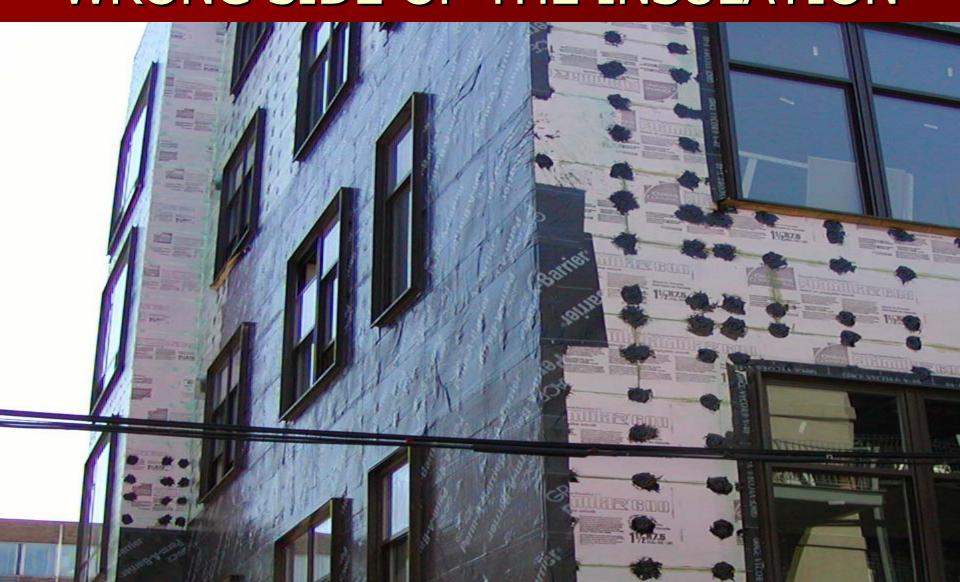
AIR/VAPOR BARRIER ON THE WRONG SIDE OF THE INSULATION

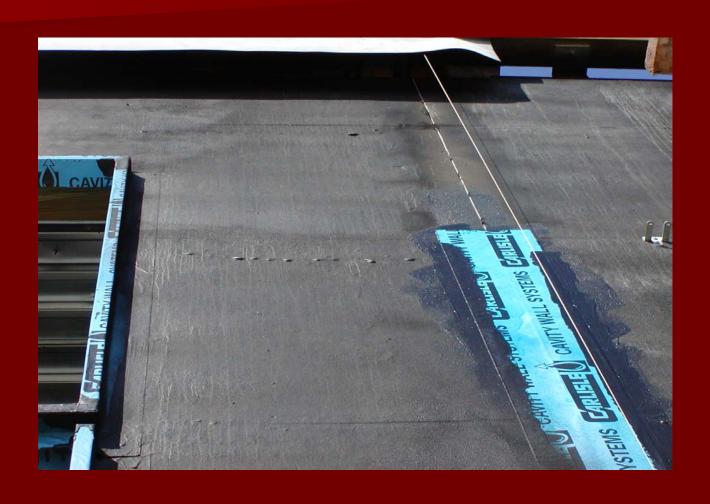
ROOF IS NOT IN BEFORE THE WALL AIR BARRIER IS INSTALLED

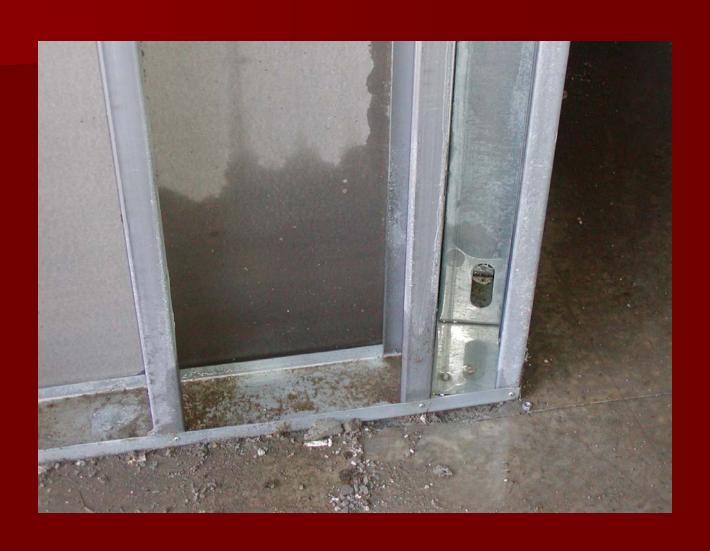
AVOID EXTERIOR GYP BOARD

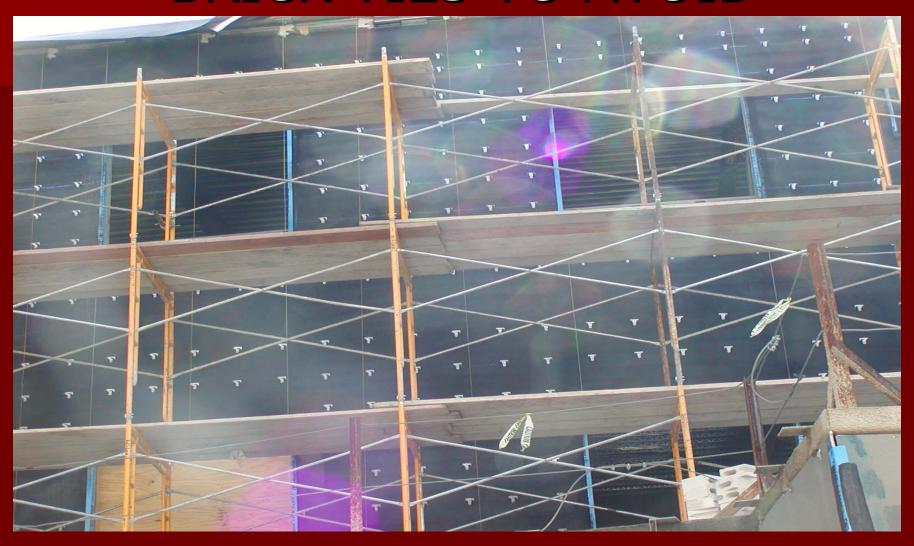
BRICK TIES TO AVOID

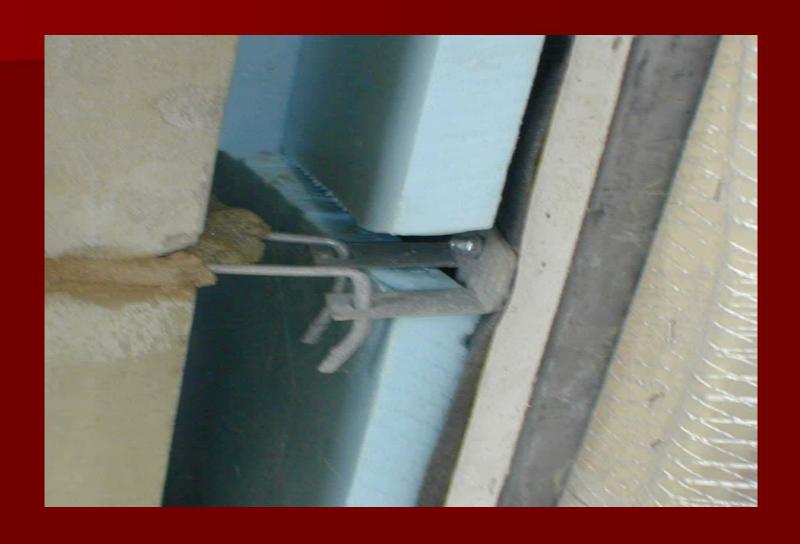
AVOID THIS TYPE OF BRICK TIE

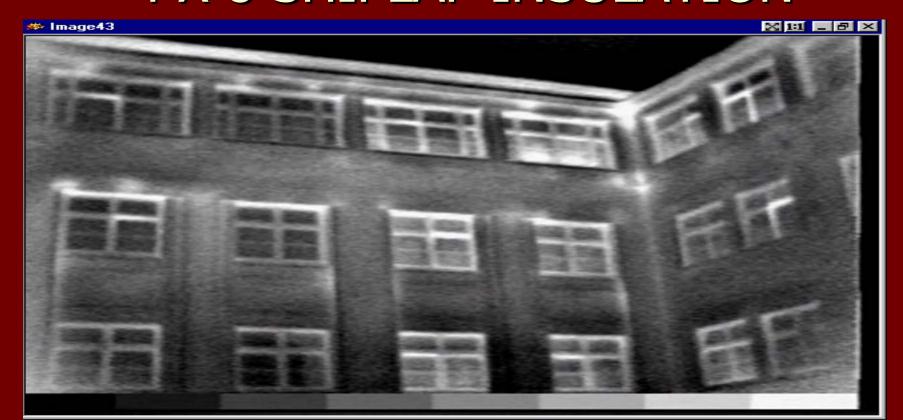
RESULT OF BRICK TIES THAT DO NOT SECURE THE INSULATION OR ALLOW FOR 4 X 8 SHIPLAP INSULATION

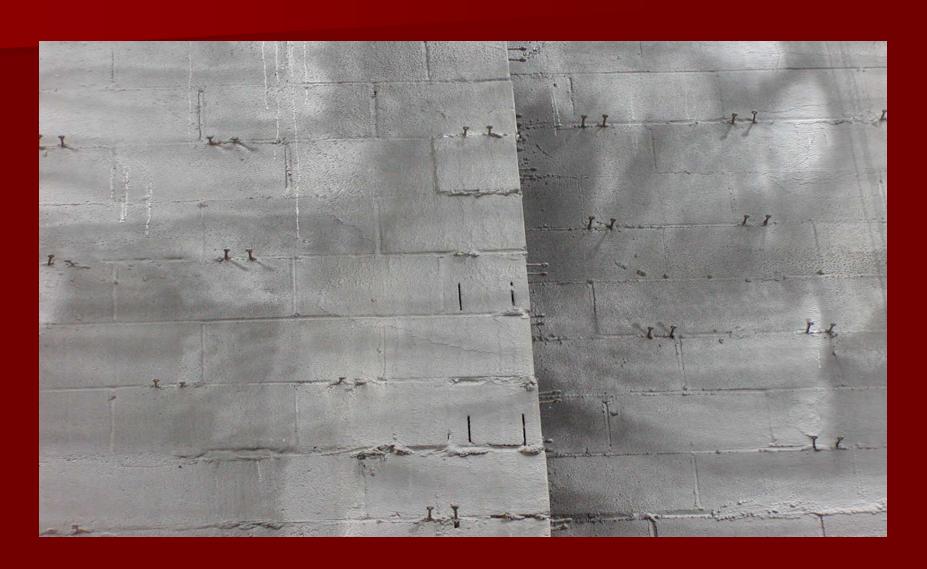
BLOCK WALLS NEED TO BE FREE OF VOIDS AND STRUCK FLUSH

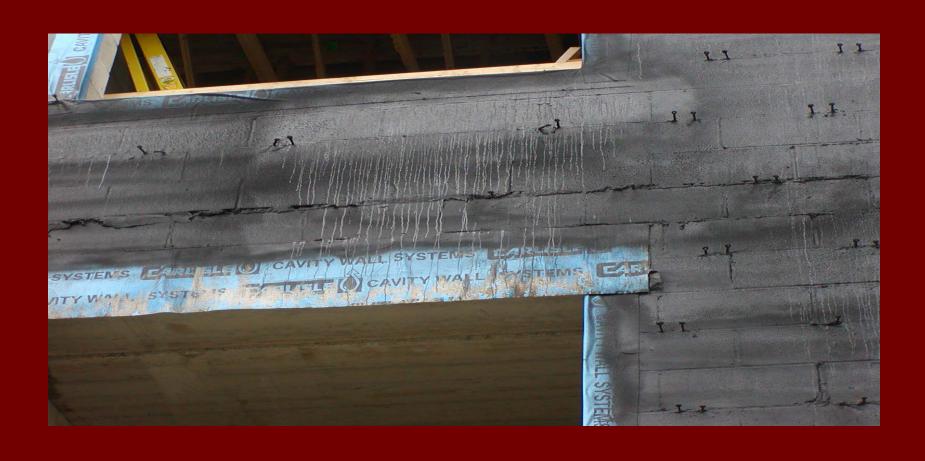
PROTECT BLOCK FROM WATER DURING CONSTRUCTION

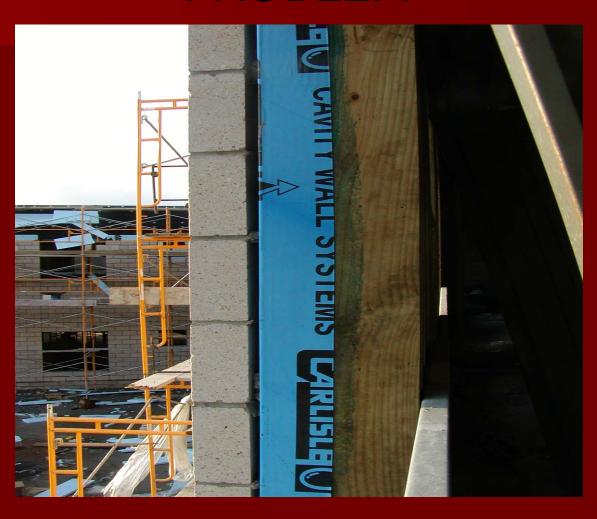
WINDOWS THERMAL BREAK PROBLEM

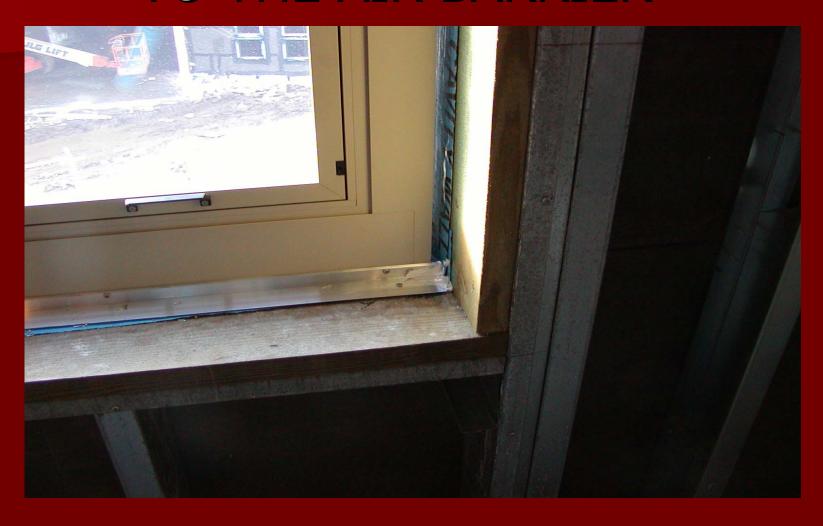
WINDOWS NEED TO BE SEALED TO THE AIR BARRIER

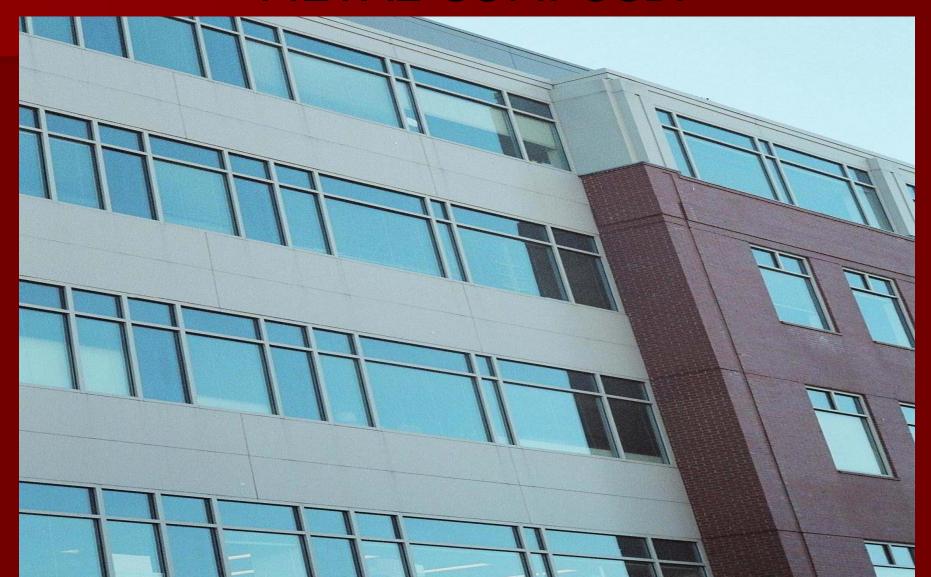
PROBLEMS WITH WET SEAL METAL COMPOSIT

- COMPOSIT MANUFACTURES DO NOT DESIGN WET SEALS TO BE VENTED AND THERE IS NO TESTING
- VENTED WET SEALS IS LIKLEY TO TAKE IN WATER NOT DRAIN WATER
- DIFFICULT IF NOT IMPOSSIABLE TO DESIGN VENTING SYSTEM TO BE 10 TIMES MORE PERMEABILITY (1304.1.13)

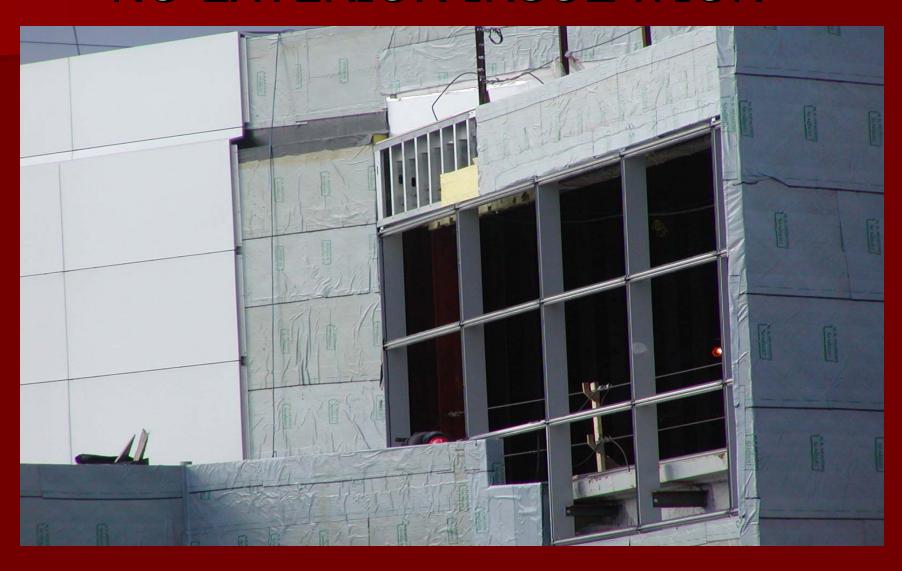
DOUBLE VAPOR BARRIOR NO EXTERIOR INSULATION

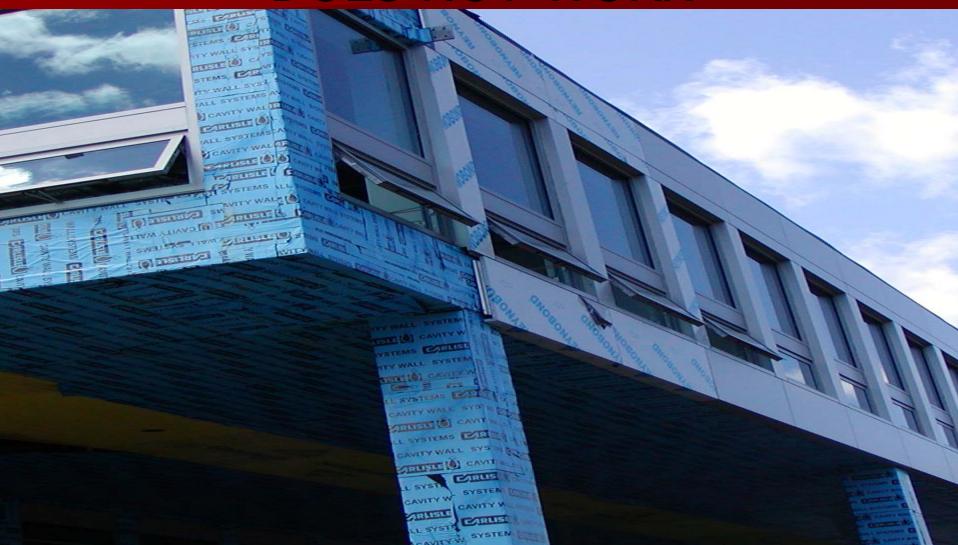
DOUBLE VAPOR BARRIER INSULATION ON THE EXTERIOR DOES NOT WORK

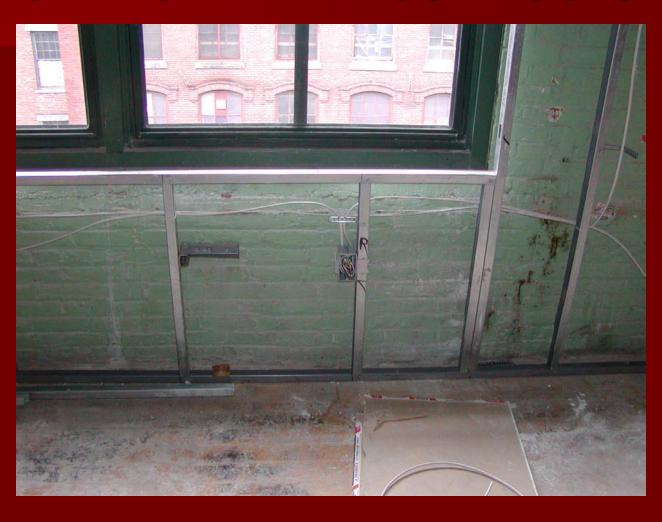
THE BUILDING OF A NEW HOME FOR MOLD AND CORROSION
