Docket No. 217 – Development and Management Plan Inspection

Northeast Utilities Service Company Certificate of Environmental Compatibility and Public Need for the construction of a 345-kV electric transmission line and reconstruction of an existing 115-kV electric transmission line between Connecticut Light and Power Company's Plumtree Substation in Bethel, through the towns of Redding, Weston, and Wilton, and to the Norwalk Substation in Norwalk, Connecticut.

Date: May 10, 2006

Location: 115 kV Underground Route

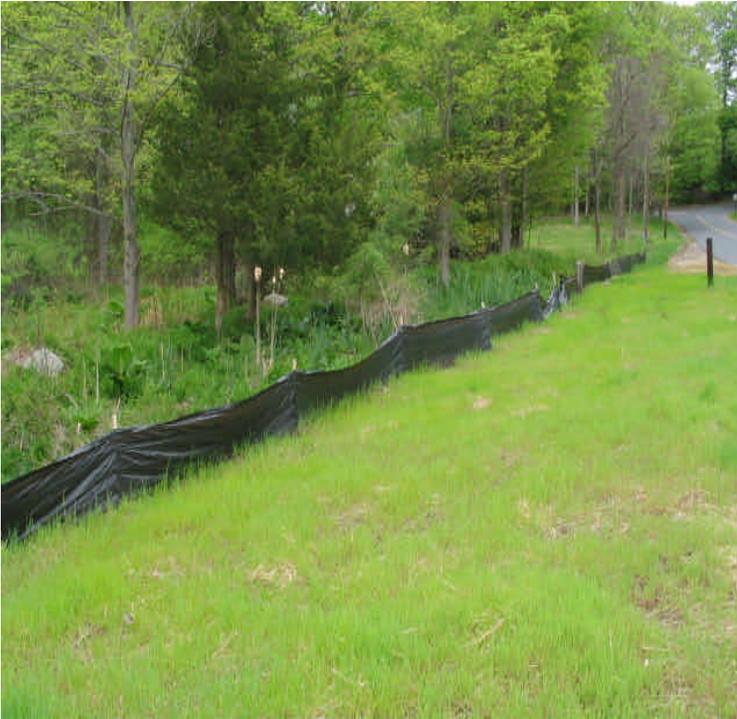
115kV (Sunset Hill): Photo on the left shows the portion of the old storage area which is well vegetated and stable. Photo on the right shows the portion along Rt. 58 which was washed out in the recent rain. Silt fence should remain on this side until the seed takes. 5/10/06

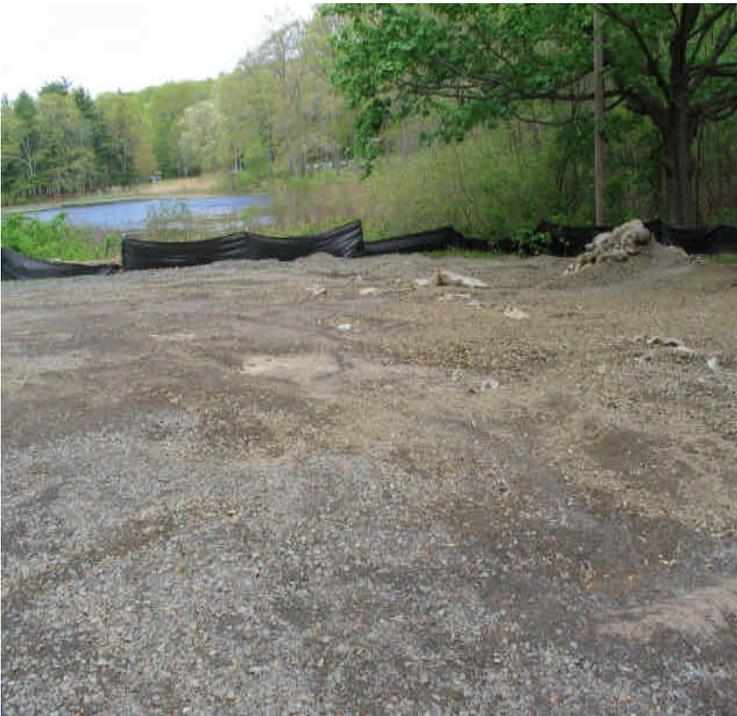
(Putnam Park, Rt. 107): Photo on the left shows the Putnam Park storage area where the pile of process was removed. Photo on the right shows controls remaining in good shape along the Redding CC storage area. 5/10/06
