Docket No. 217 – Development and Management Plan Inspection

Northeast Utilities Service Company Certificate of Environmental Compatibility and Public Need for the construction of a 345-kV electric transmission line and reconstruction of an existing 115-kV electric transmission line between Connecticut Light and Power Company's Plumtree Substation in Bethel, through the towns of Redding, Weston, and Wilton, and to the Norwalk Substation in Norwalk, Connecticut.

Date: May 25, 2006

Location: 115 kV Underground Route

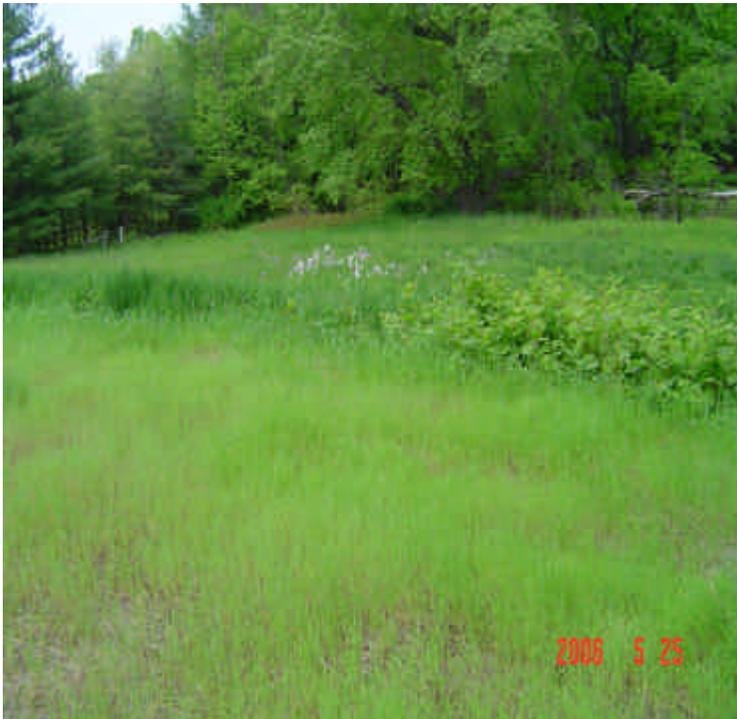
Photo on the left shows the Rt. 107 storage area with well established vegetation. Silt fence can be removed from here when feasible. Photo on the right shows the area north of Sunoco along Rt. 58 where grass is growing well. 5/25/06

Areas of Inspection	Observation	Recommended Action	Corrective Action
Staging, Storage, and Parking Areas	- The Sunset Hill Rd., Putnam Park, and Rt. 107 storage yard controls are in good shape. 5/25/06	-None at this time. Continue to monitor. Silt fence could be removed from the Rt 107 area and portions of Sunset Hill whenever feasible 5/25/06	- N/A
State species of concern, threatened and endangered species	- No species of concern are located in the areas of construction.	- N/A	-N/A
Vegetative clearing limits (including trees to save or danger trees noted)	- Most areas are quickly becoming stabilized with increased vegetative growth. 4/12-5/25/06	-Continue to monitor but areas look good. 5/25/06.	-Stabilization is occurring
Dewatering	- Dewatering is no longer necessary. 5/25/06	-None at this time. 5/25/06	-N/A
Blasting	- No blasting is occurring in any areas at this time.	- None at this time.	-N/A

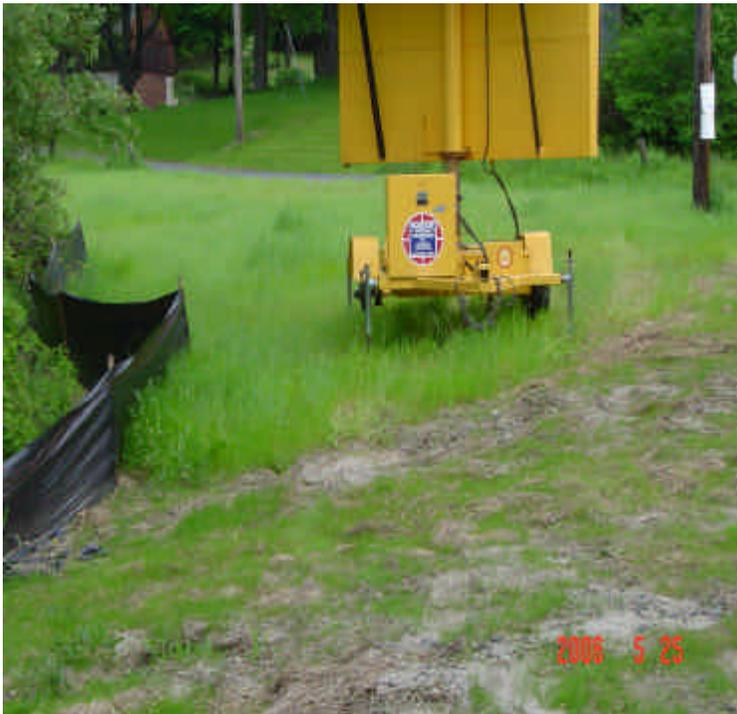
Photo on the left shows the Sunset Hill storage area where the portion of the yard adjacent to Rt 58 is beginning to fill in a little. Continue to monitor. Photo on the right shows the northern area of the ROW at Bethel Ed. Park. Vegetation is returning here following restoration. 5/25/06
