**Docket No. 217 – Development and Management Plan Inspection**

Northeast Utilities Service Company Certificate of Environmental Compatibility and Public Need for the construction of a 345-kV electric transmission line and reconstruction of an existing 115-kV electric transmission line between Connecticut Light and Power Company's Plumtree Substation in Bethel, through the towns of Redding, Weston, and Wilton, and to the Norwalk Substation in Norwalk, Connecticut.

**Date:** June 1, 2006

**Location:** 115 kV Underground Route

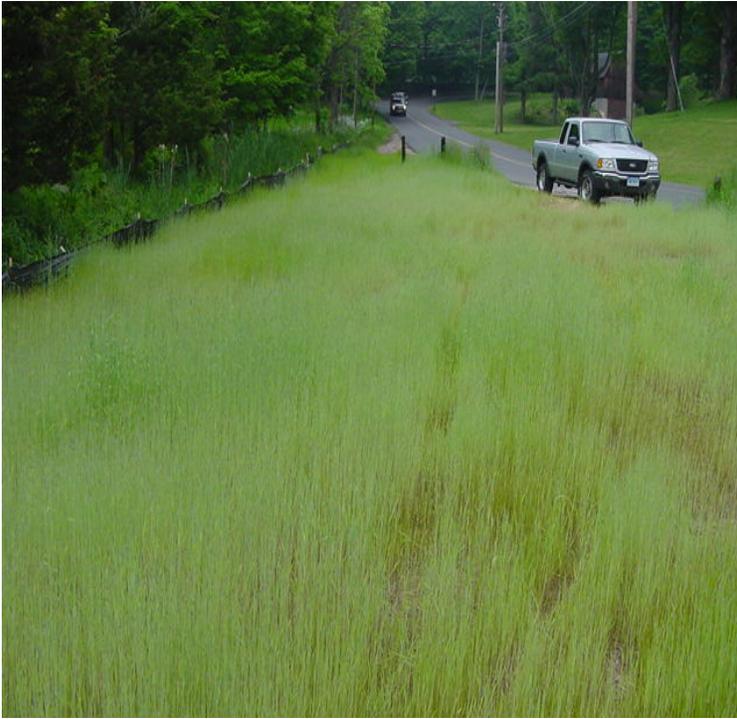
Photo on the left shows the storage area where vegetation is growing very well along the Sunset Hill Rd side. Photo on the right shows the current status of the Putnam Park storage area with controls in place. 5/31/06

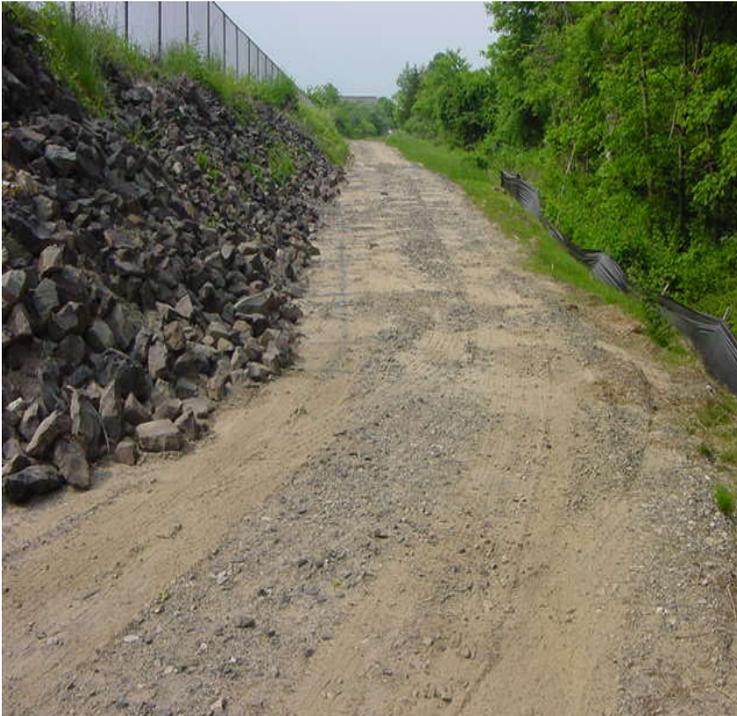
Photo on the left shows the southern portion of the ROW in the Bethel Ed Park. Washouts across the road have been reduced. Photo on the right shows the area near the southern tower where a small washout is overtopping the silt fence. 5/31/06

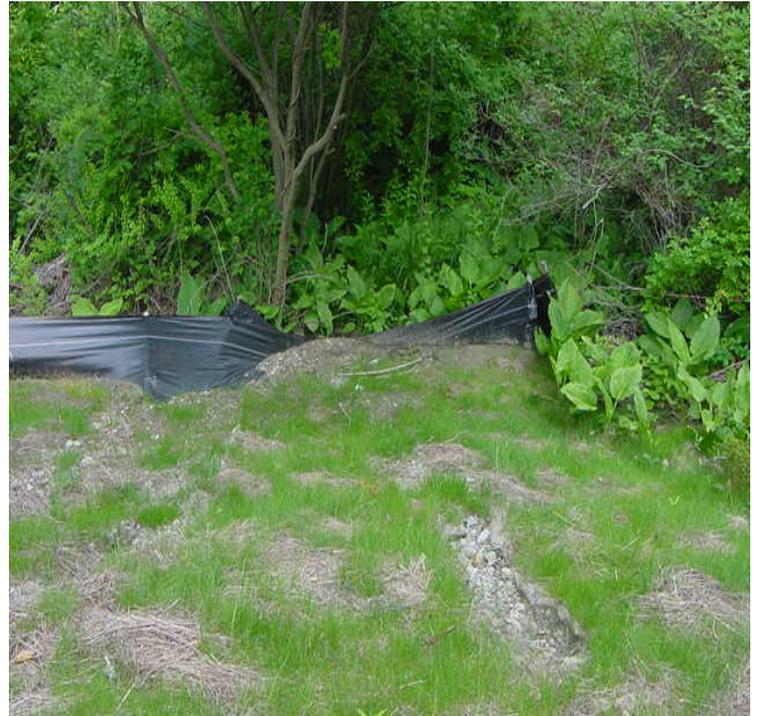
Areas of Inspection	Observation	Recommended Action	Corrective Action
<p><b>Park</b></p> <p><b>Route 58</b></p> <p><b>Rt. 107 (Lonetown Rd)</b></p>	<p>slight erosion. 4/26-6/1/06</p> <p>- A small washout was also noted at the southern tower where sediment was overtopping the silt fence. 6/1/06</p> <p>-Restoration efforts appear complete at this time. 4/26-6/1/06</p> <p>- Remain aware of controls at Putnam Park storage area when moving around the remaining stone. 6/1/06</p> <p>-The edge of the Sunset Hill Rd. storage area along Rt. 58 was restored again with topsoil, seed and mulch but rains continued to cause some erosion here. 4/26- 6/1/06</p> <p>-Restoration efforts appear complete. 4/26-6/1/06</p> <p>- Controls at the 90 degree turn on Rt. 107 are well in place and vegetative growth increases. 6/1/06</p> <p>- The Redding CC storage area stone surface remains stable and controls are in good shape. 6/1/06</p>	<p>was growing along the ROW. 6/1/06</p> <p>- Pull back sediment and repair fence if possible. 6/1/06</p> <p>- Continue to monitor for final stabilization. All previous work areas look good. 6/1/06.</p> <p>- None at this time. 6/1/06</p> <p>- The silt fence parallel to Rt. 58 should remain as it is preventing sedimentation to the wetland here but the remaining area is increasingly stable and silt fence could be removed. 5/4-6/1/06</p> <p>- Continue to monitor for final stabilization. All previous work areas look good. 6/1/06.</p> <p>- The area is stabilized. Silt fence and haybales can be removed whenever feasible here. 4/26-6/1/06</p> <p>- None at this time. The area is being used for some additional parking but will be restored after the roadway work. 6/1/06</p>	<p>- Needs attention if feasible</p> <p>- Restoration efforts appear complete and grass growth continues.</p> <p>- N/A</p> <p>- N/A (Grass growth continues)</p> <p>- Restoration efforts appear complete and areas are stabilizing</p> <p>-N/A</p> <p>- N/A</p>
