Docket No. 217 – Development and Management Plan Inspection

Northeast Utilities Service Company Certificate of Environmental Compatibility and Public Need for the construction of a 345-kV electric transmission line and reconstruction of an existing 115-kV electric transmission line between Connecticut Light and Power Company's Plumtree Substation in Bethel, through the towns of Redding, Weston, and Wilton, and to the Norwalk Substation in Norwalk, Connecticut.

Date: June 14, 2006

Location: 115 kV Underground Route

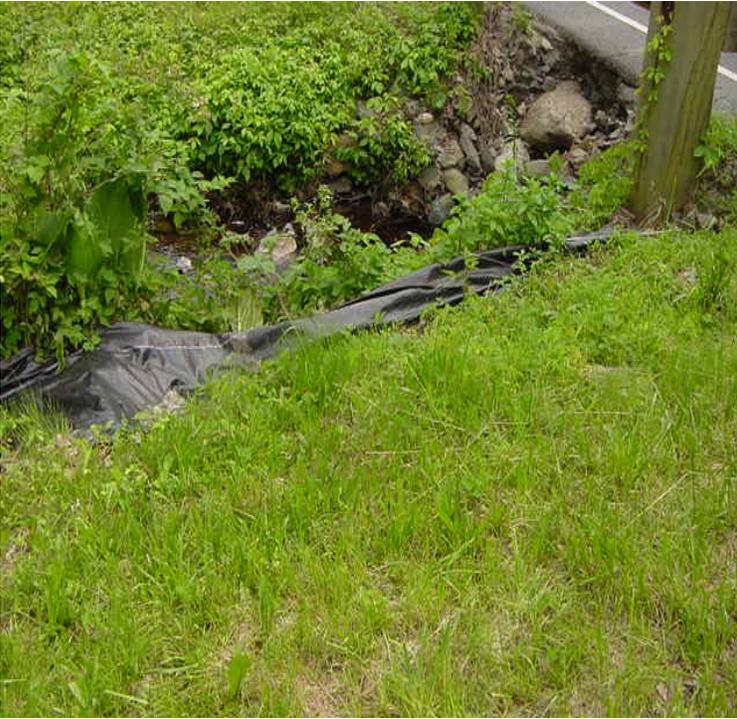
Photo on the left shows a section of silt fence down near the swale adjacent to the Putnam Park parking area. Photo on the right shows a topsoil stockpile stored near the swale. Silt fence should be righted due to the adjacent soil. 6/14/06

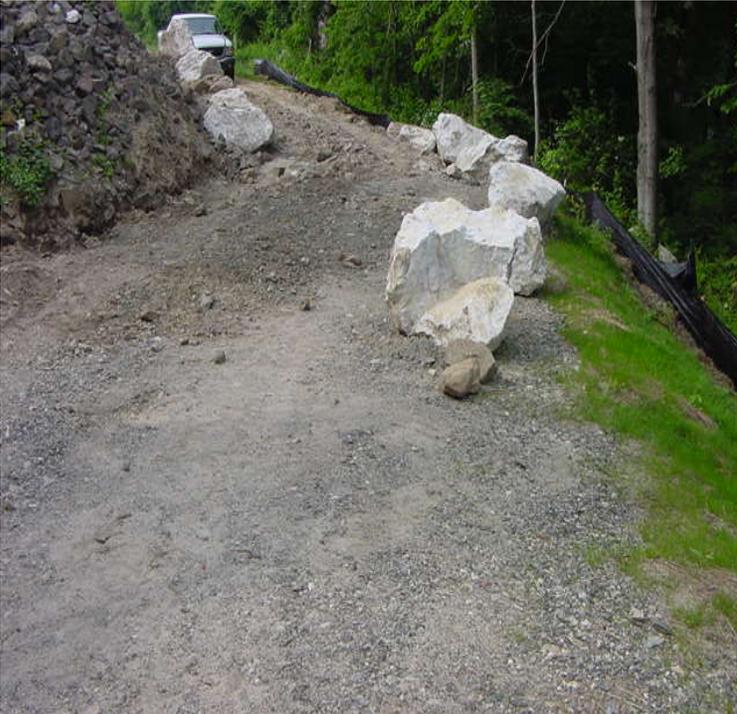
Photo on the left shows the installation of the boulders along the Bethel Education Park southern ROW. Photo on the right shows the storage area across from the Redding CC. 6/14/06
