**Docket No. 217 – Development and Management Plan Inspection**

Northeast Utilities Service Company Certificate of Environmental Compatibility and Public Need for the construction of a 345-kV electric transmission line and reconstruction of an existing 115-kV electric transmission line between Connecticut Light and Power Company's Plumtree Substation in Bethel, through the towns of Redding, Weston, and Wilton, and to the Norwalk Substation in Norwalk, Connecticut.

**Date:** June 28, 2006

**Location:** 115 kV Underground Route

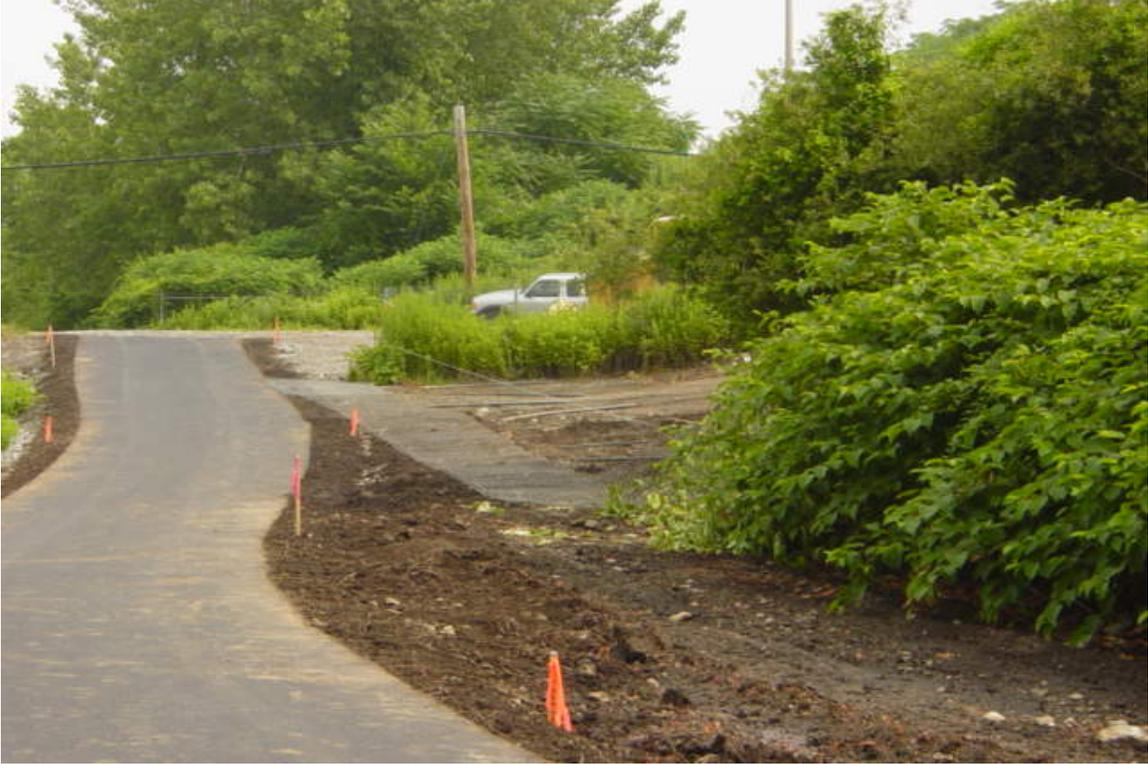
Photo shows the bike path installed from the northern edge of Norwalk Substation up the ROW to the intersection with Broad Street. It is unclear whether this work is associated with 115kV contractors. 6/28/06

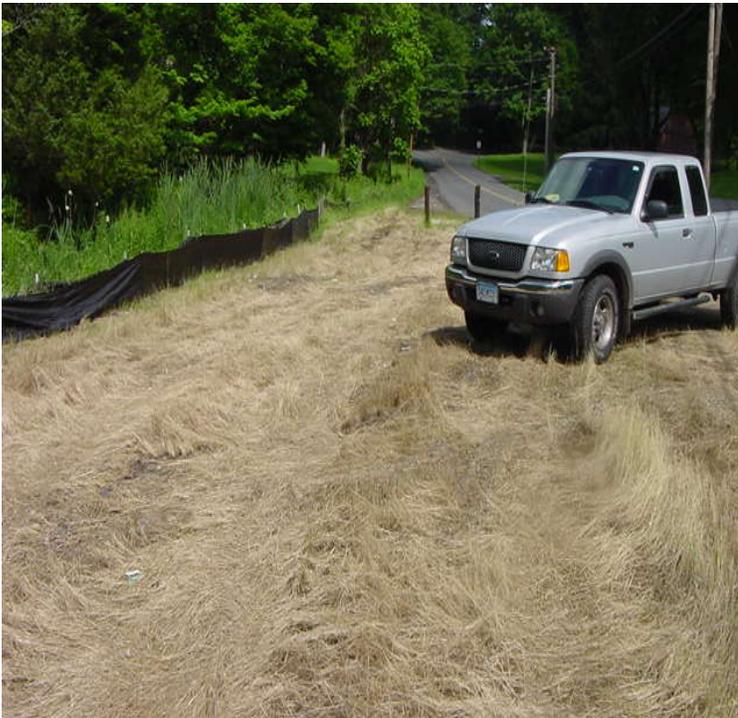
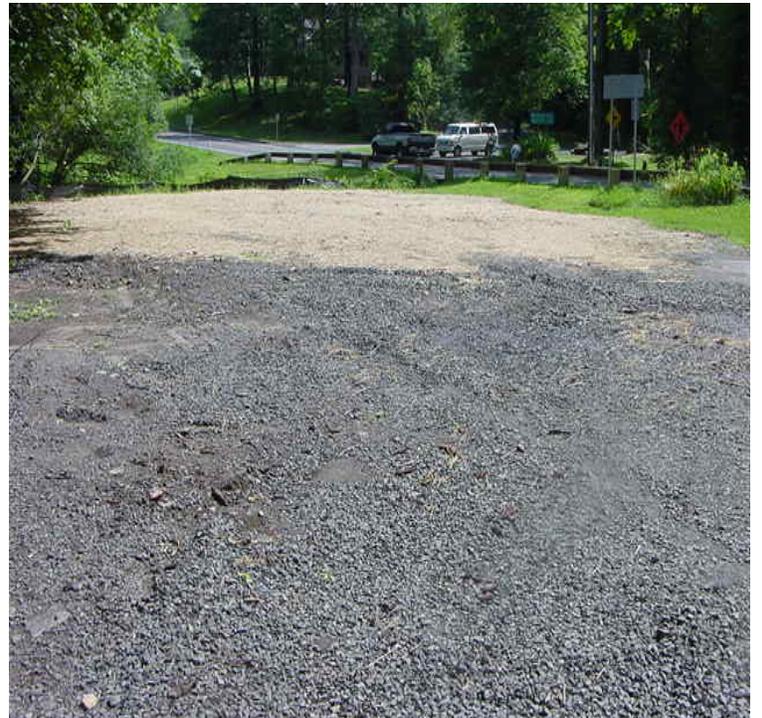
Photo on the left shows a view of the Sunset Hill storage area. The grass here is dying back but the existing root system should help stabilize. Photo on the right shows a restored portion of the Putnam Park storage area. 6/28/06
