Docket No. 217 – Development and Management Plan Inspection

Northeast Utilities Service Company Certificate of Environmental Compatibility and Public Need for the construction of a 345-kV electric transmission line and reconstruction of an existing 115-kV electric transmission line between Connecticut Light and Power Company's Plumtree Substation in Bethel, through the towns of Redding, Weston, and Wilton, and to the Norwalk Substation in Norwalk, Connecticut.

Date: July 19, 2006

Location: 115 kV Underground Route

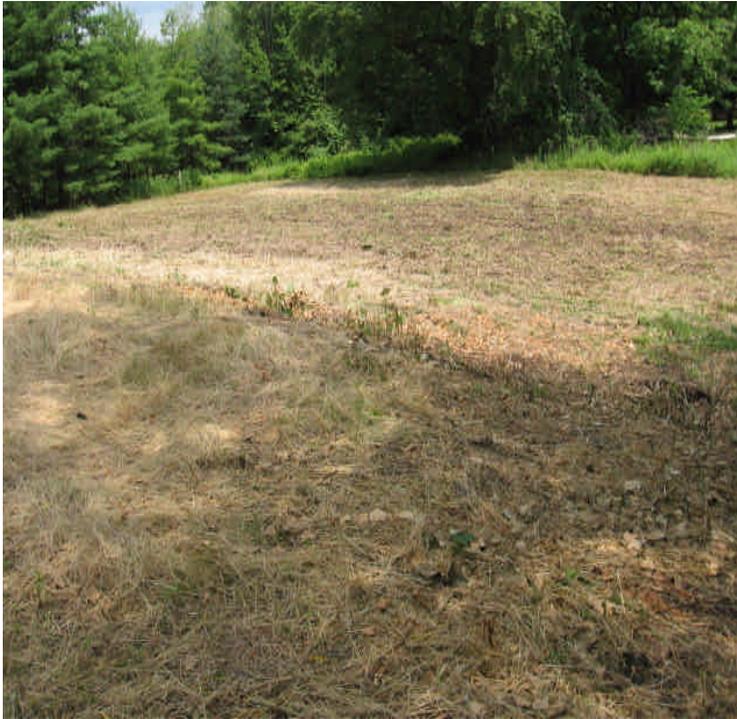
Photo on the left shows the Rt 107 turn area. The erosion controls were removed and the landowner has mowed the parcel. This area is stable and jurisdiction is essentially returned to the landowner. Photo on the right shows the Putnam Park parking area returned to the DOT which is now storing stockpiles here. This work is no longer project related. 7/19/06

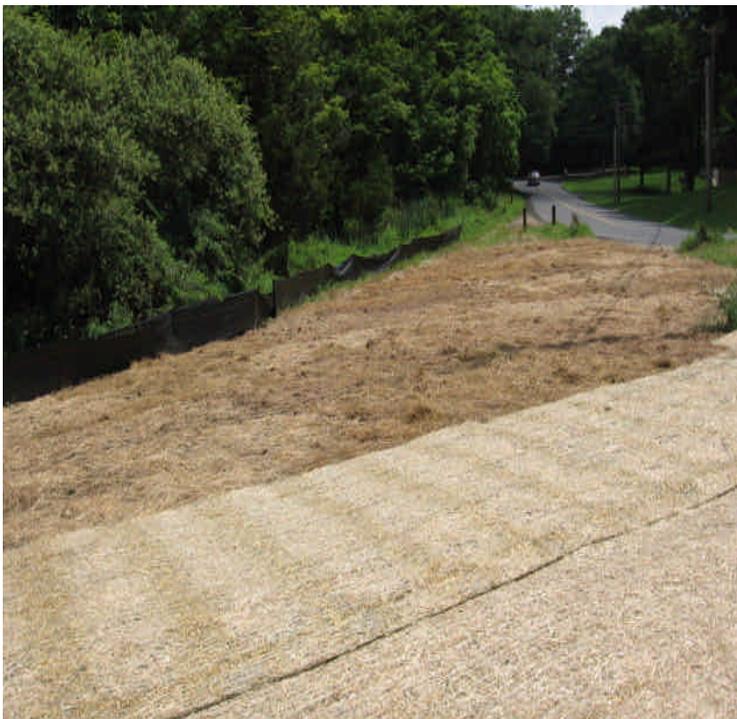
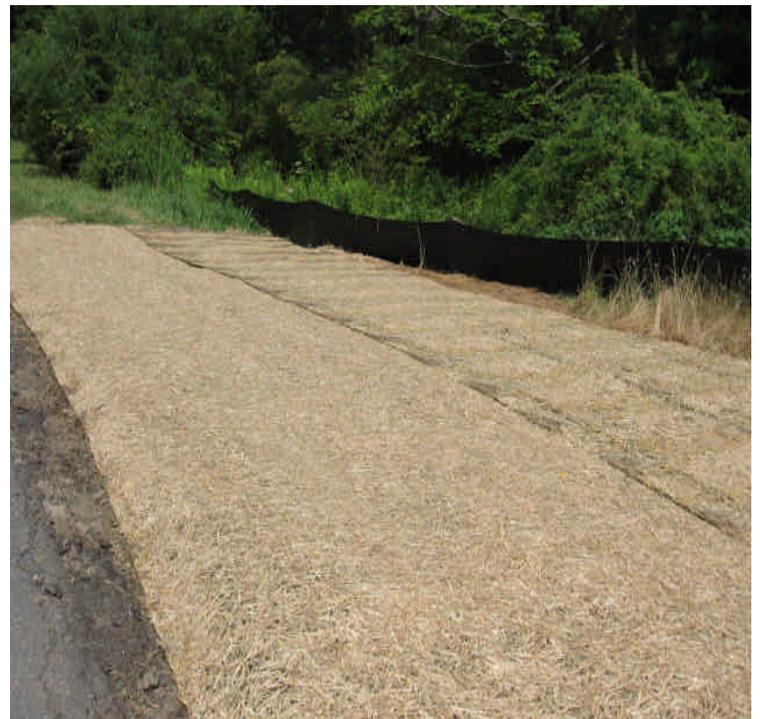
Both photos show a view of the Sunset Hill Rd storage area. The area has been restored with new seed and mulch and erosion control mats were installed in the areas that continue to wash out along Rt 58. 7/19/06

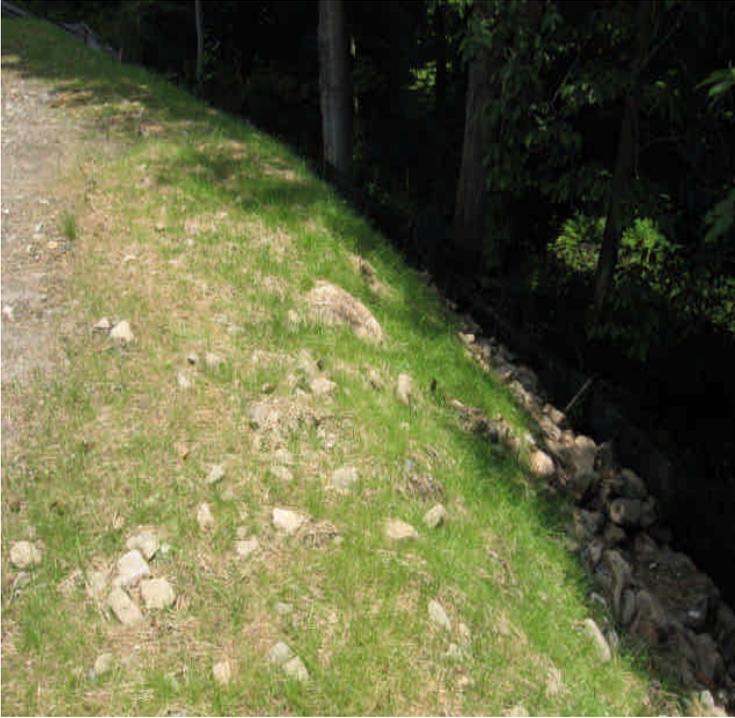
Photo on the left shows the slope on the southern portion of the Bethel Ed Park ROW. Grass is beginning to return here. Erosion control matting was going to be installed adjacent to this slope at the washout. Photo on the right shows a topsoil stockpile at the driveway to the Hoyts Hill transition structure where grading and final restoration was occurring. 7/19/06

Erosion and Sediment Controls	-The northern ROW remains in good shape 7/19/06	-Continue to monitor for stabilization. Grass is increasing here. 7/19/06	-N/A
Bethel Education	- Several washouts were noted due to the steep	-Erosion control mats were to be installed that	- Erosion control mats will be used

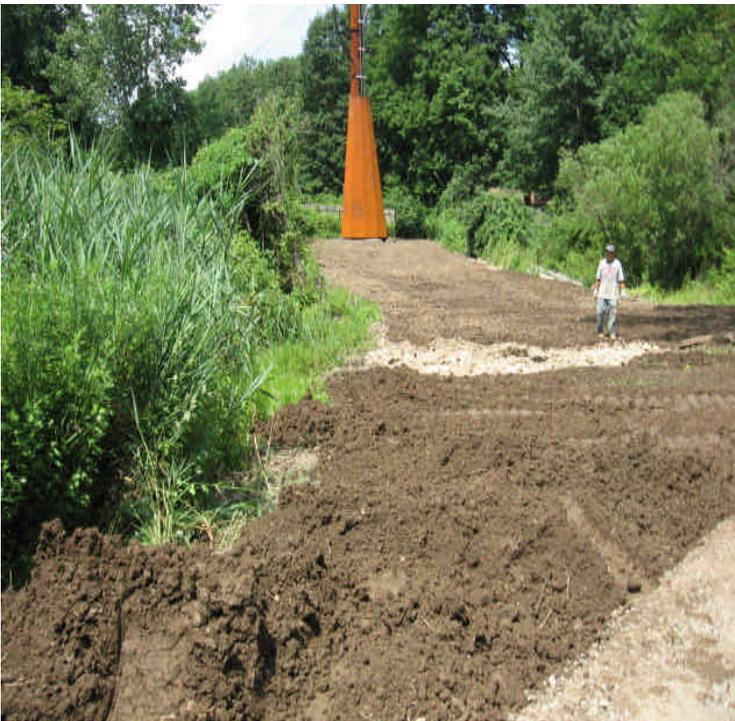
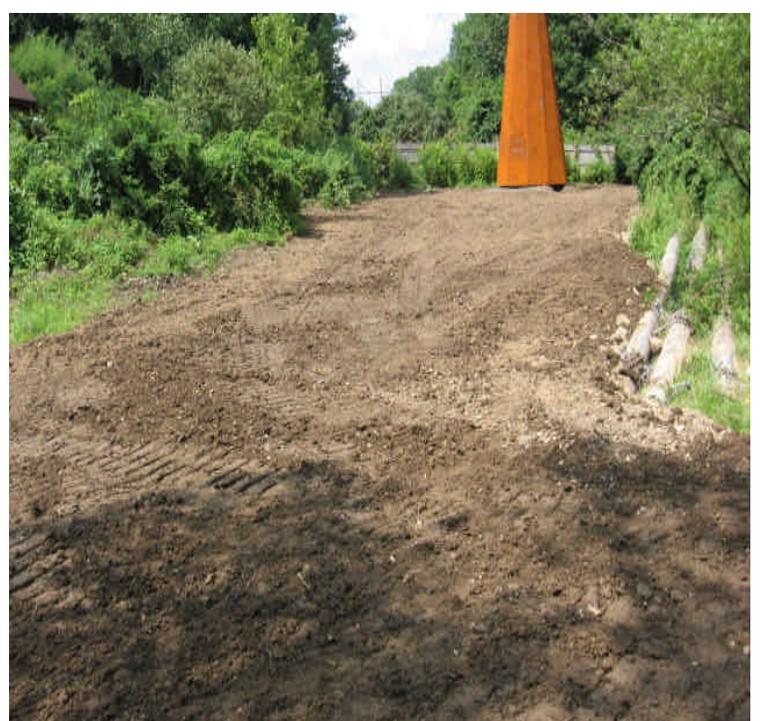
Both photos show the grading at the transition structure to prevent parking of un-authorized vehicles. This will be seeded and mulched and the access drive narrowed on request of the landowner. 7/19/06
