**Docket No. 217 – Development and Management Plan Inspection**

Northeast Utilities Service Company Certificate of Environmental Compatibility and Public Need for the construction of a 345-kV electric transmission line and reconstruction of an existing 115-kV electric transmission line between Connecticut Light and Power Company's Plumtree Substation in Bethel, through the towns of Redding, Weston, and Wilton, and to the Norwalk Substation in Norwalk, Connecticut.

**Date:** July 26, 2006

**Location:** 115 kV Underground Route

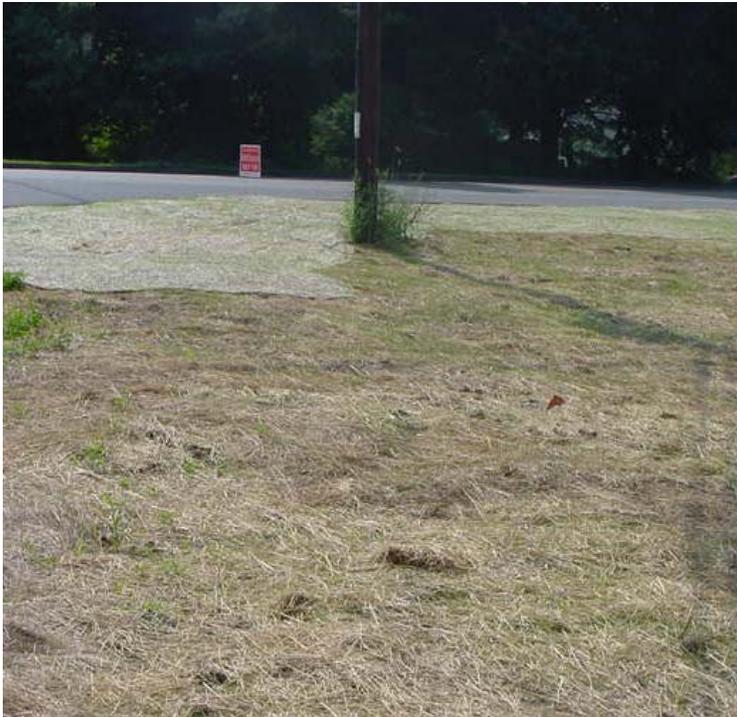
Photo on the left shows a view of the Sunset Hill Rd storage area. The recently restored area with the erosion control mats and seed and mulch was beginning to show vegetative growth. Photo on the right shows some silt fence debris remaining in the restored area adjacent to the bike path on

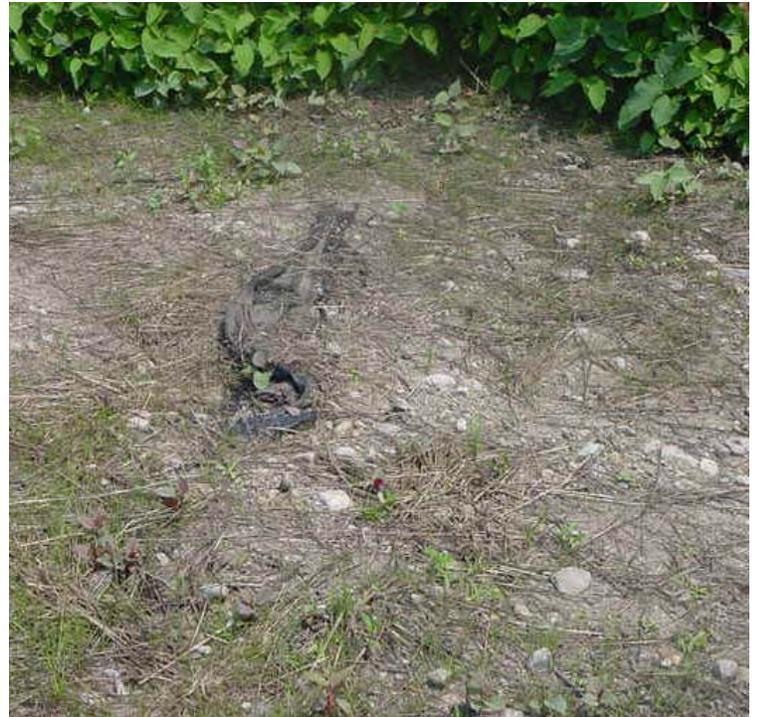
Broad St. This is along the ROW and should be removed if possible. 7/26/06

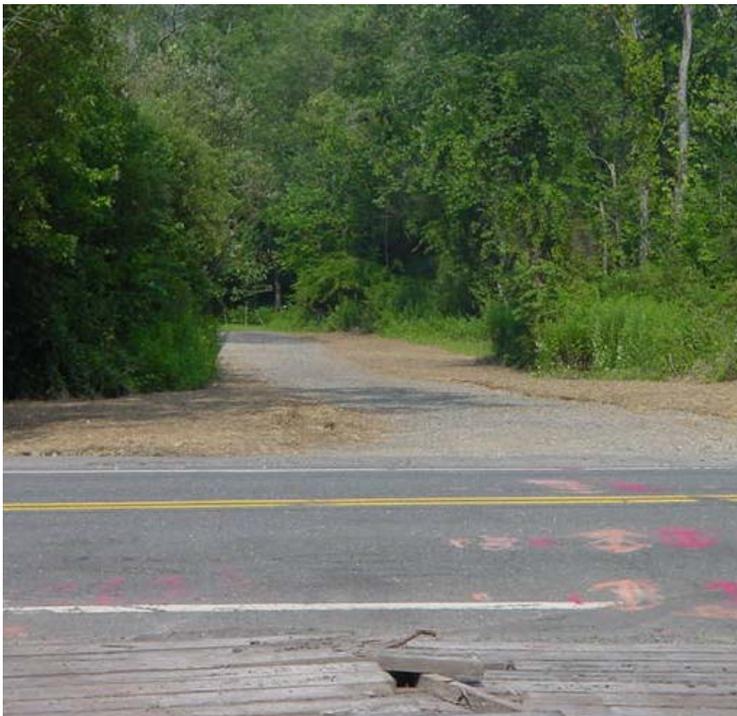
Photo on the left shows the restoration along the driveway to the Hoyts Hill transition structure. The driveway was narrowed per landowner's request and seeded and mulched. Photo on the right shows a washout remaining over the silt fence at the Bethel Ed Park near the south tower. 7/26/06

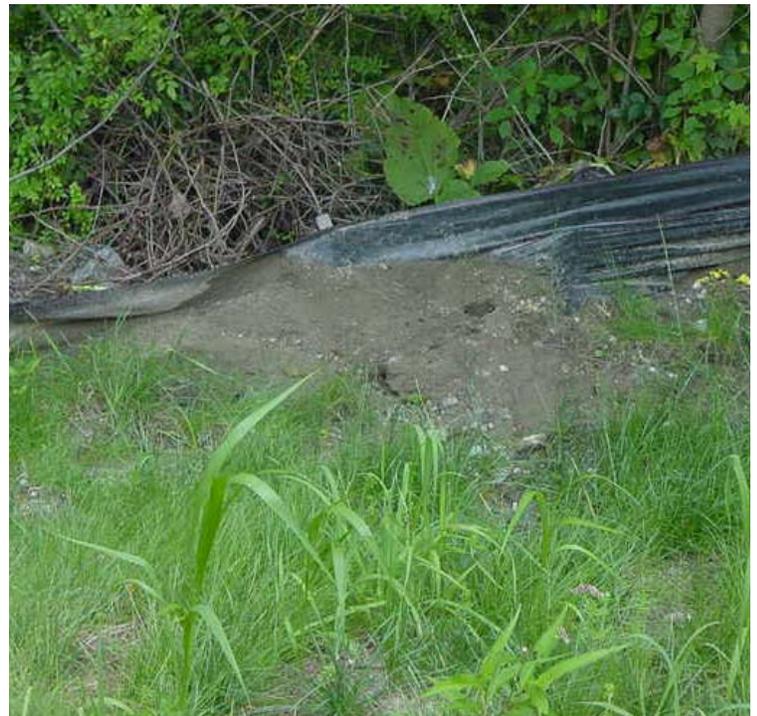
<b>Bethel Education</b>	- Several washouts were noted due to the steep	- Repair the washout as well. 7/26/06	- Erosion control mats will be used

Areas of Inspection	Observation	Recommended Action	Corrective Action
Active Work	- <b>Bethel Educational Park:</b> - A piece of erosion control mat was to be installed on the southern slope but a small washout remains. 7/26/06	-See EC section. 7/26/06	-Still needs attention
<b>Rt. 107, Redding</b>	-Most roadside restoration appears complete. 7/26/06	- See EC section. 7/26/06	- N/A
<b>Rt. 58, Bethel</b>	-Restoration work was complete at the Hoyts Hill transition structure 7/26/06	-See EC section. 7/26/06	- N/A
<b>Broad Street/ROW, Norwalk</b>	-The restored areas adjacent to the bike path had some silt fence debris under the soil. 7/12-7/26/06	-Carefully remove all old silt fence and debris from this area. 7/12-7/26/06	-Needs attention
<b>Main Ave. / Rt. 7, Norwalk</b>	-Some utility work was noted along Broad St. 7/26/06	-None at this time. 7/26/06	-N/A
Erosion and Sediment Controls	-The northern ROW remains in good shape 7/26/06	- This section appears to be stable. 7/26/06	-N/A
