Docket No. 217 – Development and Management Plan Inspection

Northeast Utilities Service Company Certificate of Environmental Compatibility and Public Need for the construction of a 345-kV electric transmission line and reconstruction of an existing 115-kV electric transmission line between Connecticut Light and Power Company’s Plumtree Substation in Bethel, through the towns of Redding, Weston, and Wilton, and to the Norwalk Substation in Norwalk, Connecticut.

Date: September 15, 2005

Location: 115 kV Underground Route

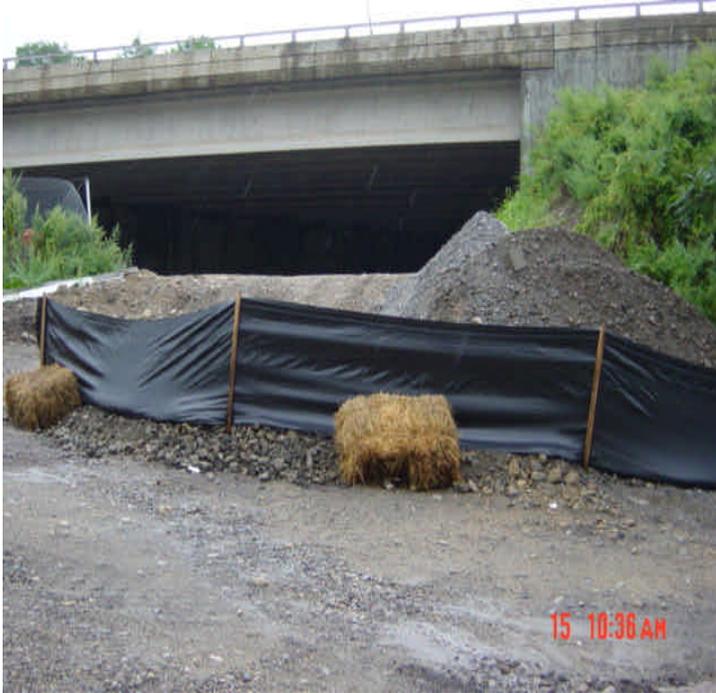
115 kV (Broad Street): Photo on the left shows silt fence installed at the base of the stockpile as recommended, but it does not appear to be toed in. Photo on the right shows protection measures placed on the catch basins as recommended. 9/15/05

<p>Broad Street and Rt. 7, Norwalk</p>	<p>- A soil stockpile from the roadwork is being kept in the ROW. Silt fence was placed here as recommended but some areas may need to be toed in. 9/15/05</p> <p>-Remove any project related debris from the ROW. 9/1-9/15/05</p> <p>-Catch basins were protected with haybales here as recommended. One set was pushed off due to stormwater volumes. 9/15/05</p> <p>- The jacking and receiving pits off Broad St. are well contained. 9/15/05</p> <p>-Nightwork on Rt. 7 continues. No issues were noted leftover during the day inspection. 9/15/05</p>	<p>-Maintain silt fence as needed. 9/15/05</p> <p>- Perform regular “good housekeeping” to remove leftover materials and clean up the workspace. 9/1-9/15/05</p> <p>- Protect any catch basins or inlets which may receive sediment. 9/7/05</p> <p>- Continue to maintain and protect catch basins. 9/15/05</p> <p>- None at this time. 9/15/05</p> <p>- The vac truck approach used at night is a very effective means of handling the muds. Continue to utilize consistently.</p>

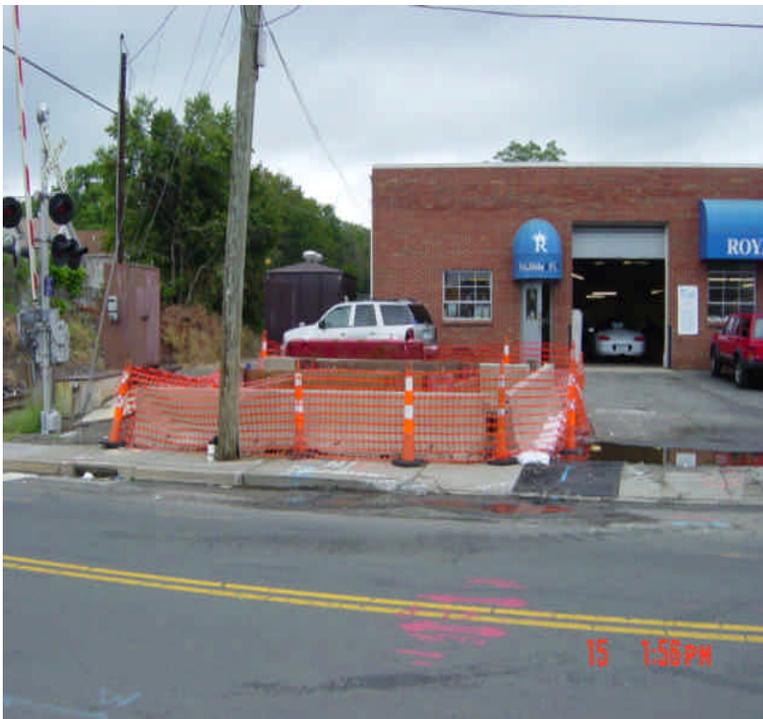
Photo on the left shows the receiving pit for the jack and bore of the railroad crossing. Photo on the right shows protection measures on the catch basins. 9/15/05

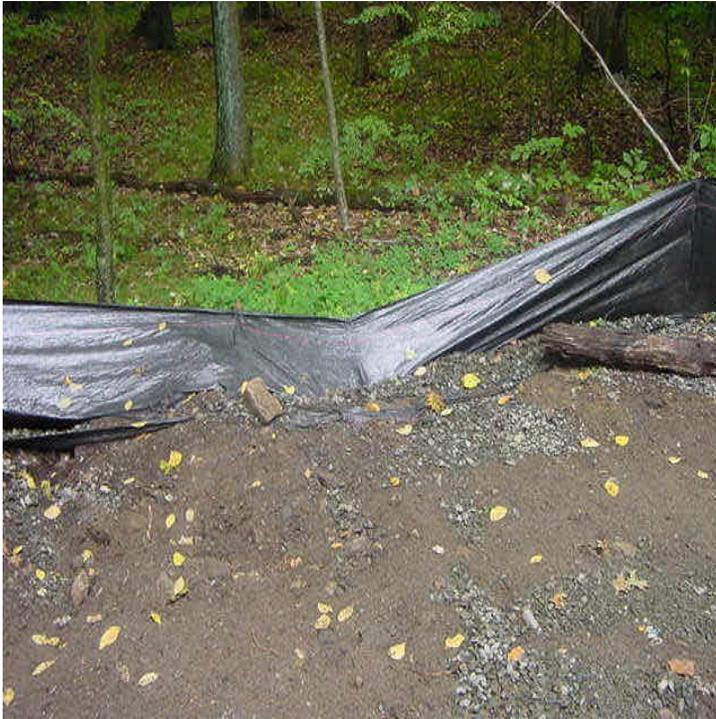
115 kV (Gallows Hill Road): Photo on the left shows some silt fence repair needed at the storage area. If the area is to no longer be used, it can be restored. Photo on the right shows the mulched vault area near Longwood Drive with silt fence removed. 9/15/05

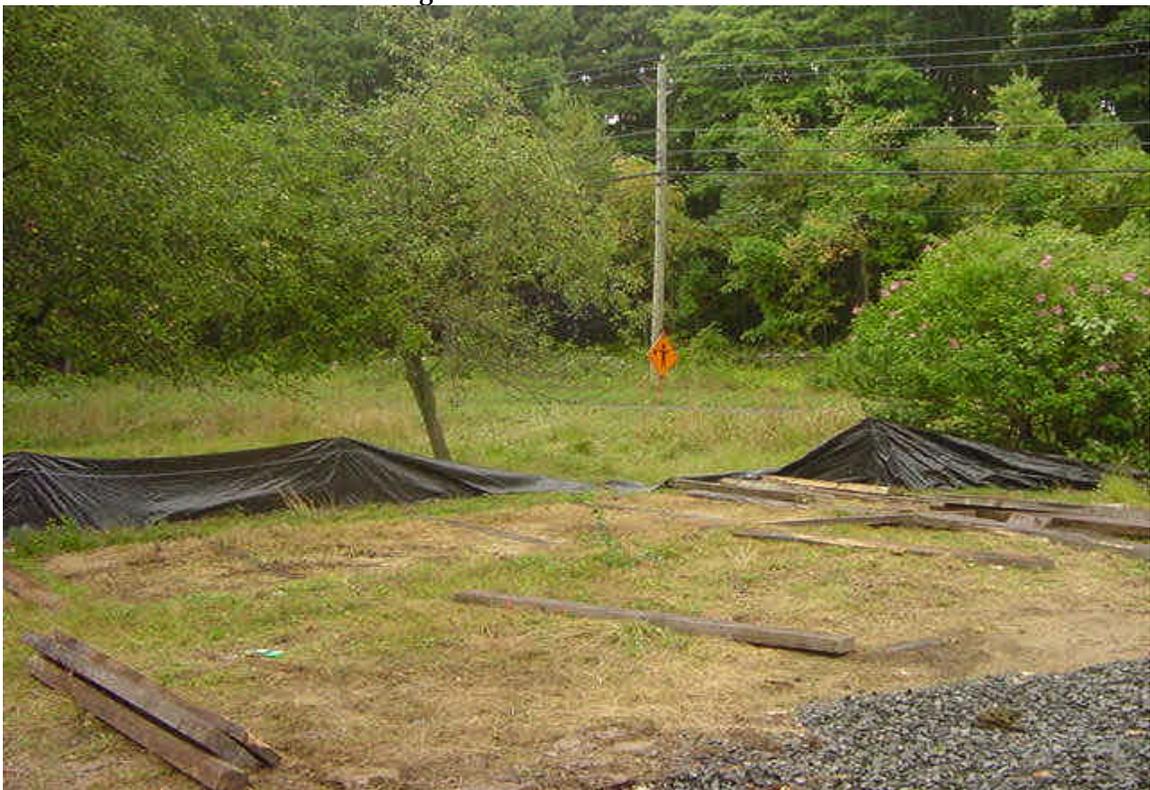
115 kV (Rt. 107): View of a the storage area near the Redding Country Club where some silt fence repair is required. 9/15/05

Areas of Inspection	Observation	Recommended Action
	<p>Rt. 58 and Sunset Hill Rd had repairs made last week but the fence was again pushed over. Some vehicles had also tracked outside of the yard. 9/15/05</p> <p>- The Redding CC storage area had a section of silt fence pushed down. 9/15/05</p>	<p>maintain it and treat it as a limit of work. Vehicles should stay within the fenced areas. 9/15/05</p> <p>-Repair the fence as necessary. 9/15/05</p>
<p>State species of concern, threatened and endangered species</p>	<p>- No species of concern are located in the areas of construction.</p>	<p>- N/A</p>
<p>Vegetative clearing limits (including trees to save or danger trees noted)</p>	<p>- Mulching of bare areas is ongoing and should continue and areas should be seeded as necessary, especially the vault areas as they are the largest disturbance. When the areas are mulched and seeded, silt fence can be removed where work will not return. 9/7-9/15/05</p> <p>-The ROW and lawns in Bethel Ed. Park are very well restored with new growth. Several other areas mentioned including vault #13 were also well attended and silt fence removed. 9/15/05.</p>	<p>- The D&M plan requires that disturbed areas to be left for more than 21-30 days before work returns here should be temporarily stabilized with mulch or seed within 7-14 days.</p> <p>- Continue to send restoration crews out in time with D&M requirements and seed mulch areas where needed. 9/15/05.</p>

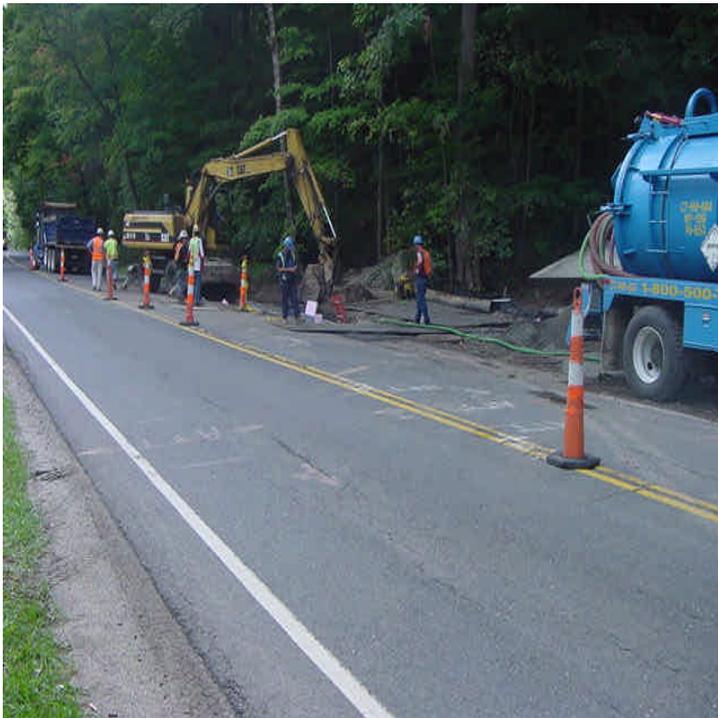
115kV (Rt. 58): Photo on the left shows some trenching along Rt. 58 near Jacob's Ladder Rd. Photo on the right shows the storage area near Sunset Hill Rd. where materials were placed on the silt fence again. 9/15/05

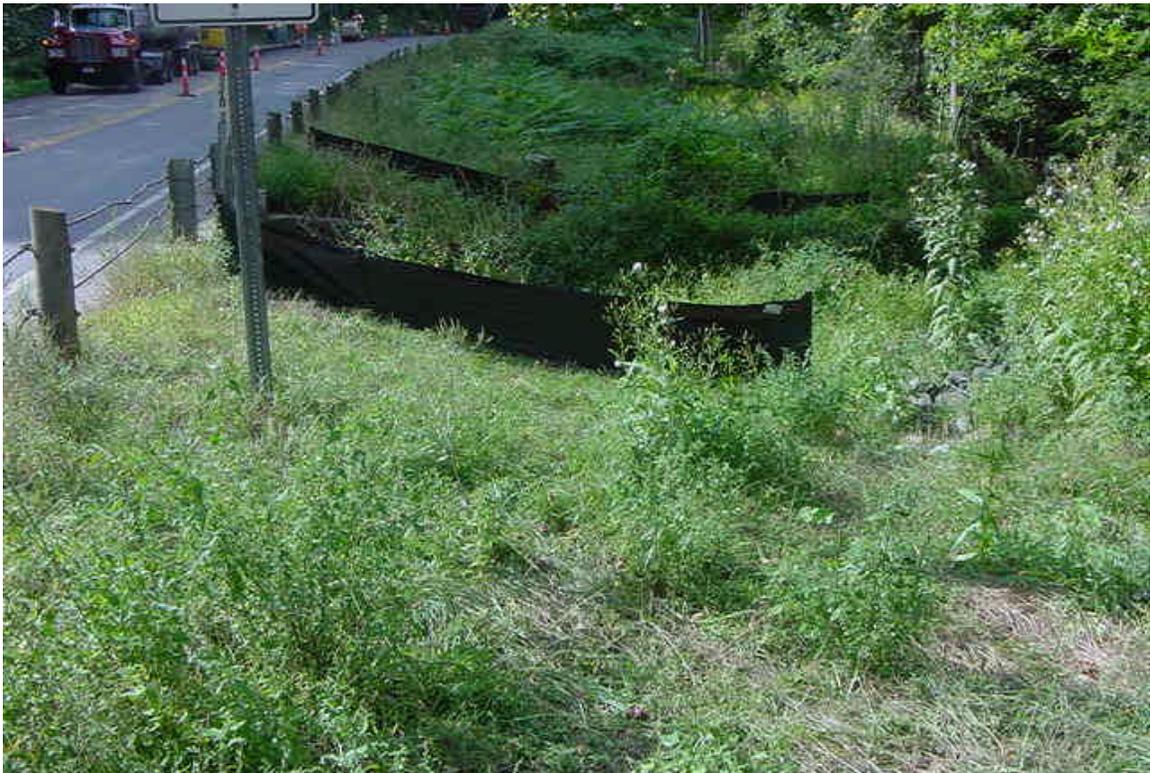
Photo shows erosion controls in place in preparation for the open cut stream crossing near Sara's Way. Work was not taking place at the time of inspection and is scheduled for next week 9/15/05

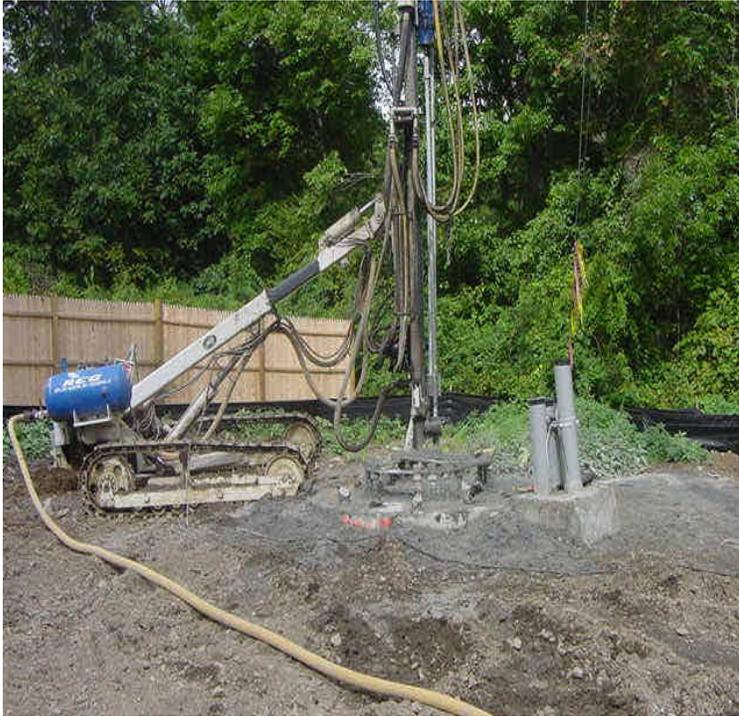
115kV: Photo on the left shows drilling for the anchors of the caisson at Hoyts Hill Transition structure. Photo on the right shows some of the new vegetative growth observed at the Bethel Educational Park ROW. 9/15/05

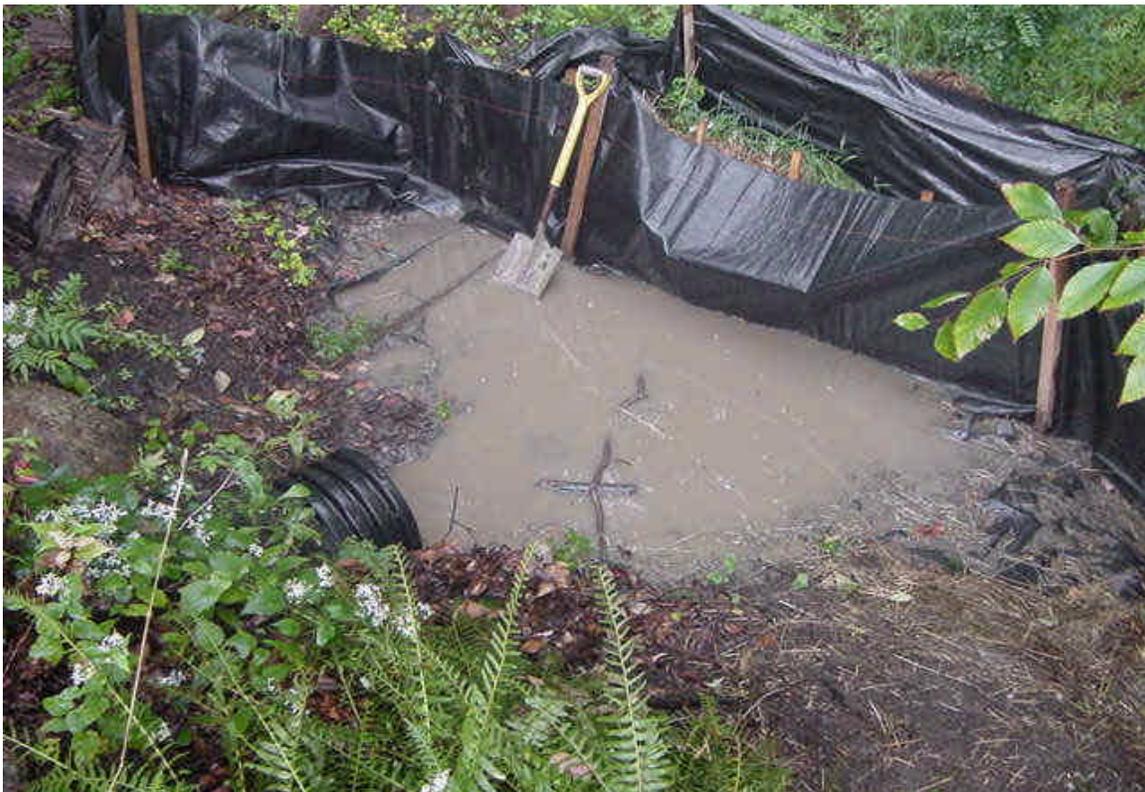
115kV (Redding Town Yard): Additional efforts have been made as requested to extend the check dams at the outlet. Water was pooling here following the recent rain. 9/15/05
