Docket No. 217 – Development and Management Plan Inspection

Northeast Utilities Service Company Certificate of Environmental Compatibility and Public Need for the construction of a 345-kV electric transmission line and reconstruction of an existing 115-kV electric transmission line between Connecticut Light and Power Company’s Plumtree Substation in Bethel, through the towns of Redding, Weston, and Wilton, and to the Norwalk Substation in Norwalk, Connecticut.

Date: December 8, 2005

Location: 115 kV Underground Route

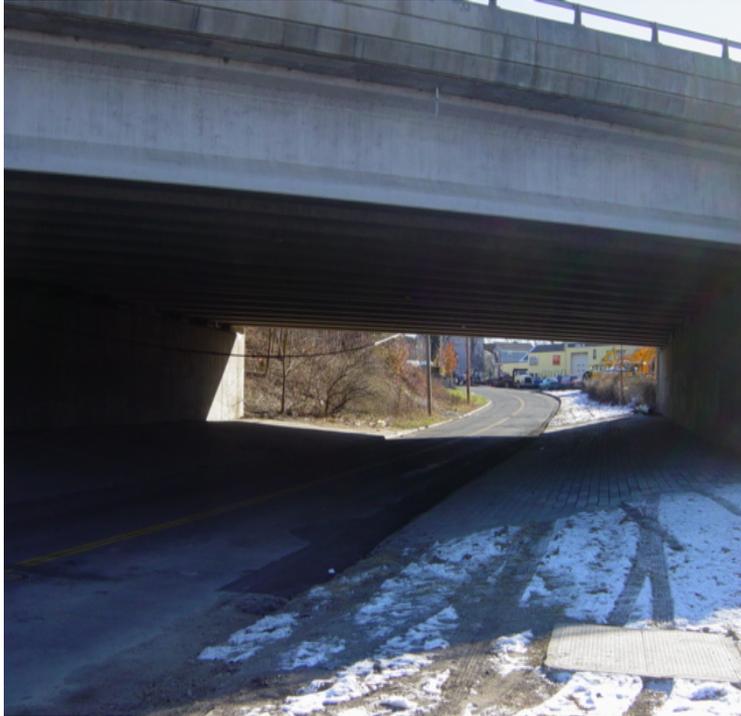
115kV (Broad Street): Photo on the left shows a view of the overpass on Broad Street where all stone pavers were well restored. Photo on the right shows the ROW with the beginnings of snow cover. 12/8/05

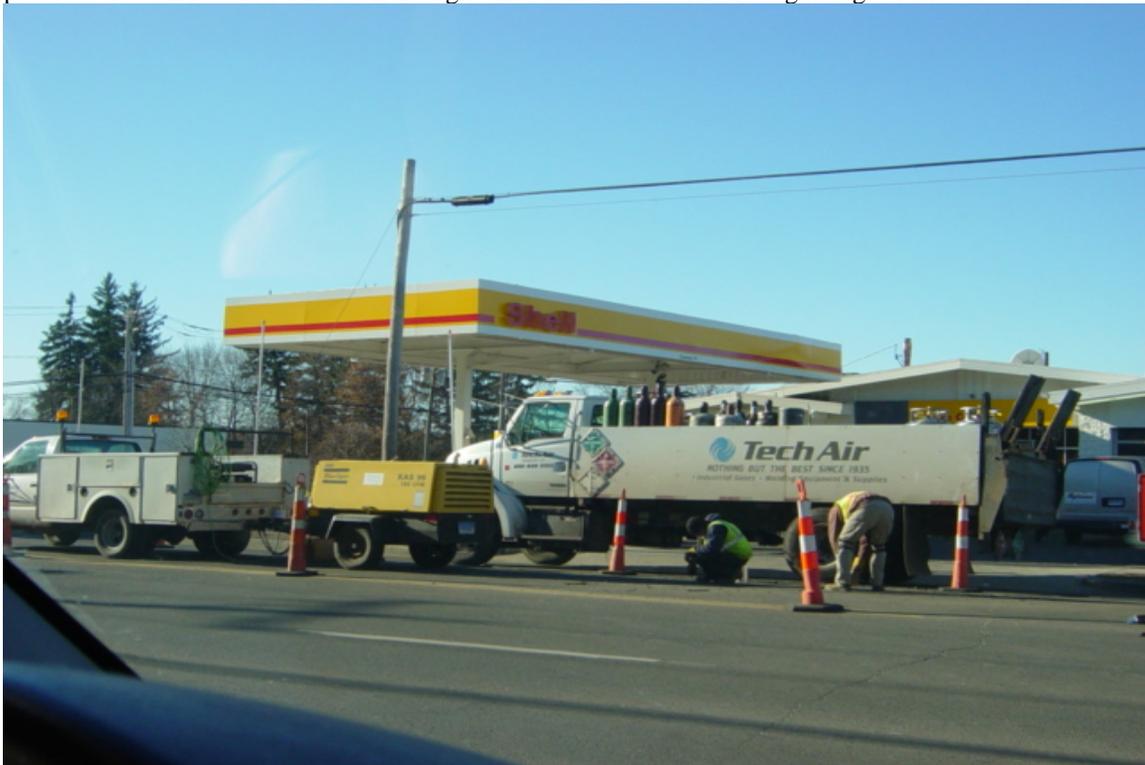
115kV (Rt. 7/Main Ave): Work internal to the vault was observed near the Broad St./Main Ave. intersection. 12/8/05

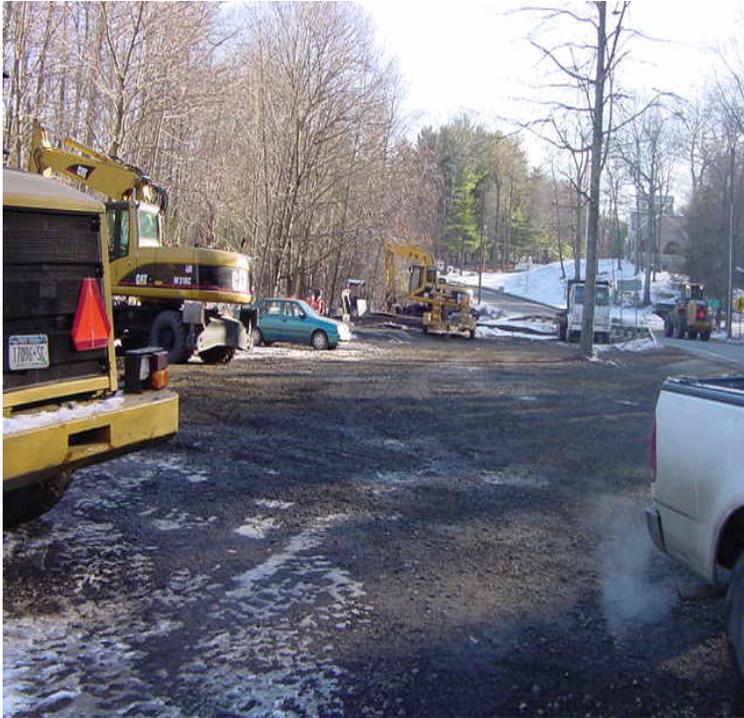
115kV (Storage yards). Photo on the left shows the Putnam Park storage area still in use by pieces of equipment. Photo on the right shows the Sunset Hill Rd. storage yard in a state of partial clean up. Controls are still in place in both locations. 12/8/05

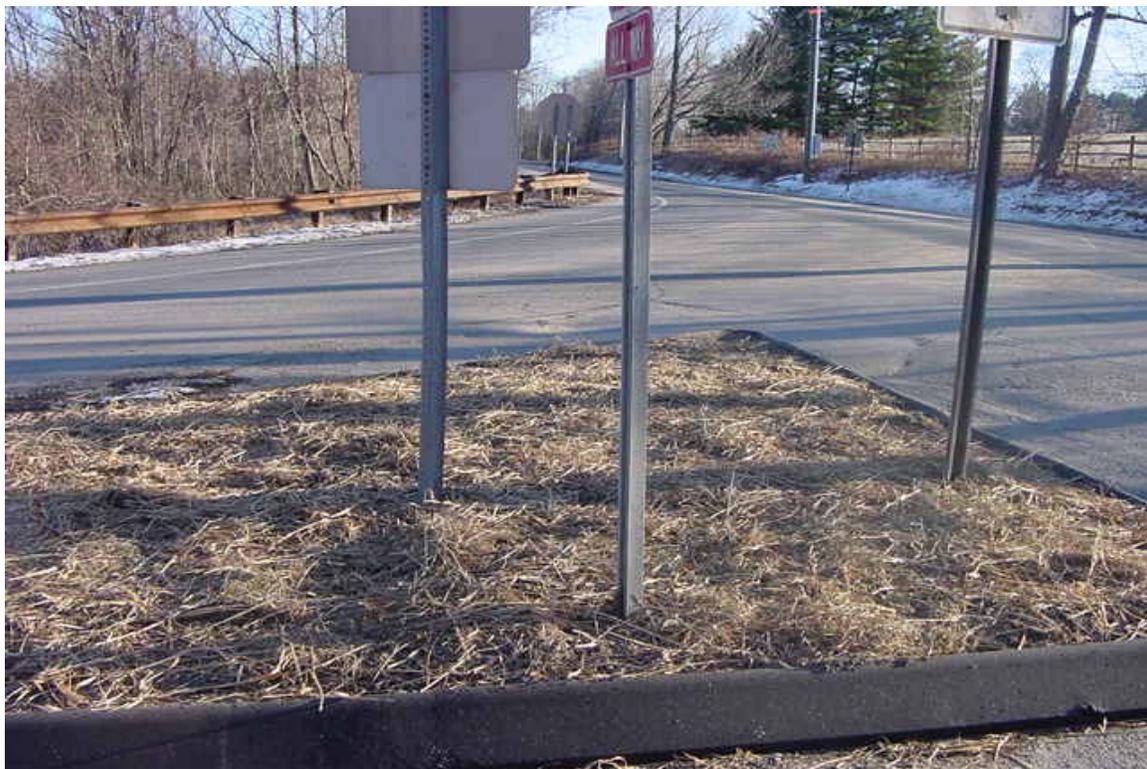
115kV (Rt 107). View of the newly restored/constructed island at the Rt. 107 90 degree turn. 12/8/05

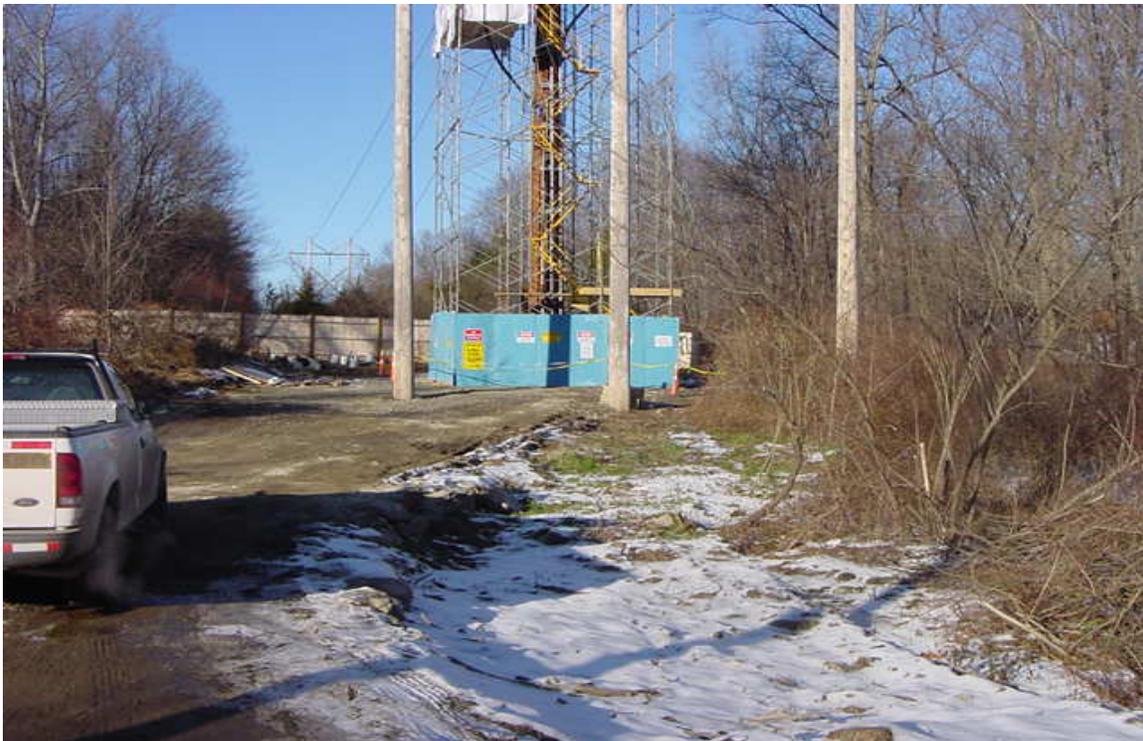
115kV: (Hoyts Hill) View of the scaffolding and work on the pole structure here. Work is nearing completion. 12/8/05

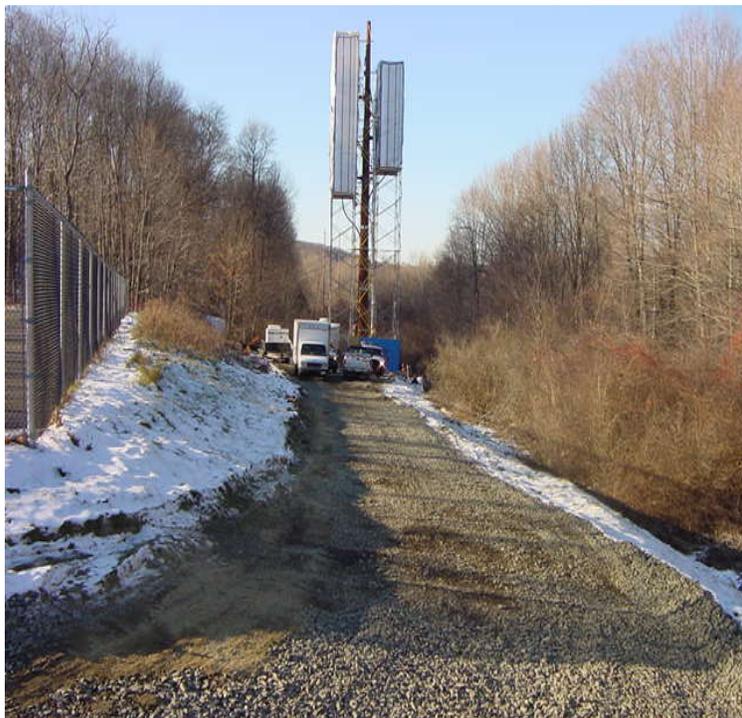
115kV: (Bethel Education Park) Photo on the left shows a view of the work on the north tower with scaffolding and shrouds. Photo on the right shows the view along the southern tower access drive. 12/8/05

<p>Erosion and Sediment Controls (includes inspection within 24 hours of a storm event)</p> <p>Bethel Educational Park</p>	<ul style="list-style-type: none"> - The northern ROW was placed with stone for equipment access but some portions were somewhat rutted. 12/1-12/8/05 -Scaffolding and shrouds were in place at the northern structure and work was ongoing. 12/8/05 - Some remaining ruts were also noted along the southern access road. 12/8/05 	<ul style="list-style-type: none"> -Some mulch should be placed on ruts when access needs are complete but snow cover is now a factor. 12/8/05 - Some mulch should be placed on ruts when access needs are complete but snow cover is now a factor. 12/8/05
Hoyts Hill Riser Transition Structure (Off Rt. 58)	<ul style="list-style-type: none"> -Scaffolding is in place and work is nearing completion on the pole structure. 12/8/05 - Equipment access has created ruts along the sides of the drive in the mud. 11/23-12/8/05 	<ul style="list-style-type: none"> - The ruts should be graded and mulch added to the area when the equipment access is complete but snow cover is now a factor. 12/8/05
