Docket No. 217 – Development and Management Plan Inspection

Northeast Utilities Service Company Certificate of Environmental Compatibility and Public Need for the construction of a 345-kV electric transmission line and reconstruction of an existing 115-kV electric transmission line between Connecticut Light and Power Company’s Plumtree Substation in Bethel, through the towns of Redding, Weston, and Wilton, and to the Norwalk Substation in Norwalk, Connecticut.

Date: December 14, 2005

Location: 345kV XLPE Component

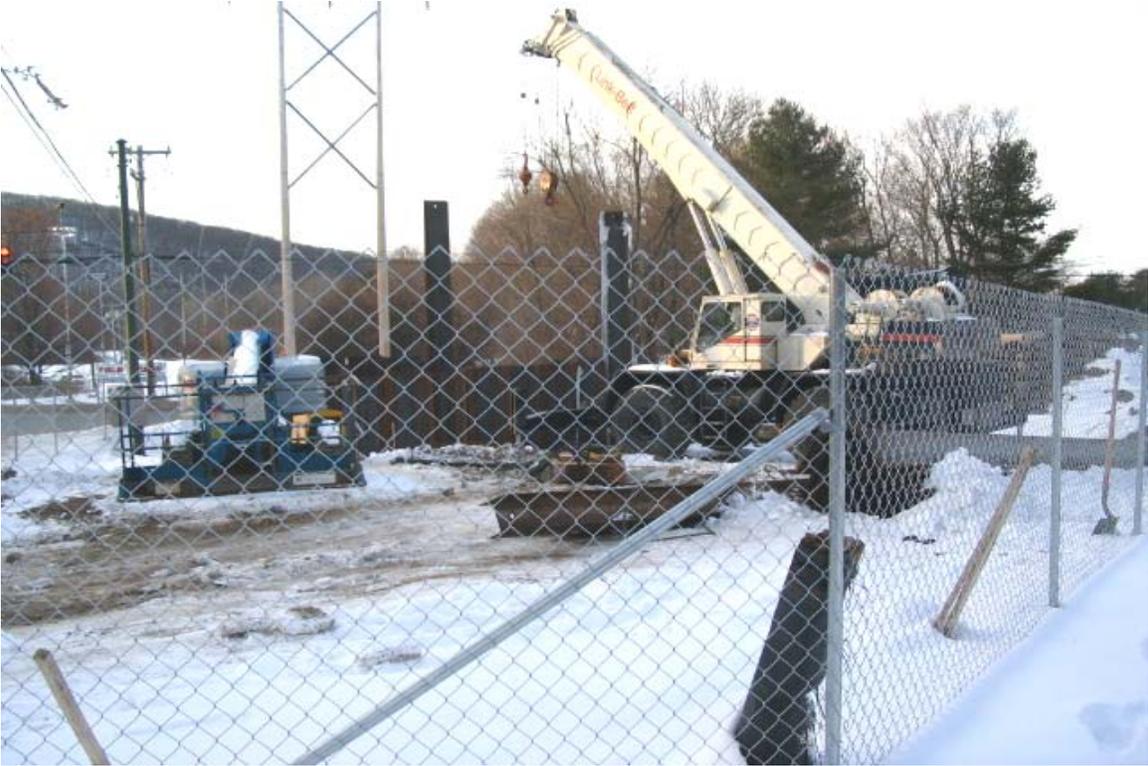
345kV XLPE (Jack and Bore): Overall view of the site with excavation underway and continued work on installing sheet piling/shoring for the bore pit. 12/14/05

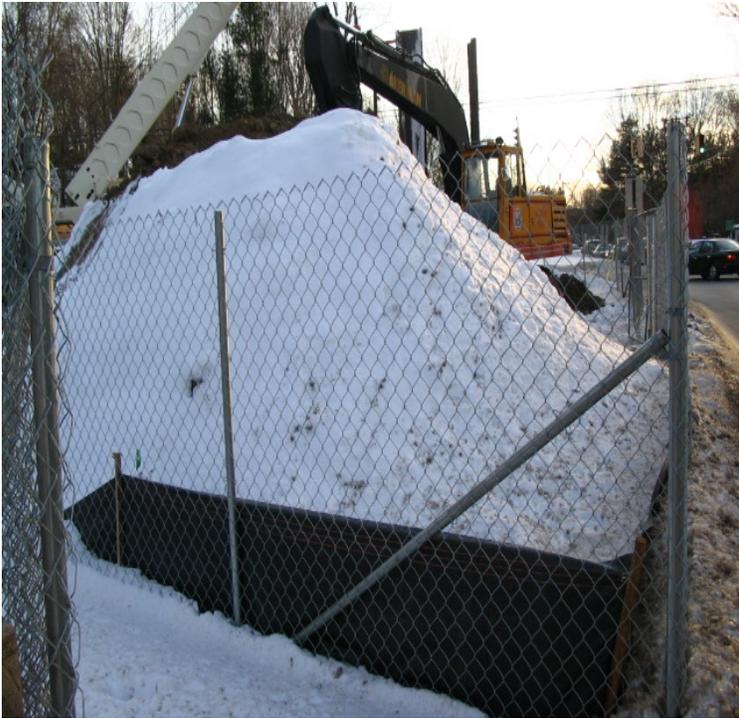
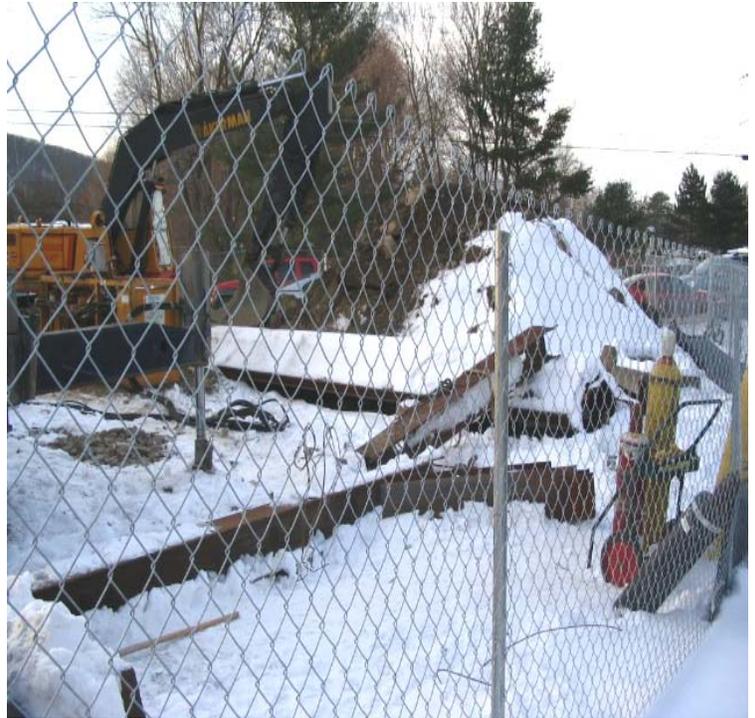
Various views of the work on the jack and bore site. The stockpile remains in place, adjacent to the silt fence. We can't confirm whether this was toed-in due to snow cover. Continue to maintain the site when conditions allow. 12/14/05
