Docket No. 217 – Development and Management Plan Inspection

Northeast Utilities Service Company Certificate of Environmental Compatibility and Public Need for the construction of a 345-kV electric transmission line and reconstruction of an existing 115-kV electric transmission line between Connecticut Light and Power Company's Plumtree Substation in Bethel, through the towns of Redding, Weston, and Wilton, and to the Norwalk Substation in Norwalk, Connecticut.

Date: October 12, 2005

Location: Overhead Line (Composite 345kV and 115kV Gallows Hill to Archers Lane)

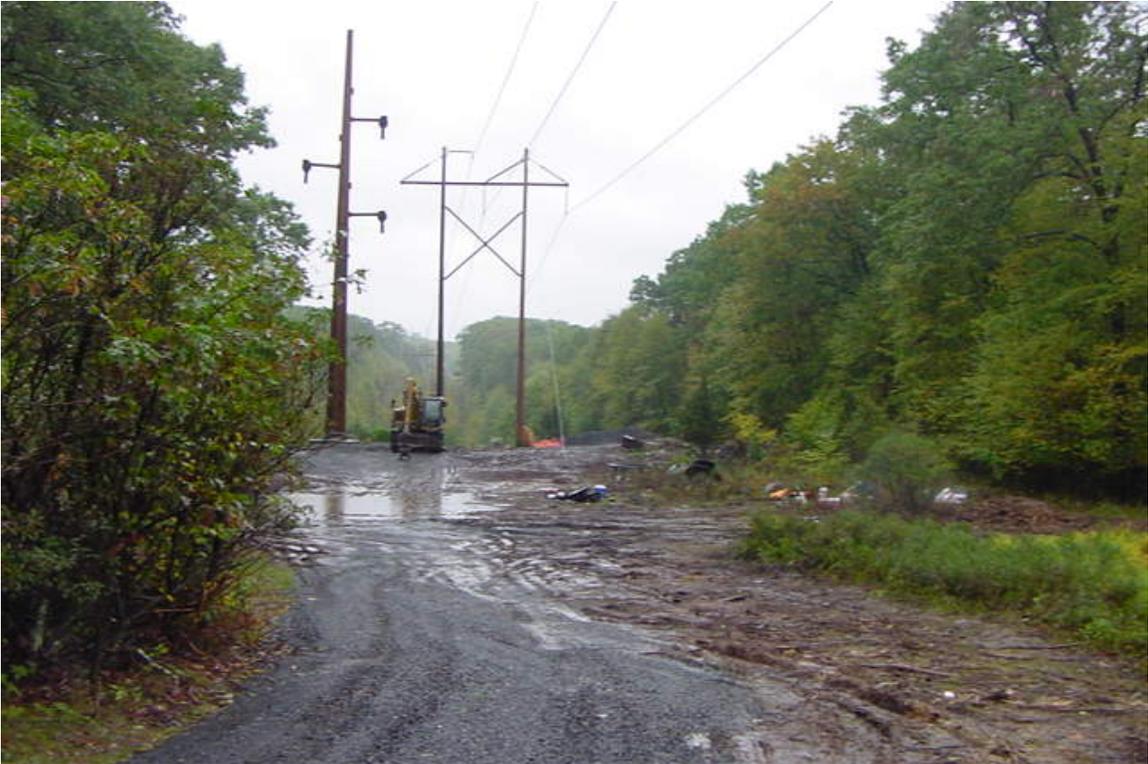
Overhead ROW: View of the riser structure adjacent to Gallows Hill Rd. where conduit is being installed from the roadway. (10/12/05)

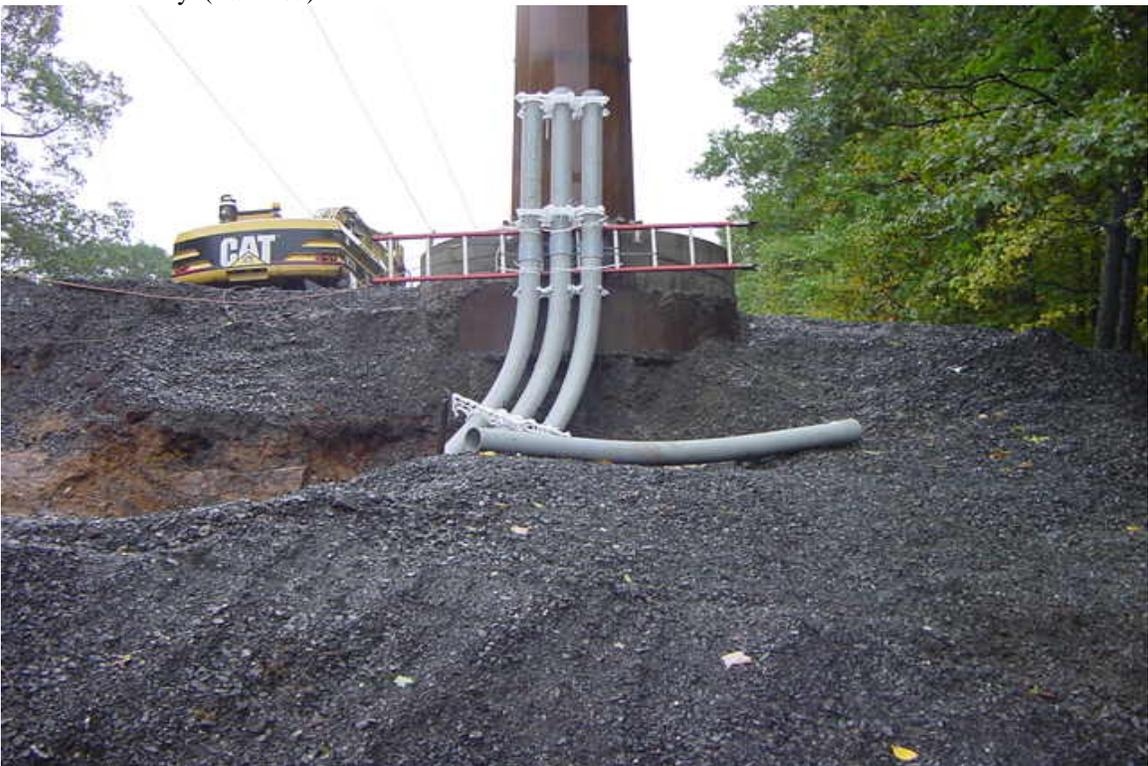
Close up view of the conduit being brought in from Gallows Hill Road to the riser transition structure at the ROW. (10/12/05)

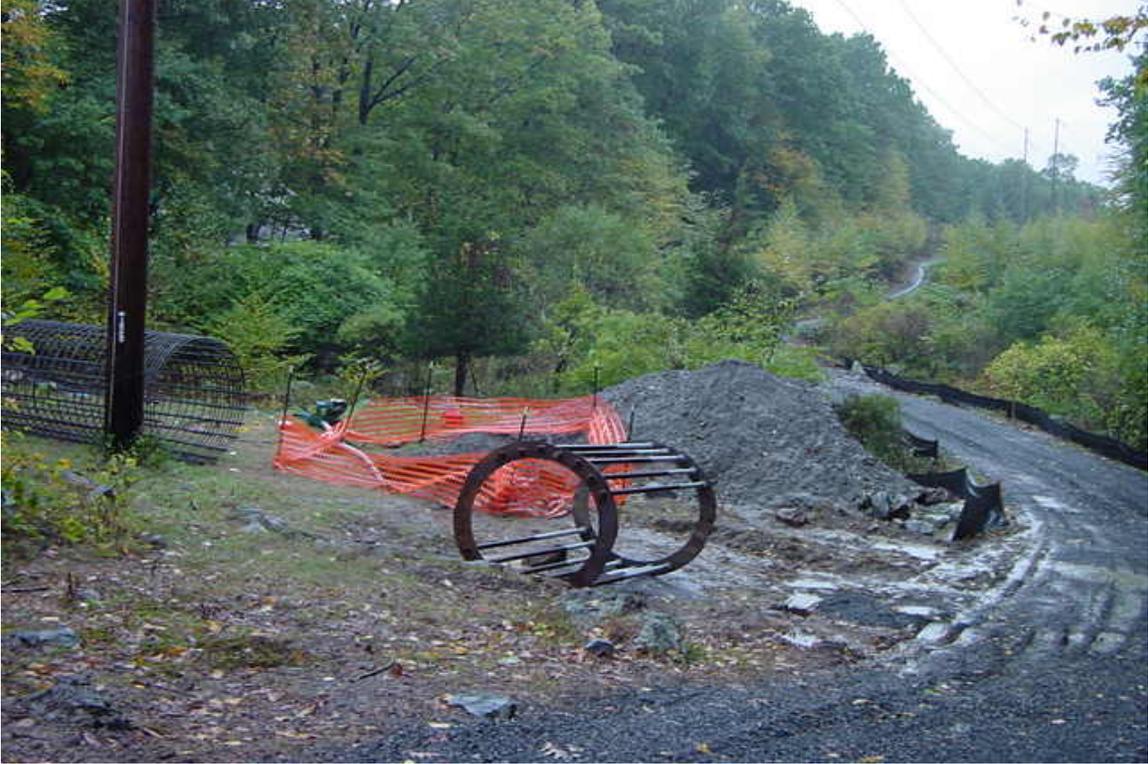
View of the excavation for the structure foundation moving south along the ROW. Continue to keep silt fence in good condition here due to the proximity of wetlands. (10/12/05)

Areas of Inspection	Observation	Recommended Action
Dewatering	- Typical dewatering will not be possible in some of the foundation holes due to a thick water/mud mixture. 10/5-10/12/05	-A compound may need to be added to evaporate the water or a berm may need to be set up to contain it. 10/5-10/12/05
Blasting	-No blasting has been necessary at this time except in the adjacent Archers Lane transition station. 10/12/05	-None at this time. 10/12/05
Spills and Material Storage	- No further spills were noted at this inspection and the previously affected soil had been removed. 10/12/05	<ul style="list-style-type: none"> - Continue to keep all vehicles maintained well (i.e. no apparent fluid leaks) if they will be used or stored on site - Keep adequately size fuel kits for worst case scenarios. - Report spills immediately, even if they are being controlled. - Take care not to get carried away and to be vigilant when refueling. Avoid refueling in the areas near the wetlands. Use proper storage for all materials.

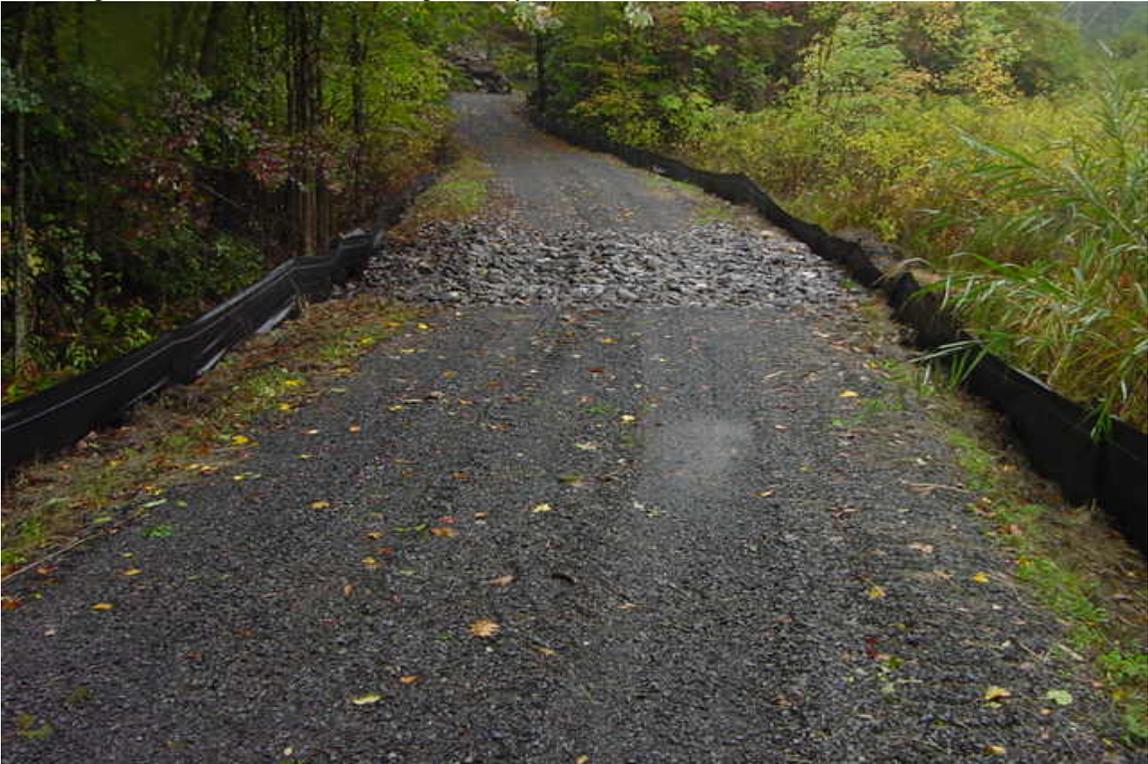
View of the access road to the ROW near Archers Lane. Low spots/wetland crossings reinforced with stone remain in good shape. (10/12/05)

<p>Inland Wetland and Watercourse encroachment and mitigation</p>	<p>- The main access path in the ROW and the Archers Lane access crosses several low wetland spots. The D&M plan allows for stone on geotextile fabric here to support continued crossings. 9/15-10/12/05</p>	<p>- None at this time, the crossings have been constructed. As the access is considered temporary, the stone will be removed when final work ends so the wetlands can be restored. 10/12/05</p>
<p>State species of concern, threatened and endangered species</p>	<p>- The overhead portions have been identified as having potential habitat for several state listed species, including several species of turtles and plants. This particular portion of overhead work includes the turtle habitat area. 9/15-10/12/05</p> <p>-The Eastern box turtle has not been observed since the first sighting. 10/12/05.</p>	<p>-Crews have been doing daily sweeps for any turtles in the work areas and noting the results of their efforts on daily construction reports. 10/12/05</p>
