Docket No. 217 – Development and Management Plan Inspection

Date: May 4, 2005

Location: Norwalk Substation Expansion

Location: Plumtree Substation Expansion , Bethel

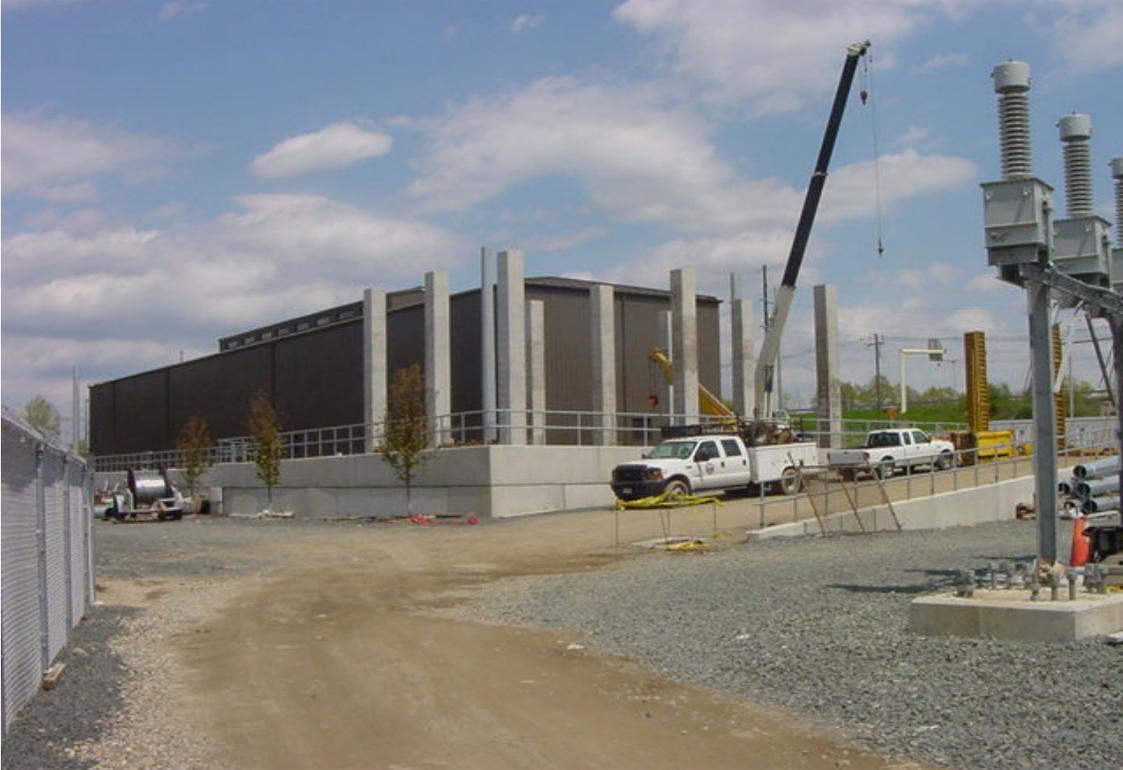
Norwalk Substation-Structure work continues near retaining wall #3 and the GIS building. (5/4/05)

<p>Foundation construction</p>	<p>-Siding work for the GIS building is complete and work is ongoing internally placing the equipment. 4/27-5/4/05</p> <p>-Work on the structures near retaining wall #3 and the control house is still ongoing. With concrete being poured</p>	<p>- None at this time. 5/4/05</p> <p>- Soil stockpiles are well within the yard and areas are contained, no issues at this time. 5/4/05</p>

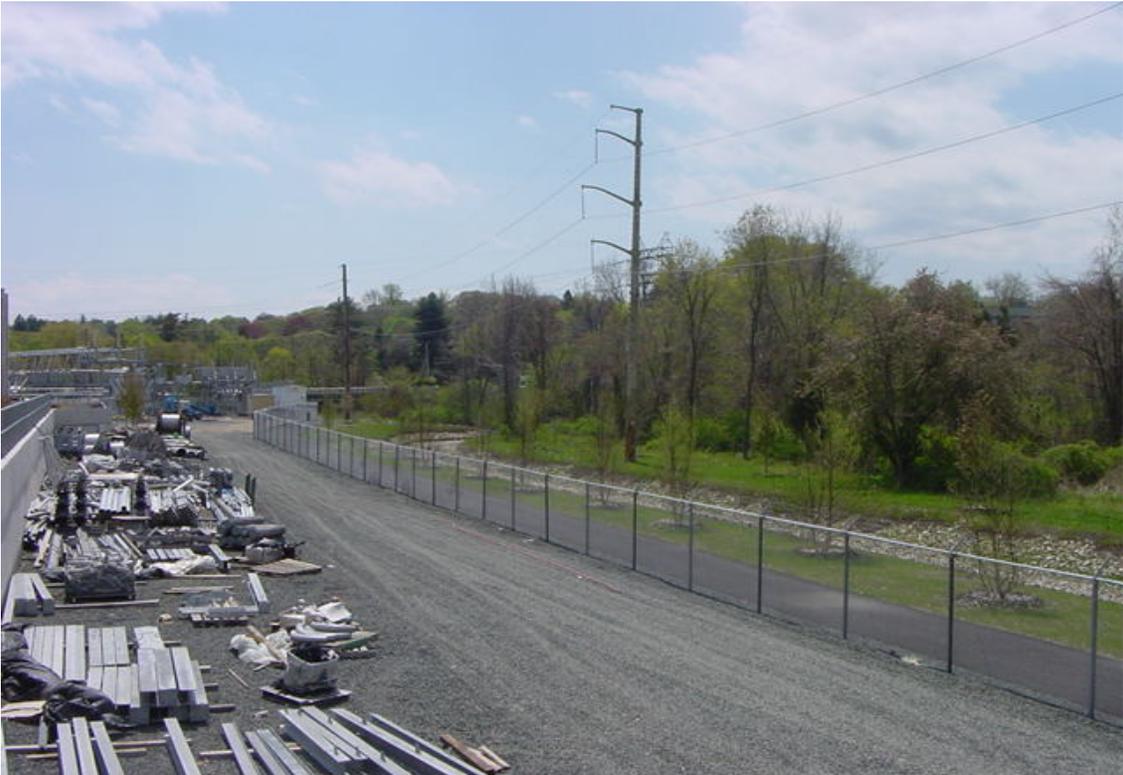
Overflow channel along the Norwalk River. (5/4/05)

Areas of Inspection	Observation	Recommended Action
	5/4/05	
Erosion and Sediment Controls (includes inspection within 24 hours of a storm event)	-The overflow channel continues to work well with some minor erosion along the slope and grass growth is noticeable along the sides. The plantings within the channel are also showing new growth 4/27-5/4/05.	- Continue to monitor for overall stabilization. Vegetative growth appears to be off to a good start and the situation should be evaluated later in the growing season. The minor erosion may require repair if it worsens. 5/4/05

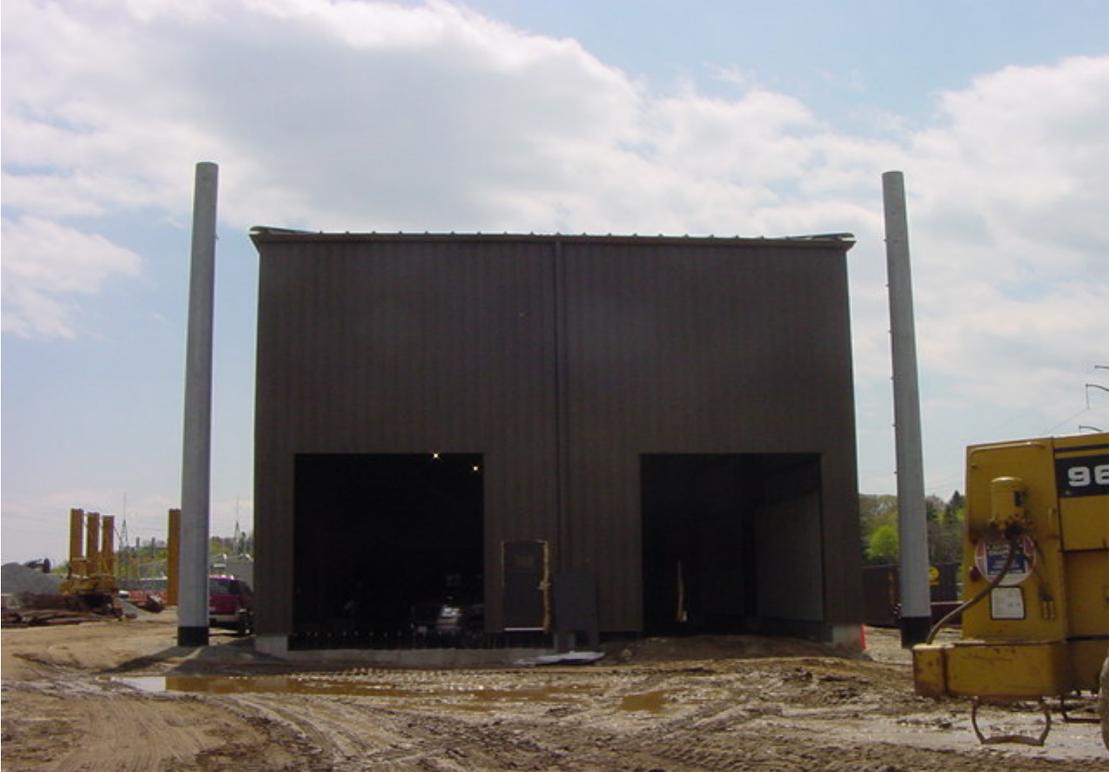
Exterior work is complete; interior work continues on GIS Building. (5/4/05)

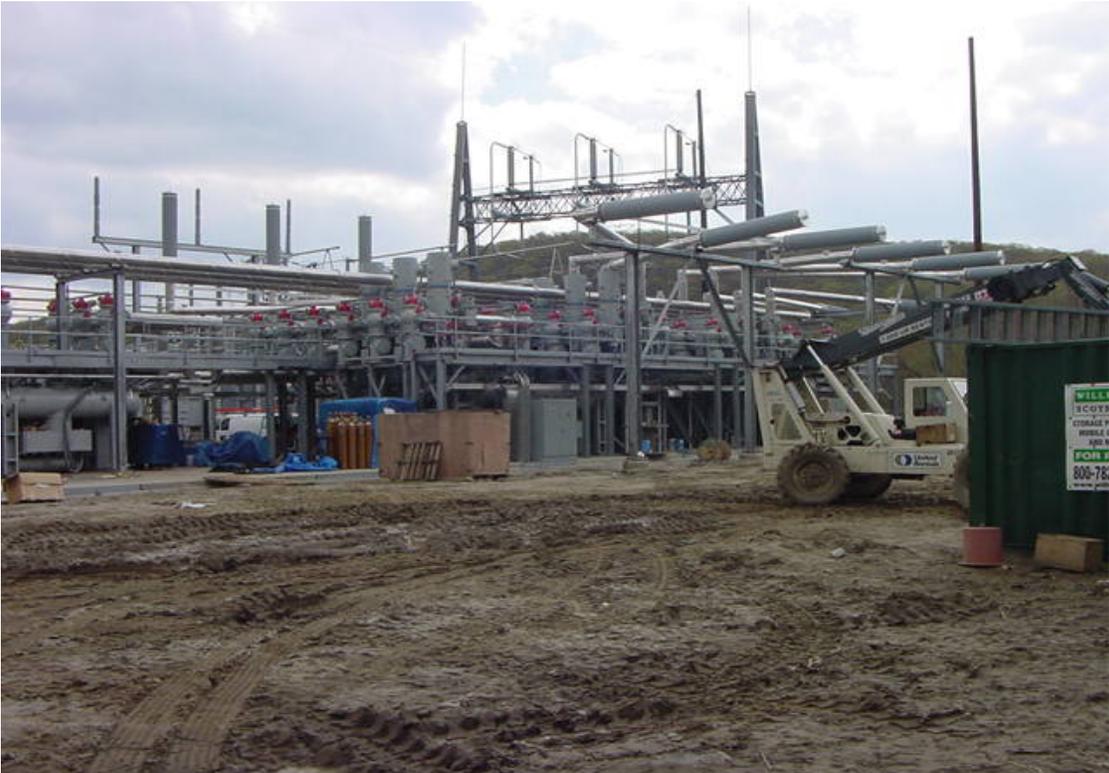
Bethel Substation-Work continues on the concrete slab. (5/4/05)

Areas of Inspection	Observation	Recommended Action
Access Roads	- No new access roads have been constructed at this time 5/4/05	- None at this time.
Foundation construction	-The major work of connecting the equipment on the constructed slab to the existing equipment is on-going. 3/23-5/4/05 - Some underground cable pulls were occurring at the time of the inspection. 5/4/05	- The areas are all contained at this time and there is little ongoing work that involves soil disturbance. 4/6-5/4/05
Erosion and Sediment Controls (includes inspection within 24 hours of a storm event)	- The working areas of the site were slightly muddy again but the perimeter stone berm continues to work well. 5/4/05	-Nothing at this time. 5/4/05

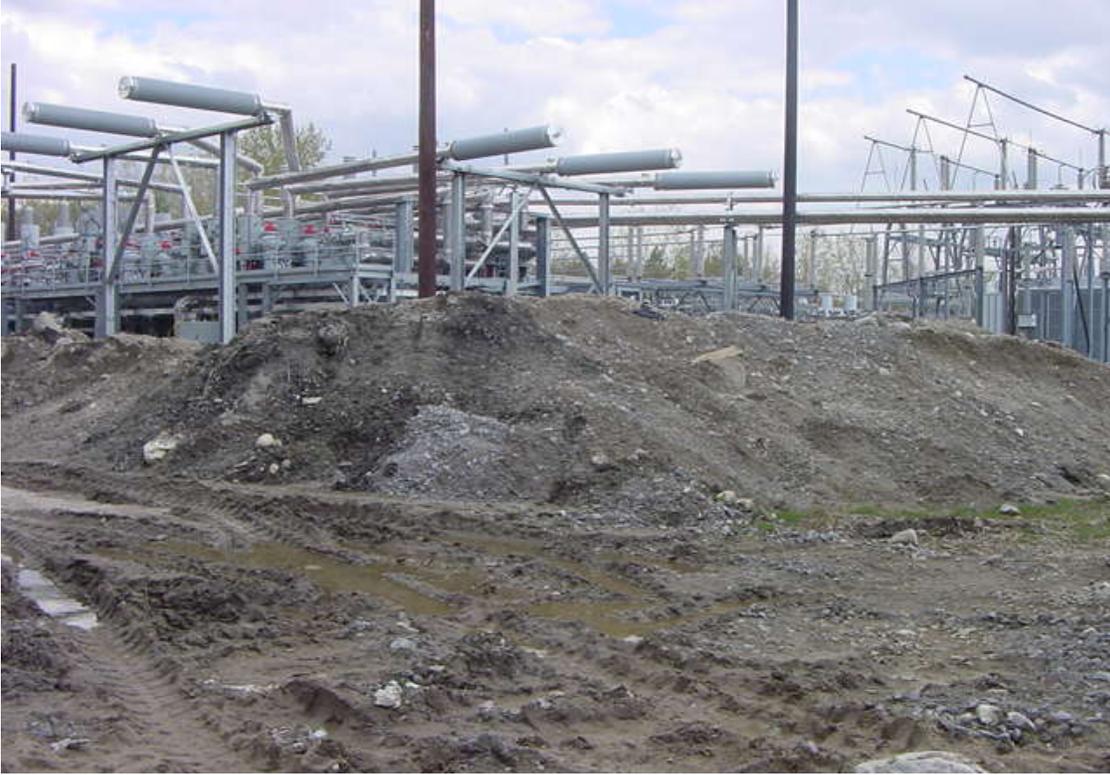
Soil stockpile at the rear of the site which remains contained at this time. (5/4/05)

Areas of Inspection	Observation	Recommended Action
	<p>- There is no silt fence in place at this time, however the stone perimeter berm is in place and contains the yard well. 5/4/05</p>	<p>-All stockpiles are well-contained and the berm is working effectively at this time. 5/4/05</p>
	<p>- A majority of the soil has been removed to appropriate off-site locations but some will remain on an as needed basis for the remainder of construction. Portions are not covered in plastic but are well within the site. 3/2-5/4/05</p>	<p>-Continue to monitor status and cover stockpiles with plastic if necessary. 3/2-5/4/05</p>
<p>Inland Wetland and Watercourse encroachment and mitigation</p>	<p>- Wetlands are located around the outskirts of the substation yard. The work within the substation yard has caused no observed sedimentation. 5/4/05</p>	<p>- The stone berm around the perimeter of the yard continues to prevent sedimentation and water from leaving the site and getting to the wetland edge. 5/4/05</p>
