Docket No. 217 – Development and Management Plan Inspection

Northeast Utilities Service Company Certificate of Environmental Compatibility and Public Need for the construction of a 345-kV electric transmission line and reconstruction of an existing 115-kV electric transmission line between Connecticut Light and Power Company's Plumtree Substation in Bethel, through the towns of Redding, Weston, and Wilton, and to the Norwalk Substation in Norwalk, Connecticut.

Date: December 18, 2003

Location: Norwalk Substation Expansion

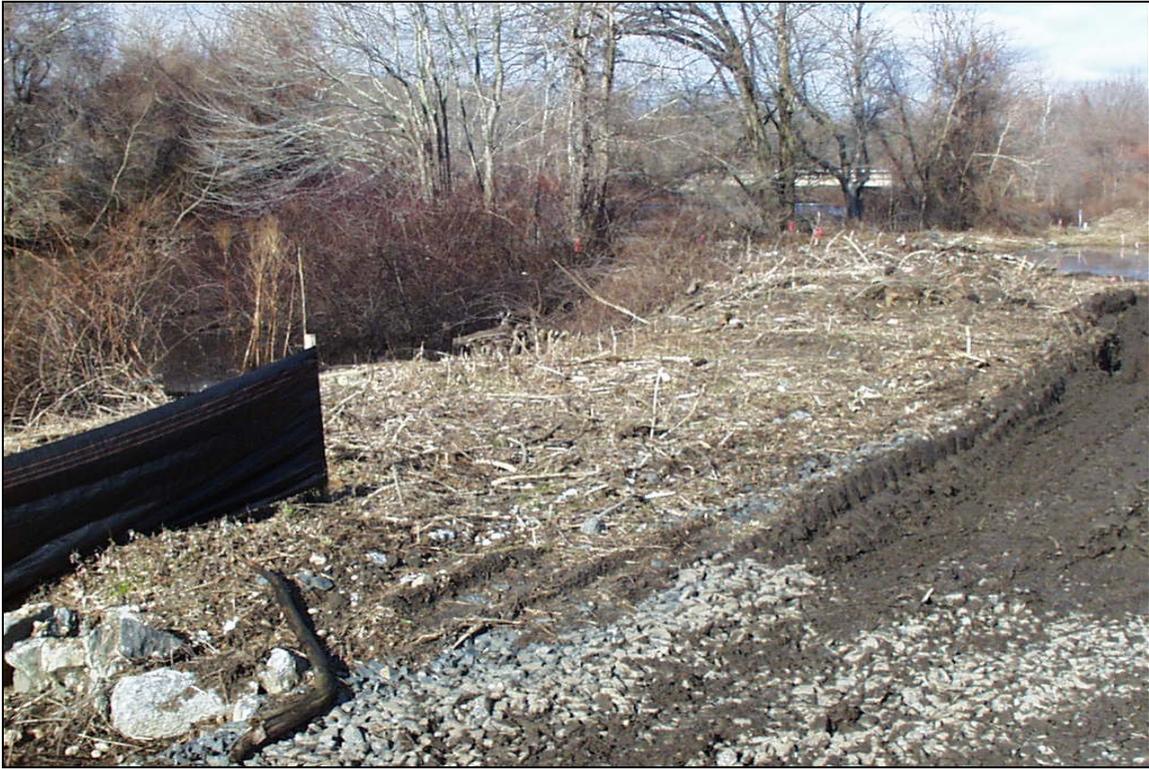
VIEW NEAR THE GRAVEL ACCESS PAD AND DRAINAGE SWALE. THE SLIT FENCE WILL BE EXTENDED TO ACCOMMODATE THE DISTURBED SOIL ON THE EXISTING ROW ACCESS 12/18/03

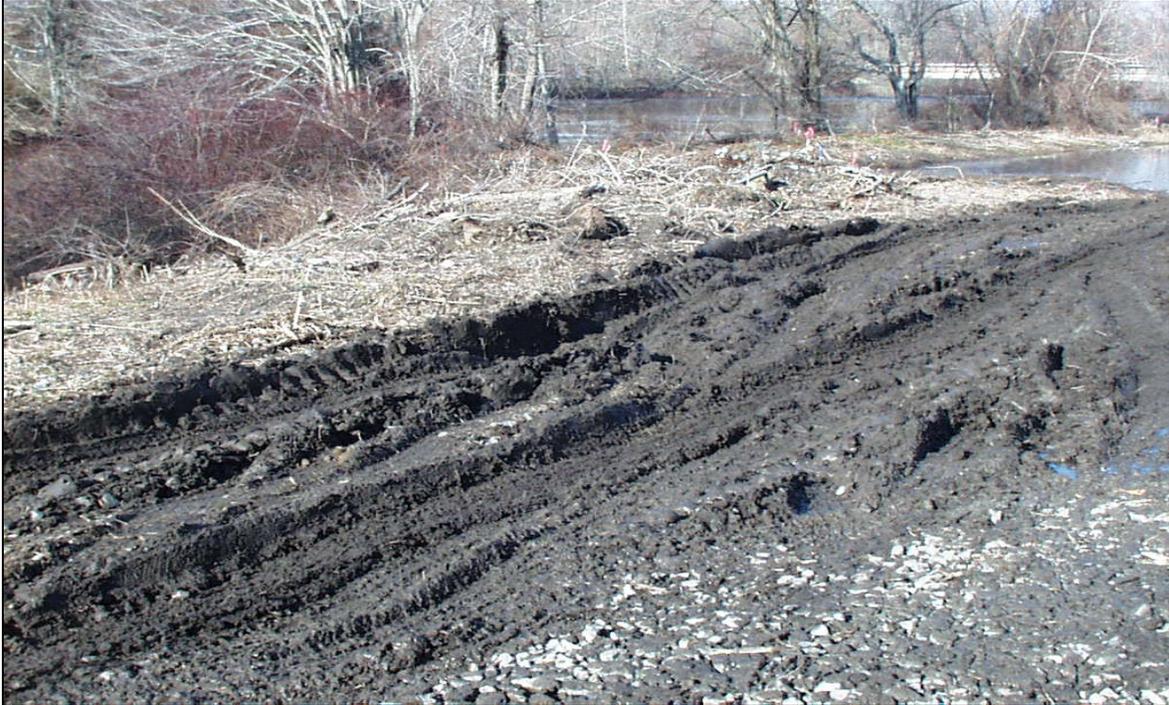
CLOSER VIEW OF THE SOFT GROUND DISTURBED FROM EQUIPMENT TRACKING. SILT FENCE WILL BE EXTENDED AND MATS WILL BE USED FOR CROSSING IF THE GROUND DOESN'T FREEZE BY THE FIRST WEEK OF JANUARY WHEN ACTIVITIES HERE RE-COMMENCE. 12/18/03

Areas of Inspection	Observation	Recommended Action
Access Roads	<ul style="list-style-type: none"> - The Route 7 ramp access road is in active use. No issues with erosion were noted at this time, however it is accumulating a good deal of mud from the equipment tracking. 12/18/03 - The existing access road into the existing ROW has become very muddy due to the rain. Rutting and tracking has occurred due to equipment crossings. 12/18/03 	<ul style="list-style-type: none"> - None at this time. Completing the road will help abate this but nothing can be done until the stream encroachment permit is finalized. 12/18/03 - Silt fence will be installed between the soft, disturbed ground and the river. The area will be graded smooth and equipment will not need to cross here again until the 1st week of January. If the ground is not frozen by that point, timber mats will be used for stabilization. 12/18/03

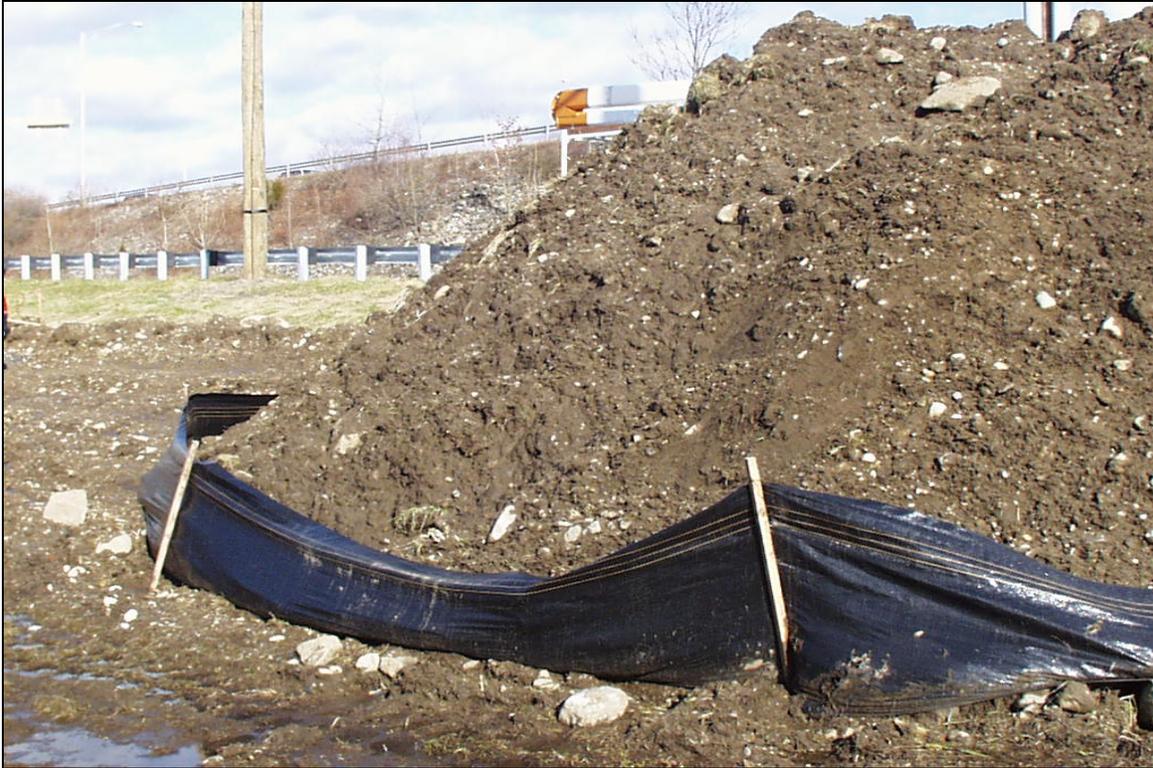
STOCKPILE AT BASE OF ROUTE 7 RAMP NEAR POLE INSTALLATION. THE SILT FENCE IS EXPERIENCING STRAIN AND REQUIRES SOME MAINTENANCE. THIS AREA IS NOT PARTICULARLY SENSITIVE HOWEVER DUE TO ITS DISTANCE FROM THE RESOURCE AREAS. 12/18/03

<ul style="list-style-type: none"> - The silt fence at the larger soil pile near the Route 7 ramp is experiencing some strain. 12/18/03 	<ul style="list-style-type: none"> - The fence will be maintained but this spot is not extremely sensitive due to its distance from the river and wetlands. 12/18/03
<p>Inland Wetland and Watercourse encroachment and mitigation</p>	<ul style="list-style-type: none"> - All work/clearing in this area is still on hold until the stream encroachment permit has been finalized. 12/18/03 	<ul style="list-style-type: none"> - There are no erosion or sedimentation issues at this time 12/18/03
<p>State species of concern, threatened and endangered species</p>	<ul style="list-style-type: none"> - No species of concern are located in this area of construction 12/18/03 	<ul style="list-style-type: none"> - N/A
<p>Vegetative clearing limits (including trees to save or danger trees noted)</p>	<ul style="list-style-type: none"> - More clearing is scheduled for potentially the week of 12/29 if the permit is obtained. 12/18/03 - Clearing will be necessary in the wetland buffer around the 	<ul style="list-style-type: none"> - Limit clearing and disturbance to what is necessary 12/18/03
