Docket No. 217 – Development and Management Plan Inspection

Northeast Utilities Service Company Certificate of Environmental Compatibility and Public Need for the construction of a 345-kV electric transmission line and reconstruction of an existing 115-kV electric transmission line between Connecticut Light and Power Company’s Plumtree Substation in Bethel, through the towns of Redding, Weston, and Wilton, and to the Norwalk Substation in Norwalk, Connecticut.

Date: September 1, 2005

Location: Transition Stations (Hoyts Hill, Archers Lane)

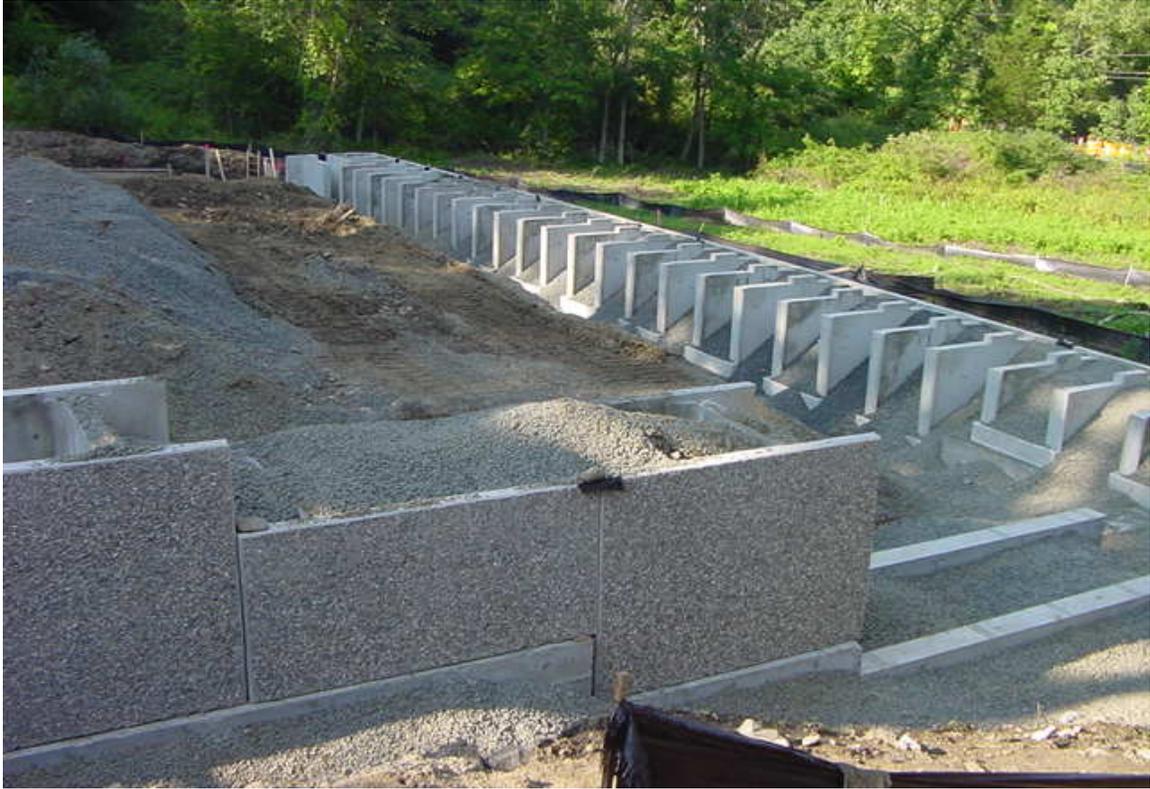
Hoyts Hill Transition Station: Observable progress is being made on the construction of the station yard walls and all silt fence and controls remain in good condition. (9/1/05)

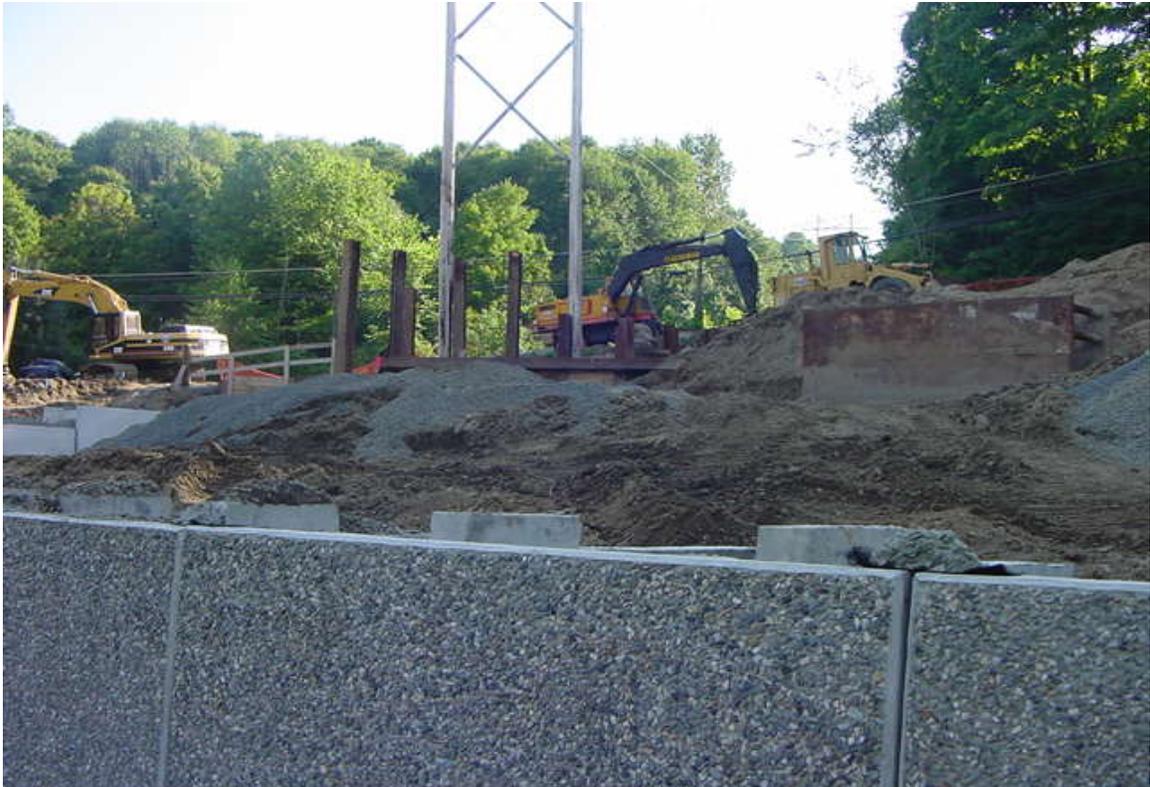
Another view of the ongoing earthwork and the wall construction. (9/1/05)

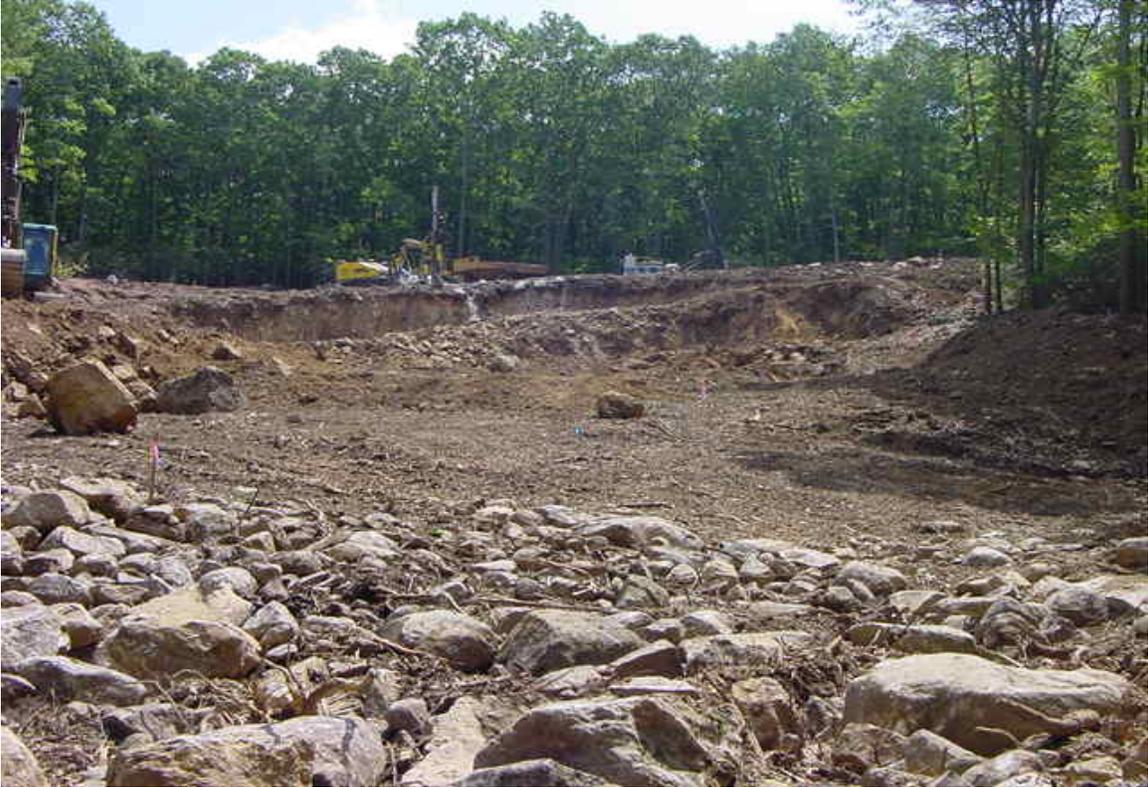
Archers Lane Transition Station: Overall view of the station site where drilling is occurring in preparation for blasting and rock is being excavated. (9/1/05)

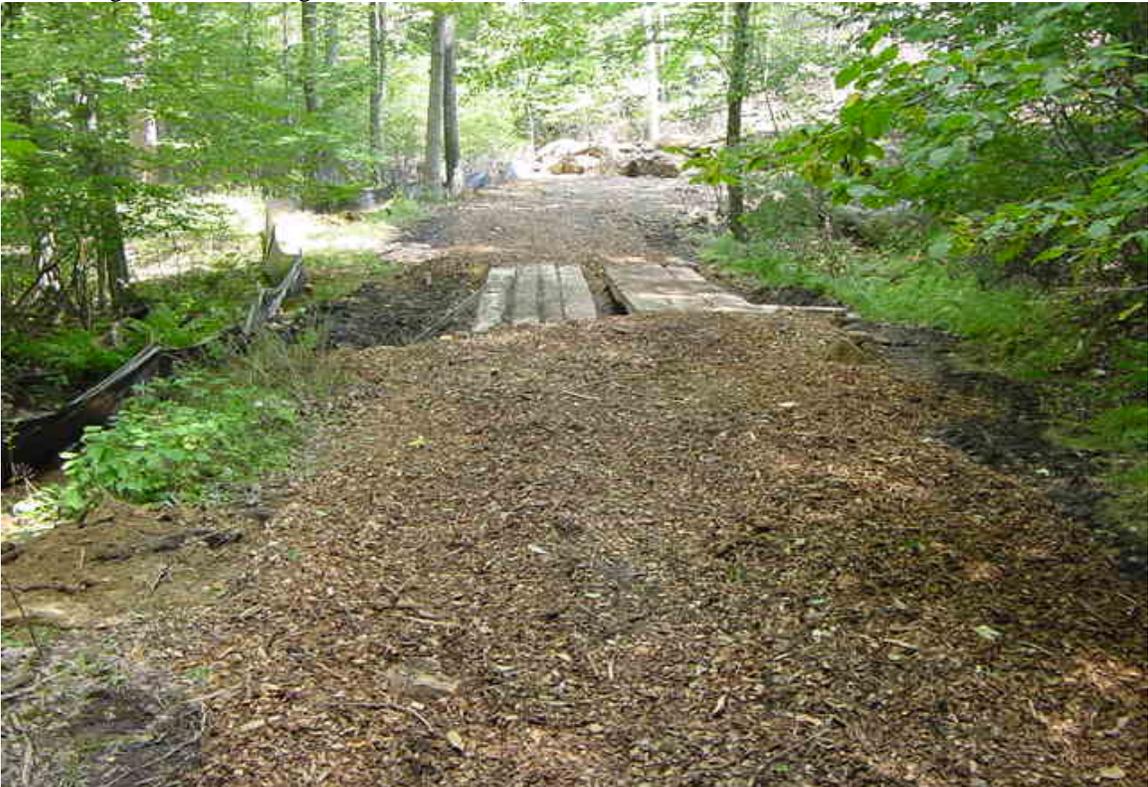
View of the woods/cart path where wood chips were placed. Avoid placing wood chips directly in the low spot/wetland crossing but the adjacent areas are appropriate. (9/1/05)

Areas of Inspection	Observation	Recommended Action
	currently ongoing. 9/1/05	
Erosion and Sediment Controls (includes inspection within 24 hours of a storm event)	<p>-Hoyts Hill: The perimeter and internal silt fence remains in good condition. 9/1/05</p> <p>- Archers Lane: All silt fence is still well in place along the cleared new access road as well the existing woods/cart path. Some wetland areas are located along the access road but are also separated by a stone wall and a small wetland area is located adjacent to thee woods path. 9/1/05</p>	<p>- None at this time. Continue to monitor the controls and be proactive in repair as necessary. 9/1/05</p> <p>- None at this time. Continue to monitor the area and be proactive in maintenance of the erosion controls, especially in areas with wetland immediately adjacent. 9/1/05</p>
Inland Wetland and Watercourse encroachment and mitigation	<p>- Hoyts Hill: As part of the transition station, a small area of wetland was cleared and altered. The double silt fence row is up as a work limit and to protect the remainder of the wetland. 7/22-9/1/05</p> <p>Archers Lane: The timber span over the potential wetland crossing on the woods path is in good condition. Wood chips were placed on the path, adjacent to this area 9/1/05</p>	<p>-Continue to monitor. In general, keep all equipment and materials out of wetlands not to be disturbed and keep controls in good repair. 9/1/05</p> <p>- Avoid placing any wood chips directly in the low wetland spot. Areas adjacent are appropriate. 9/1/05</p>
