Docket No. 217 – Development and Management Plan Inspection

Northeast Utilities Service Company Certificate of Environmental Compatibility and Public Need for the construction of a 345-kV electric transmission line and reconstruction of an existing 115-kV electric transmission line between Connecticut Light and Power Company's Plumtree Substation in Bethel, through the towns of Redding, Weston, and Wilton, and to the Norwalk Substation in Norwalk, Connecticut.

Date: October 25, 2006

Location: 345kV XLPE Component

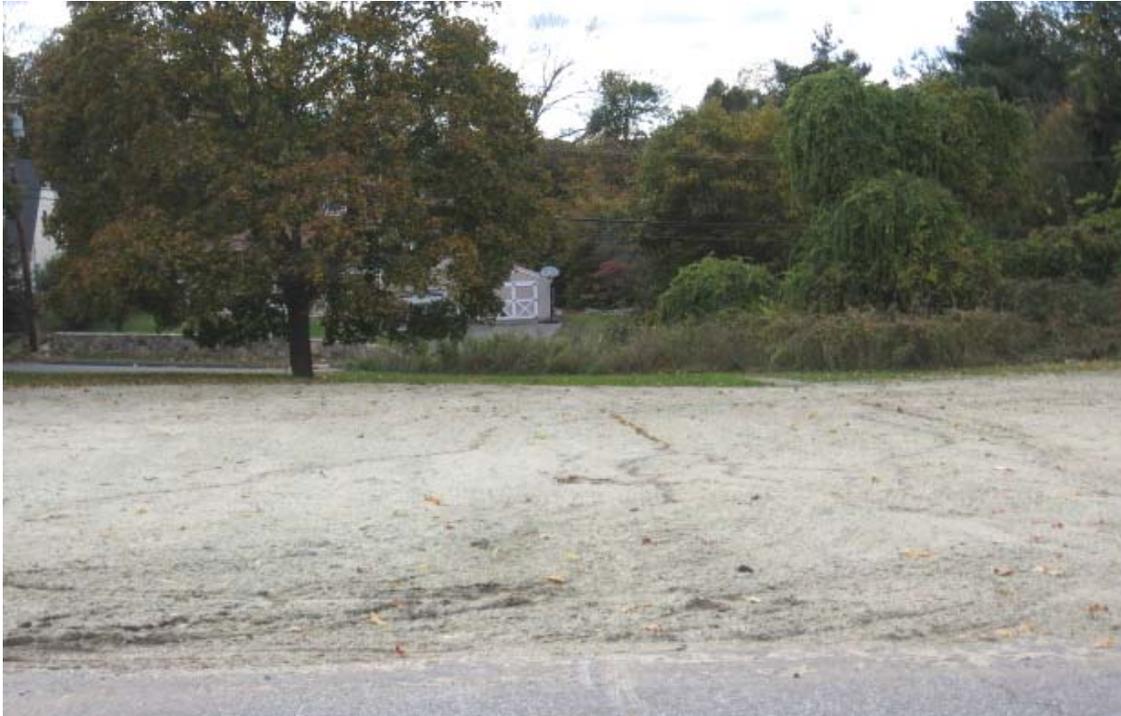
345kV XLPE: Photo on the left shows the demobilized contractor yard in the Bethel Ed Park which was recently hydroseeded. Minor rill erosion was noted on the soil surface. Vegetative cover is not expected prior to the winter. 10/25/06

- None. 10/25/06
- The contractor yard on Whittlesey Dr was recently hydroseeded but some minor rill erosion was noted on the soil surface.
 - Vegetative cover is not expected prior to the winter but continue to monitor and provide further stabilization if needed. 10/25/06

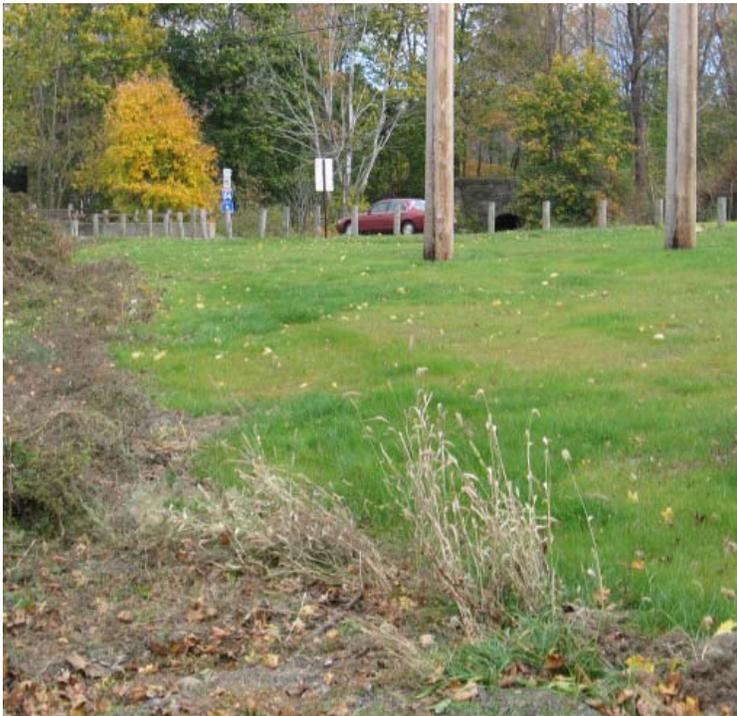
Photo on the left shows the lawn area in the ball park where silt fence has been removed following stabilization with grass cover. Photo on the right shows the stream banks with patchy vegetation in place. Additional or alternative stabilization measures may be needed here prior to the winter as no further vegetative cover is expected. 10/25/06

- Silt fence could be removed completely here but a few haybales should be added in strategic locations as a precaution. 10/4-10/25/06
- Silt fence was removed from the ball park lawn area following stabilization of the area with good vegetative cover.

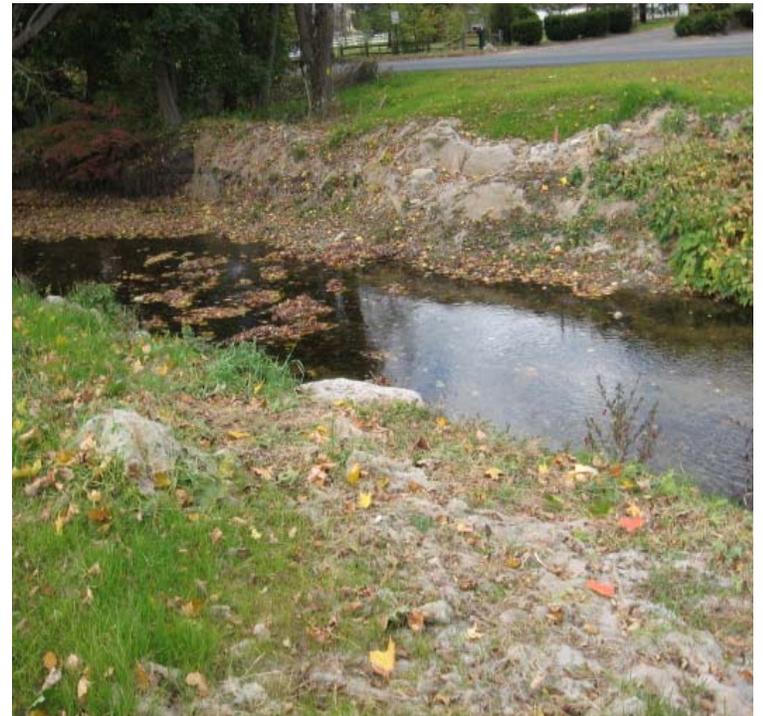
- None. The area can be removed from inspection. 10/25/06
- The erosion control blankets remained in place along the banks of East Swamp Brook, but vegetation remains sparse and patchy.

- Consider additional stabilization measures along the banks since additional vegetative cover is not likely at this point. 9/13-10/25/06
