**Docket No. 217 – Development and Management Plan Inspection**

Northeast Utilities Service Company Certificate of Environmental Compatibility and Public Need for the construction of a 345-kV electric transmission line and reconstruction of an existing 115-kV electric transmission line between Connecticut Light and Power Company's Plumtree Substation in Bethel, through the towns of Redding, Weston, and Wilton, and to the Norwalk Substation in Norwalk, Connecticut.

**Date:** October 18, 2006

**Location:** 345kV Underground Route

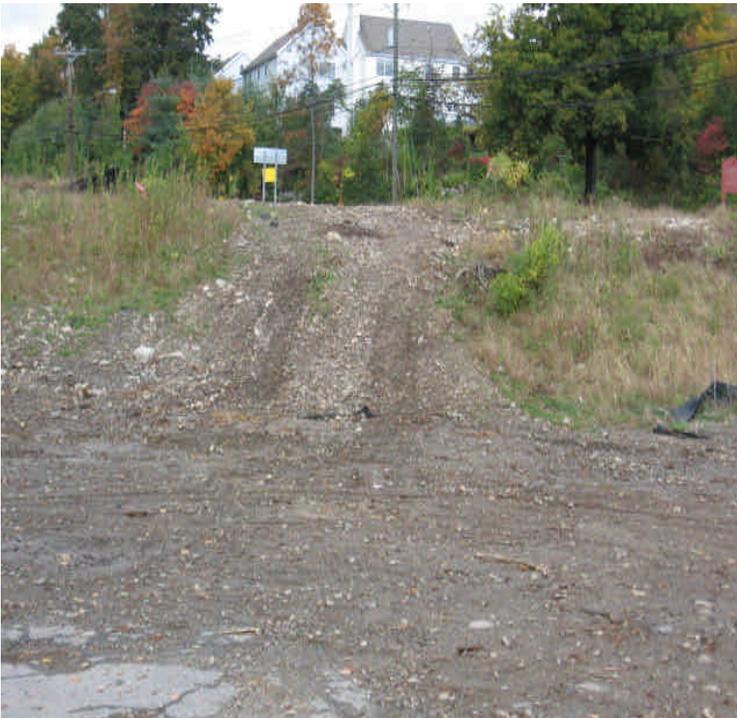
Photo on the left shows a view of the demobilized storage area across from Old Highway Rd. This area should be seeded and mulched if it will not be affected in the near future by the Rt 7 project. Photo on the right shows the Four Seasons racquet club where equipment from the project is stored. Restore to original conditions when the area is demobilized. 10/18/06

<p>Staging, Storage, and Parking Areas</p>	<p>- The storage area along Rt 7 across from Old Highway Rd was graded and demobilized but the soil surface is still exposed. 8/30-10/18/06</p> <p>- The racquet club storage yard has a pile of sandbags</p>	<p>- Temporary stabilization (i.e. mulch) is still needed here. 10/18/06.</p> <p>- Install haybales at the culvert within the swale in</p>	<p>- Needs attention when feasible unless it will be affected by Rt 7 project work.</p> <p>- Needs attention</p>

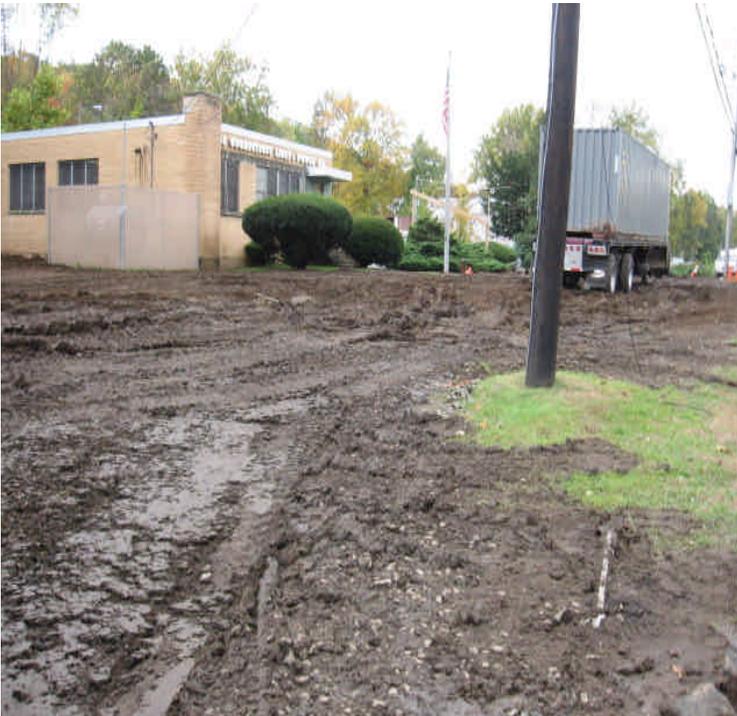
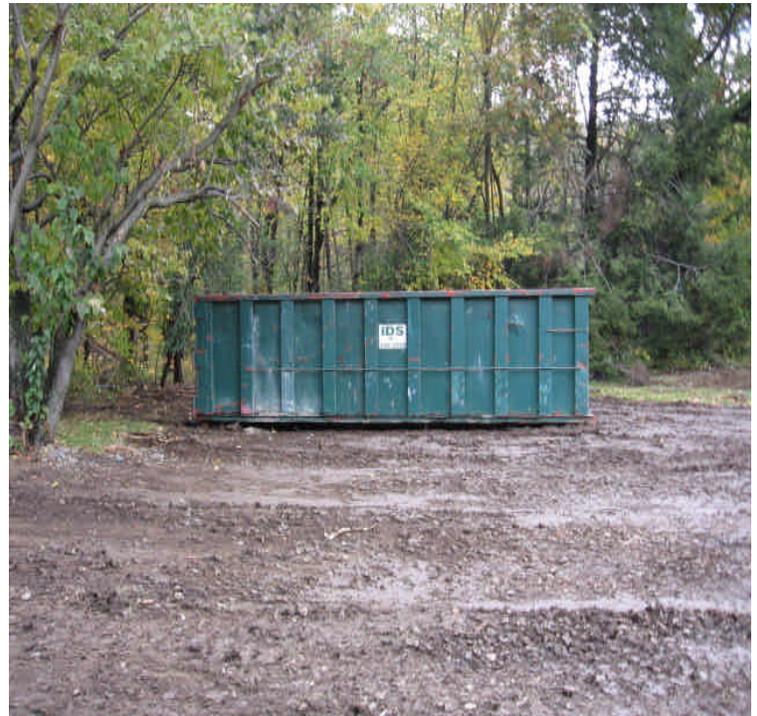
Both photos show the demobilized contractor trailer yard along Rt 7. Crews were placing topsoil and regrading this area to original conditions at the time of inspection. The topsoil stockpile has been graded out. 10/18/06.

Areas of Inspection	Observation	Recommended Action	Corrective Action
Vault Openings and Trench Construction	- Topsoil was replaced at the contractor trailer yard and the area was being graded. 10/18/06	- Continue to restore. 10/18/06	-Restoration is occurring at the trailer yard.
	-Some vaults may continue to require internal access however the line is now energized. 10/18/06	- Include these areas as part of the restoration efforts when access is complete. 4/12-10/18/06	-Needs attention when feasible
	-Work was noted along Rt 107 in an effort to bring the trench line up to final grade. 10/18/06	- Use catch basin controls if sawcutting is necessary. 10/4-10/18/06	-N/A

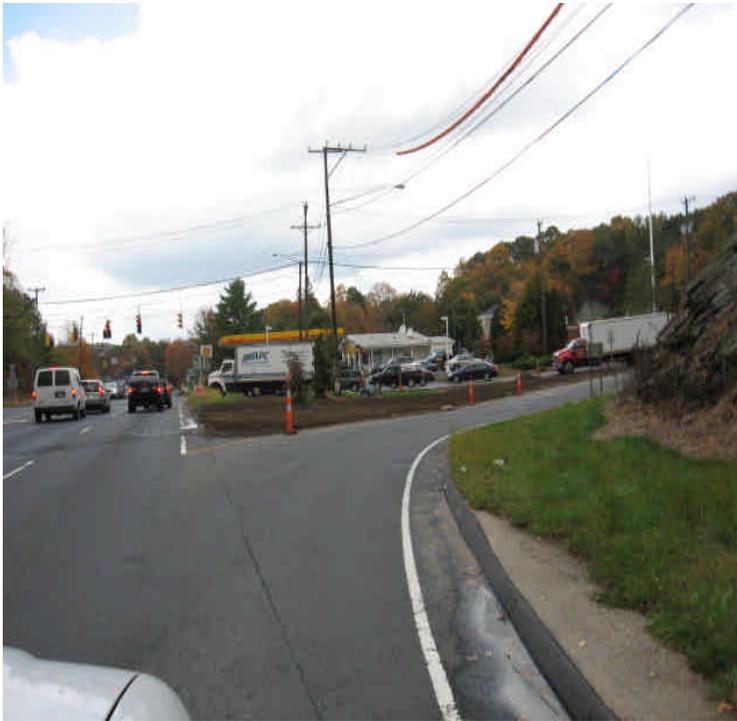
Photo on the right shows the Rt 7/107 intersection which has been regraded to original conditions and stockpiles were removed. Final restoration is still needed. Photo on the right shows active work along Rt 107 to bring the roadway to grade. 10/18/06

<p><b>Rt. 107</b></p> <p>Erosion and Sediment (E&amp;S) Controls continued</p>	<p>- The Rt. 107 &amp; 7 intersection has been re-graded to original conditions and stockpiles no longer remain here. 10/18/06. Some Sedimentation was noted to the roadway here. 10/4-10/18/06</p> <p>- Good controls remain at the Georgetown HDD site (Gilbert &amp; Bennett lot). 10/18/06. No grass growth was noted this week. 10/18/06.</p>	<p>- Temporary stabilization (i.e. mulch) is still needed here. 10/18/06.</p> <p>- None. The area is in good shape and will be removed from the inspection. Vegetative is not expected prior to the next growing season. 10/18/06</p>	<p>- Restoration is underway here.</p> <p>- Area is well stabilized for the winter and will no longer be inspected.</p>
<p>Adjacent Wetlands and Waterways</p>	<p>- All resource areas were restored following the 345kV project work. 10/18/06</p>	<p>-None 10/18/06</p>	<p>- N/A</p>

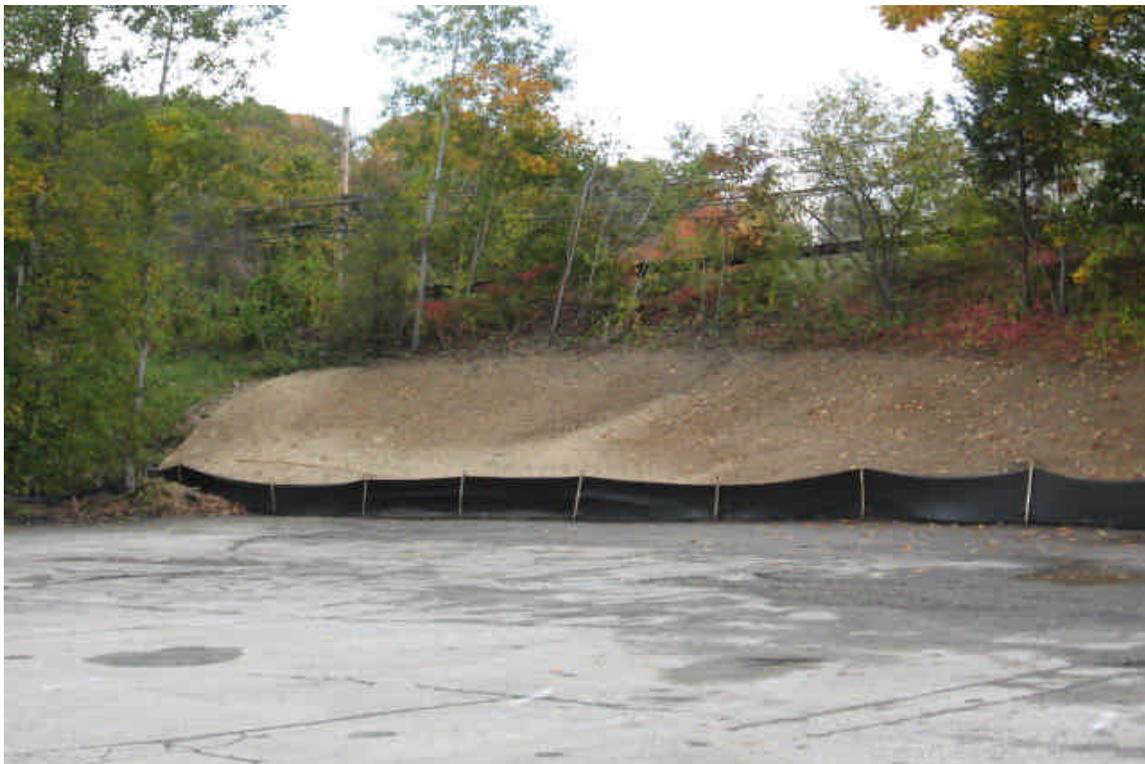
Photo shows a view of the erosion control mats in place along the slope at the Gilbert & Bennett lot. This area is temporarily stabilized. 10/18/06.
