**Docket No. 272 – Development and Management Plan Inspection**

**Underground Line Watercourse and Railroad Crossings**

**Date:** December 31, 2007

**Location:** Crossings of Watercourses and Railroads in Segments 3, 4a and 4b

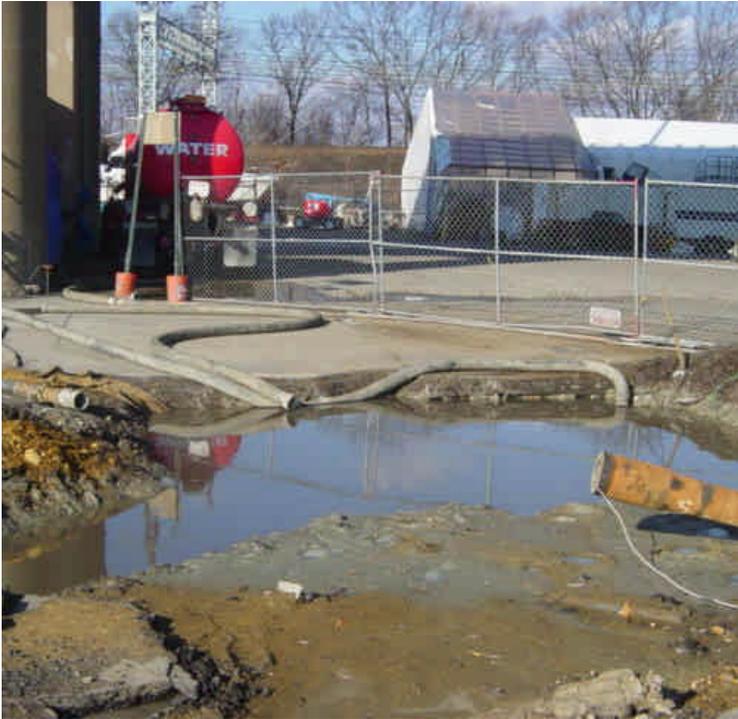
**On the west side of the Housatonic River, the drill pit was left inactive during the holiday break. Recent storm events and run-off have raised the level of fluid in the drilling pit, which is nearing capacity.**

<b>Housatonic River</b>	<p>The large drill pit on the west side of the Housatonic River is intended to facilitate drilling activities and project sequencing. The contractor indicated that some slurry must remain in the pit overnight during cold weather to prevent the equipment from freezing. Runoff/ storm events have raised the level of fluid in the drilling pit and is nearing capacity. 12/31/07</p> <p>A frac-out was observed on the east side of the Housatonic River within the paved area prior to the break. There was also an area of run-off and slurry by</p>	<p>Continue to monitor the amount of slurry in relation to the size of the pit to ensure adequate storage capacity. Also consider impacts from future storm events and run-off. Contractor states that the level of slurry in the pit will be lowered at the end of each workday to provide additional capacity 12/12-12/31/07</p> <p>While the areas are contained within the staging area, slurry should be cleaned up to avoid unanticipated impacts. 12/21-12/31/07</p>	<p>Needs regular evaluation.</p> <p>Needs regular attention.</p>

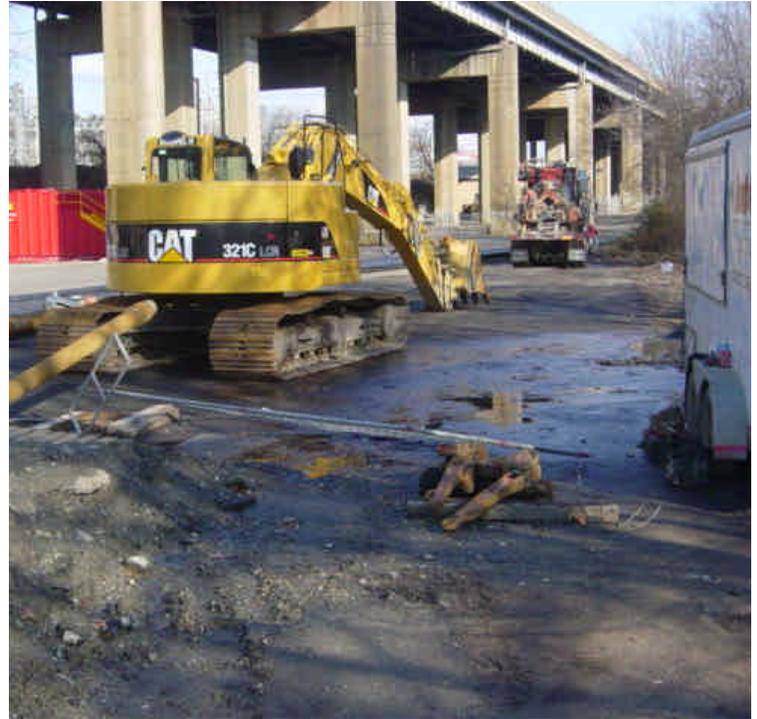
**On the east side of the Housatonic River, spilled drilling fluid remains over the paved area near the drilling pit and trailer. The area is contained, but the material should be removed prior to work resuming in this area.**

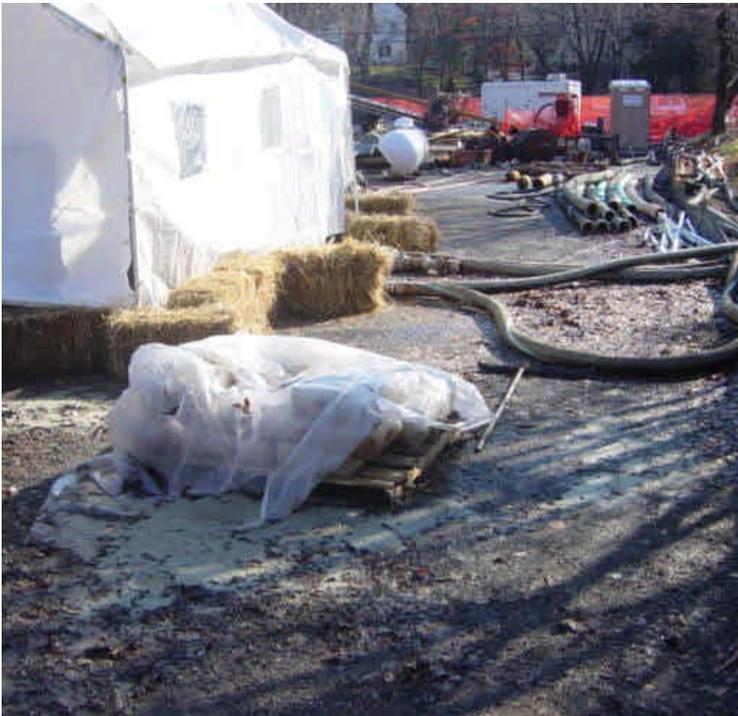
**Leaves and snow had covered previously spilled slurry material within the yard on the east side of the Saugatuck River. During the inspection, the area was exposed and it was evident that the spilled material remains in several locations here.**

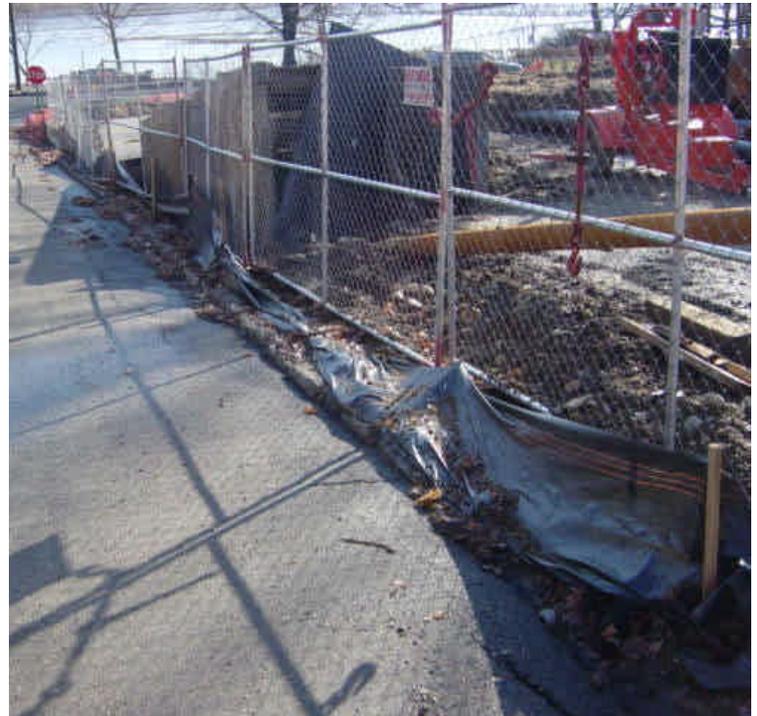
**On the west side of the Saugatuck River, silt fence along Lincoln St. is in need of repair.**

Areas of Inspection	Observation	Recommended Action	Corrected Action
Ash Creek	<p><b>Lincoln St. needs repair. 12/31/07</b></p> <p><b>On the east side of the Saugatuck River, silt fence around the drill pit needs repair again. Construction fence is in place. 12/21-12/31/07</b></p>	<p><b>12/31/07</b></p> <p><b>Continue to monitor and maintain the controls. Identify areas of potential high flow or run-off and reinforce controls when necessary. 12/21-12/31/07</b></p>	<p><b>Needs attention again.</b></p>
	<p><b>Catch basins near Ash Creek appear to be free of construction related sediment and debris as work is on hold here. 12/31/07</b></p>	<p><b>Continue to monitor and maintain sediment control measures. Contractors state the area is cleaned regularly as spills are common during active work. 12/31/07</b></p>	<p><b>Catch basins were free of debris.</b></p>
Housatonic River	<p><b>Perimeter controls are in place around the work area on the west side of the Housatonic River. A dirt berm is in place around the drilling pit. Runoff/ recent storm events have contributed to the amount of fluid in the drilling pit, which is nearing capacity. 12/31/07</b></p>	<p><b>Continue to monitor the area and maintain the controls to ensure they adequately contain the area. Ensure adequate capacity for drilling materials as well as stormwater run-off. 12/31/07</b></p>	<p><b>Continue to monitor. Needs attention soon</b></p>
