Docket No. 272 – Development and Management Plan Inspection

Segment 1b (Royal Oaks Bypass) Inspection

Date: September 8, 2008

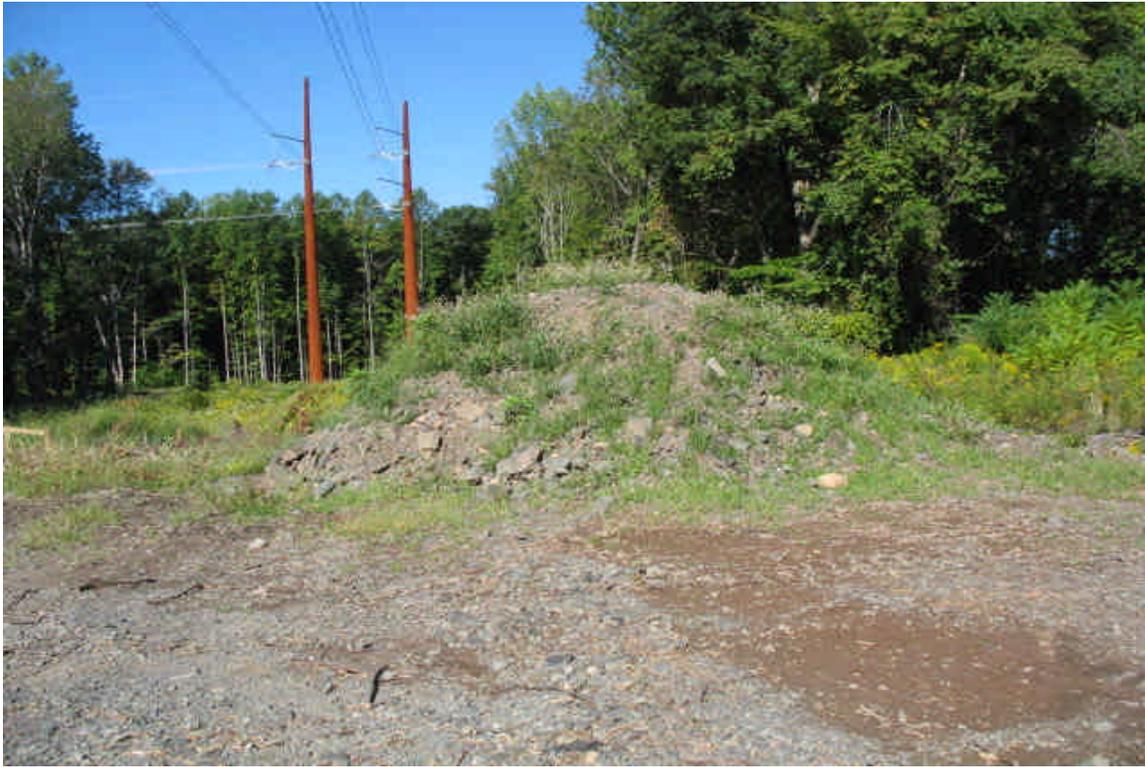
Stockpile located upgradient from the wetlands at the edge of the contractor receiving yard. Controls are in place, but the material should be relocated.

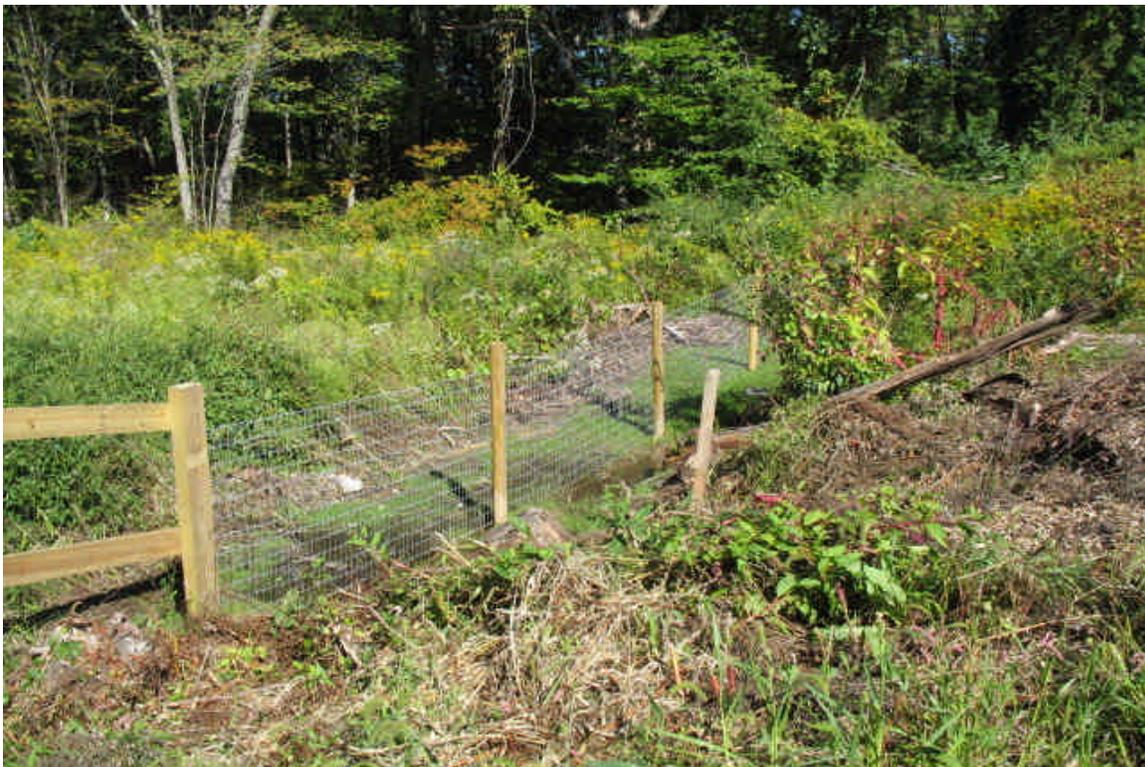
New fence remains upgradient of the wetland and across the access road past the contractor yard. This was likely installed by the private property owner. Minor grass growth noted along the disturbed area.
