**Docket No. 272 – Development and Management Plan Inspection**

**Segment 2a Inspection**

**Date:** September 8, 2008

**Location:** Segment 2a – Beseck Switching Station to Cheshire/Hamden Town Line

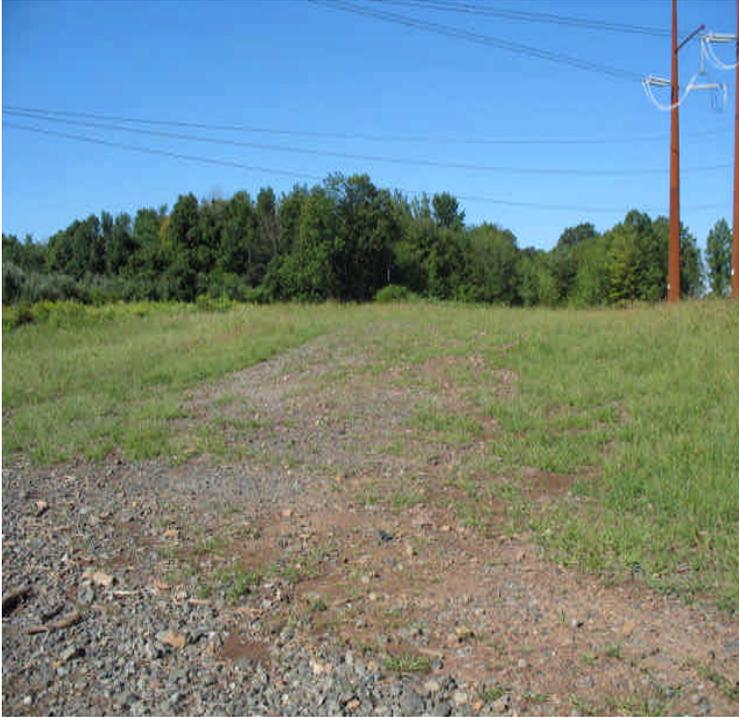
**Carpenter Ln:** Recently restored uplands are still sparsely vegetated. Additional seed may be needed.

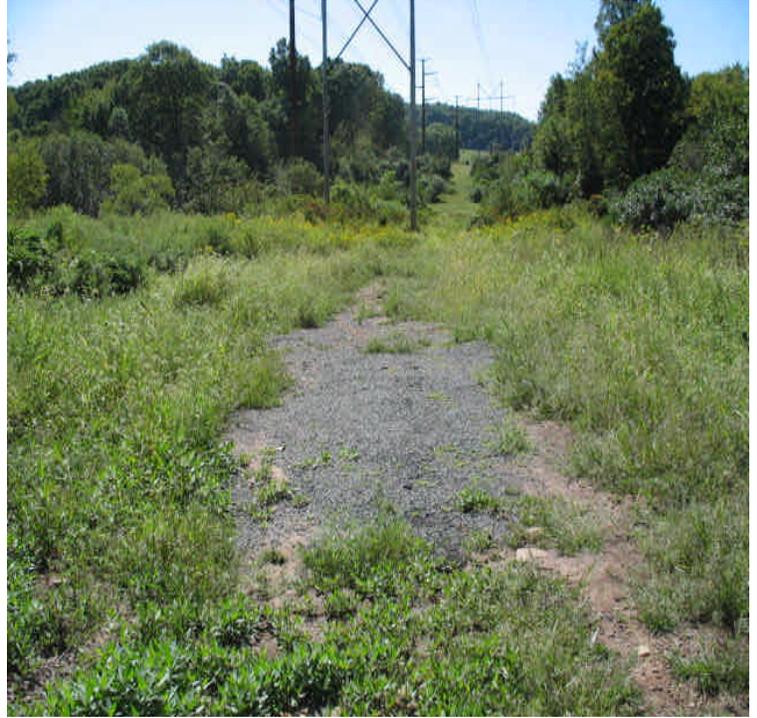
**Durham Rd:** Restoration work is complete within the wetlands. Small area of upland along the access road is still sparse however, wetlands are stable.

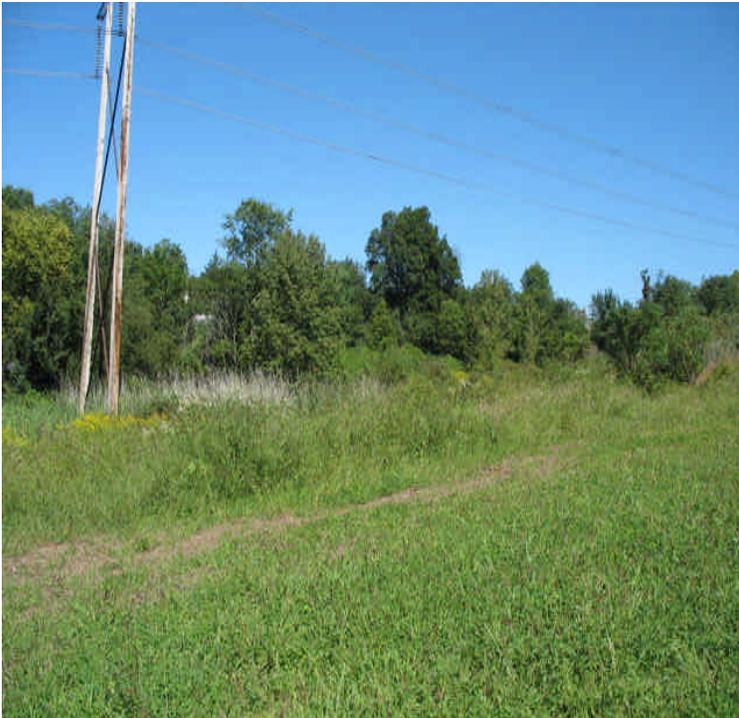
**Stony Brook Rd:** Small sparse area of vegetation located at the site entrance. It will be evaluated if there is 70% cover overall.

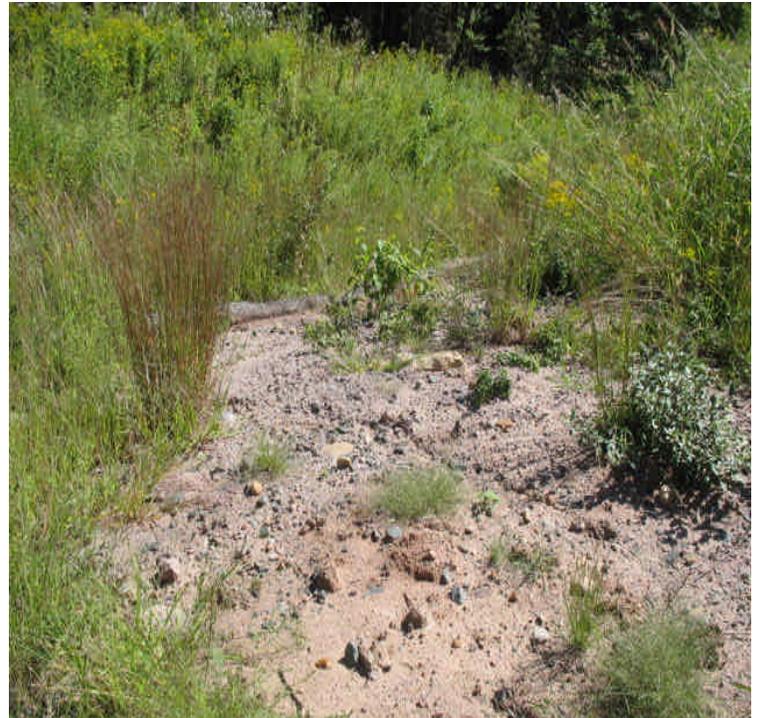
**Cook Hill Jct:** Fiber roll in place upgradient of a wetland crossing. Stabilization of upland area is still needed.
