**Docket No. 272 – Development and Management Plan Inspection**

**Segment 2a Inspection**

**Date:** September 16, 2008

**Location:** Segment 2a – Beseck Switching Station to Cheshire/Hamden Town Line

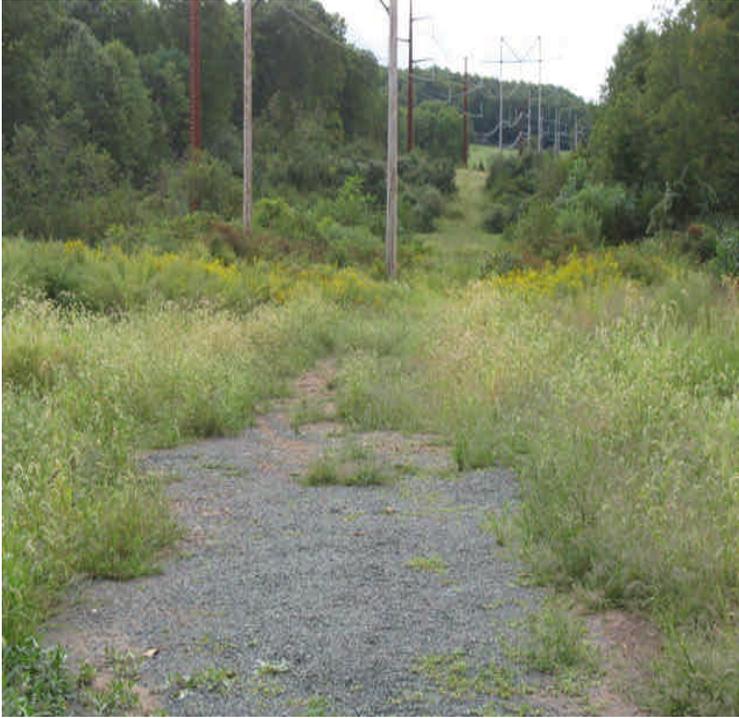
**Durham Rd: Wetlands are stable with over 70% vegetative cover. Small area of upland along the access road is still sparse however, it will be evaluated if there is 70% cover overall.**

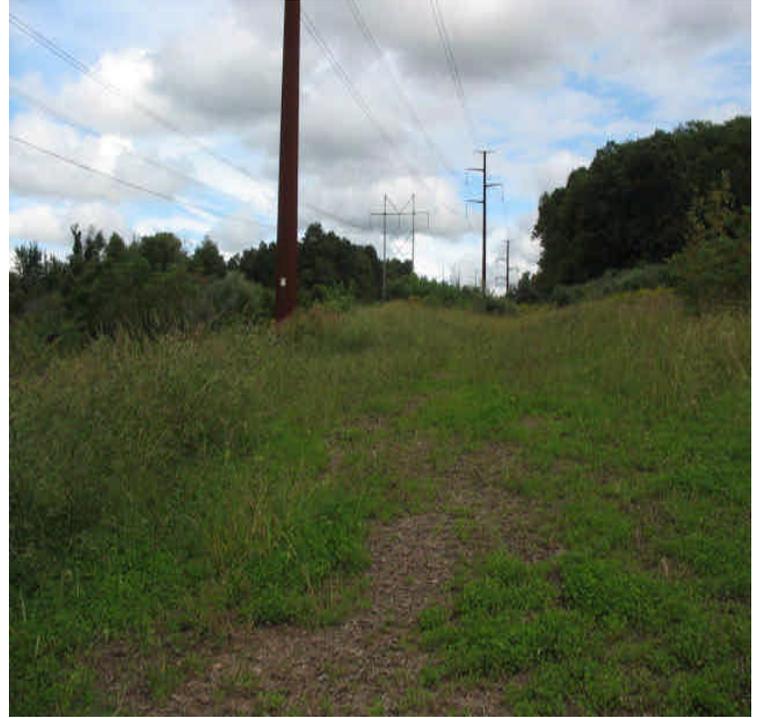
**Stony Brook Rd: Small sparse area of vegetation located at the site entrance. It will be evaluated if there is 70% cover overall.**

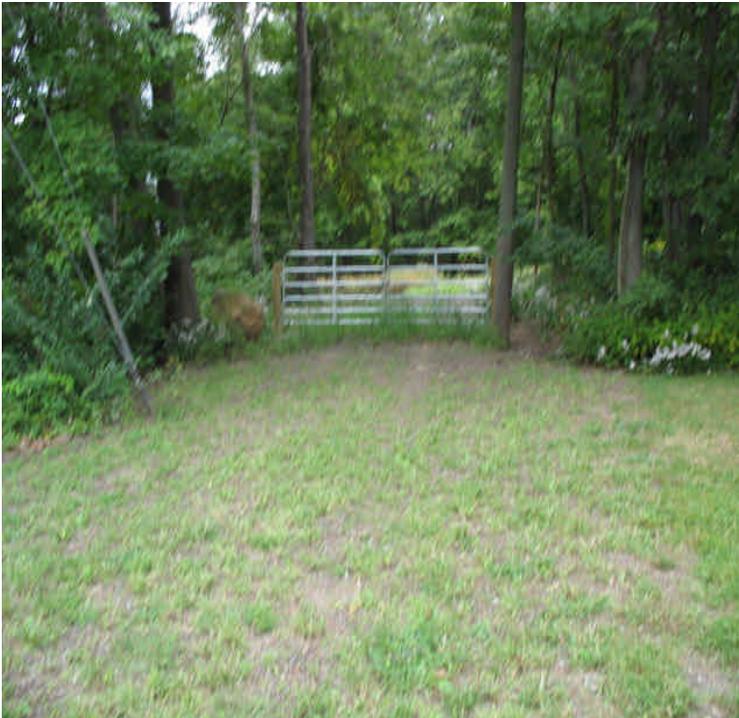
**Docker Dr: Area of sparse vegetation located at the site entrance.**

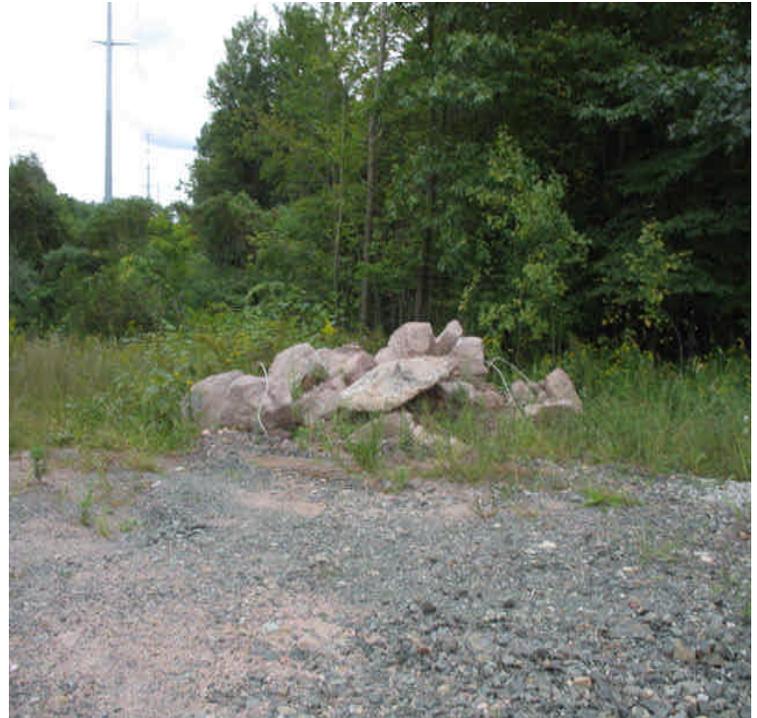
**Cook Hill Jct: Stone stockpile to be removed during final restoration. BSC was informed this will be one of the last sections restored.**
