Docket No. 272 – Development and Management Plan Inspection

Segment 2a Inspection

Date: September 29, 2008

Location: Segment 2a – Beseck Switching Station to Cheshire/Hamden Town Line

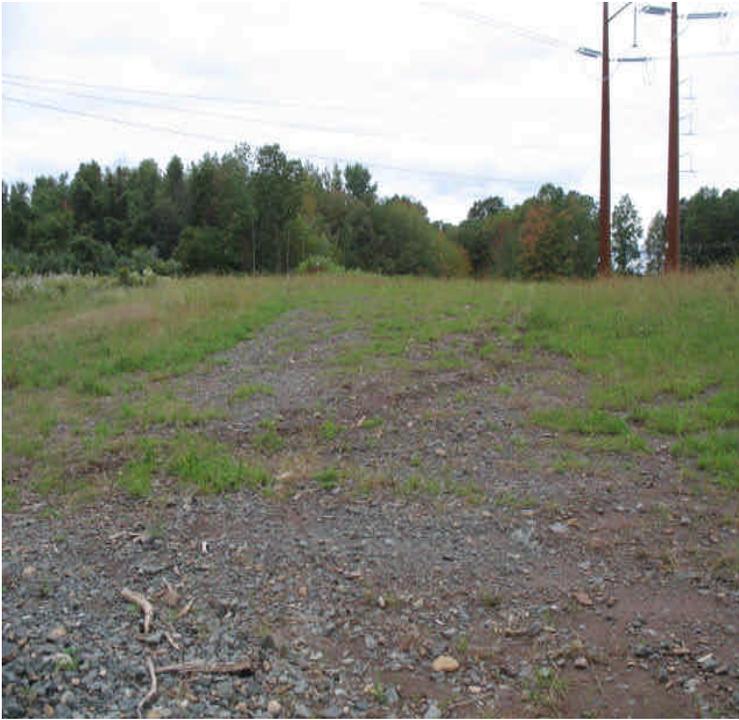
Carpenter Ln: Recently restored uplands are still sparsely vegetated. Additional seed may be needed.

Areas of Inspection	Observation	Recommended Action	Corrected Action
Access roads and adjacent roadways Carpenter Ln. to Rte 68	South of Carpenter Ln, the large area upgradient of the wetlands is sparsely vegetated and may need additional seed. 9/29/08	Continue to monitor the area. See the erosion control section for more details. 9/29/08	NA (Not Applicable) Additional seed may be needed.
	ATV traffic has rutted and disturbed several sections of slope off High Hill Rd. before vegetation could establish. Contractor has installed fences and signs to reduce ATV traffic. 9/29/08	Haybales were added to the base of slope proactively in one location. The area should be stabilized further if feasible. 9/29/08	Contractor has made efforts to reduce ATV traffic. Ruts need attention if feasible.
Durham Rd. Liney Hall Ln.	A ditch/waterbar was installed (8/12) to divert run-off across the exposed access road, away from the wetlands downgradient. 9/29/08	Continue to monitor the access road upgradient from wetlands until stable. 9/29/08	NA at this time

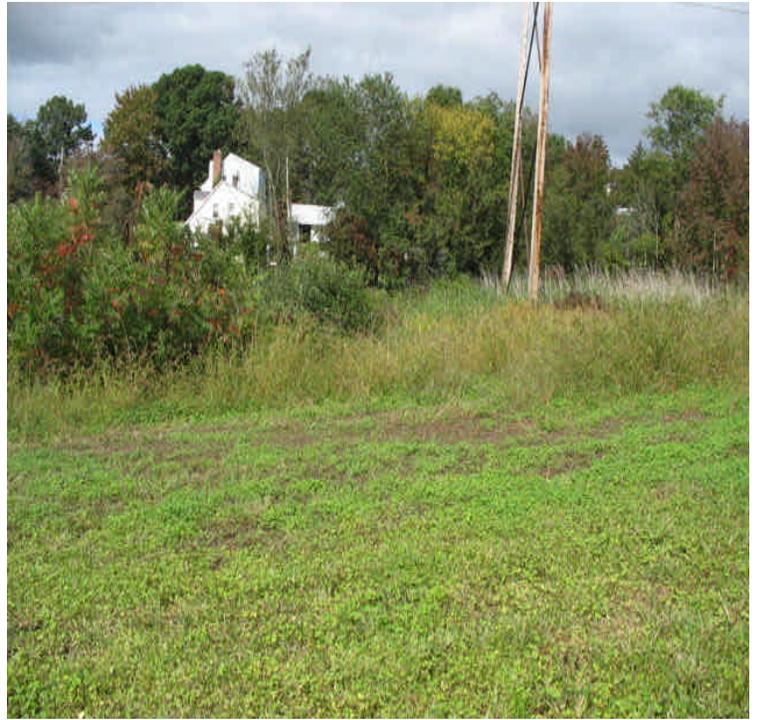
Stony Brook Rd: Small sparse area of vegetation located at the site entrance. It will be evaluated if there is 70% cover overall. It appears to be slowly filling in with grass.

Areas of Inspection	Observation	Recommended Action	Corrected Action
Woodhouse Ave and Harrison Rd.	establishes, (e.g slopes to wetlands on Durham, at Structure #24281 and the Stony Brook Rd. entrance. However, the areas do appear to be slowly filling in. 9/29/08 As requested by state representatives and Siting Council staff, native shrubs were planted (9/18/07) in clusters to provide shading for Allen Brook. 9/29/08	continue to evaluate whether the overall area is at 70% cover. 9/29/08 Continue to monitor and replace shrubs if needed. B&M intends to monitor the survival status of the shrubs.9/29/08	evaluate. NA at this time.
Dewatering	All foundations and dewatering is complete at this time. 9/29/08	Remove and stabilize old dewatering pits as necessary. 9/29/08	NA at this time. Work has shifted to restoration.
Spills, soils and material storage	Spill control materials are being brought to sites when work is performed. 9/29/08	Always use spill control materials when working on equipment and during refueling. Replace as needed. Check equipment daily for leaks and repair as soon as possible. 9/29/08	Needs regular attention.

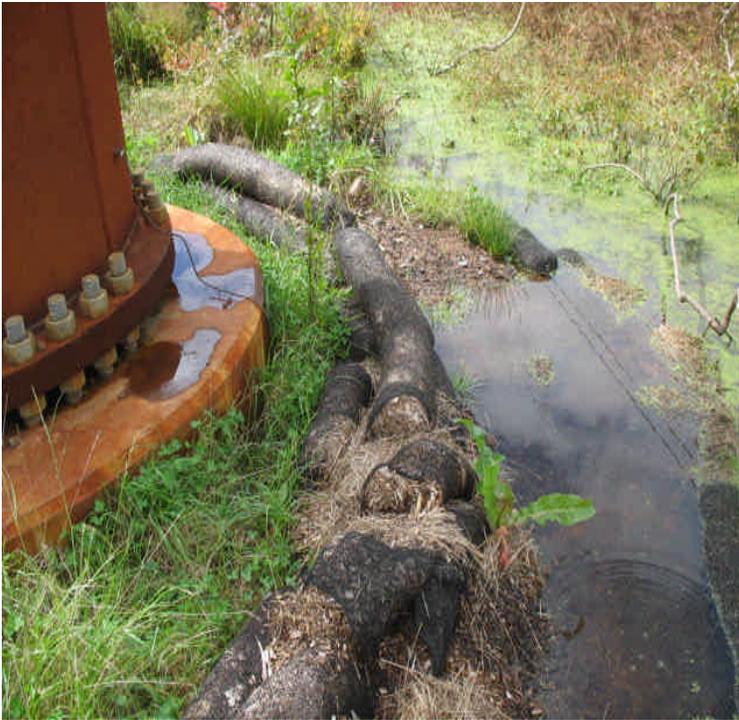
Tamarack Swamp Rd: Grass growth noted; area is stable. The filter socks will be left to deteriorate in place.

Areas of Inspection	Observation	Recommended Action	Corrected Action
Tamarack Swamp Rd.	<p>installed (8/12) to redirect stormwater into stable vegetated areas above the wetland. 9/29/08</p> <p>Grass cover has established at structure #24252 immediately adjacent to the wetland. The filter socks will be left to deteriorate in place. 9/29/08</p>	<p>Monitor areas for final vegetative cover. 9/29/08</p>	<p>Vegetation has established.</p>
Powers Rd. Woodhouse Ave. Harrison Rd.	<p>Vegetative cover continues to increase along the channel at Powers Rd 9/29/08</p>	<p>This area is stable. The few sparse areas have been filling in. 9/29/08</p>	<p>The area appears to be stable.</p>
Pond Hill Rd. & Docker Dr. (I 91 – Rte. 5)	<p>Area is stable. ATV traffic has reduced. Silt fence and silt sock remain at the base of slope. 9/29/08</p>	<p>Silt fence should be removed if the area is fully stable. 9/29/08</p>	<p>ATV traffic appears to have reduced. Area is stable. Remove silt fence.</p>

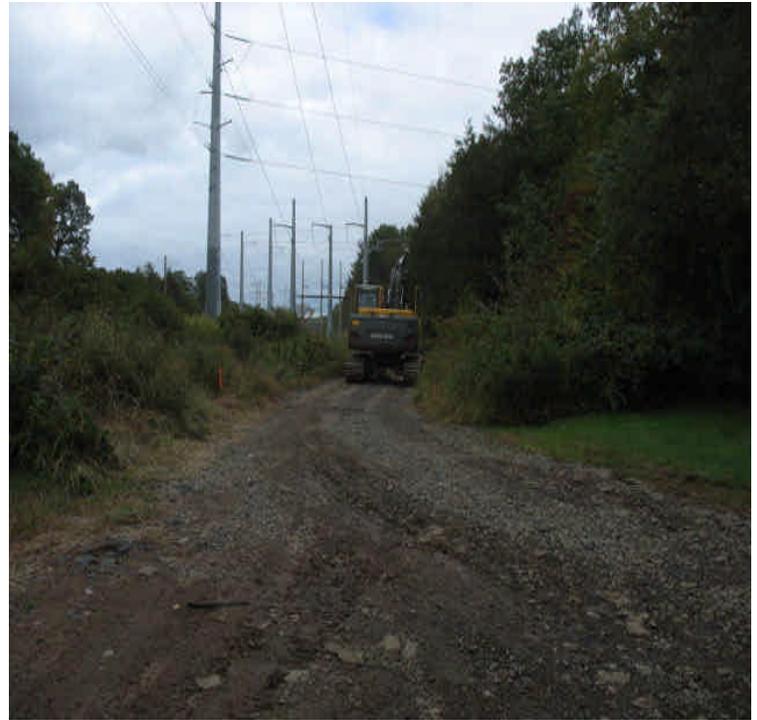
Cook Hill Jct: Final restoration underway in this section.
