Docket No. 272 – Development and Management Plan Inspection

Underground Line Watercourse and Railroad Crossings

Date: January 18, 2008

Location: Crossings of Watercourses and Railroads in Segments 3, 4a and 4b

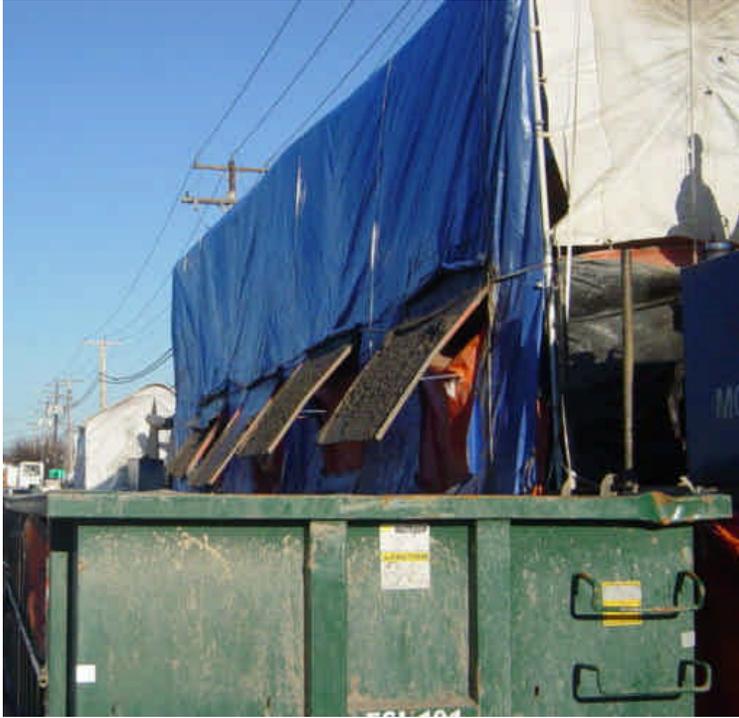
On the west side of Ash Creek, dewatering was in progress. No sediment was observed on the roadway in this area.

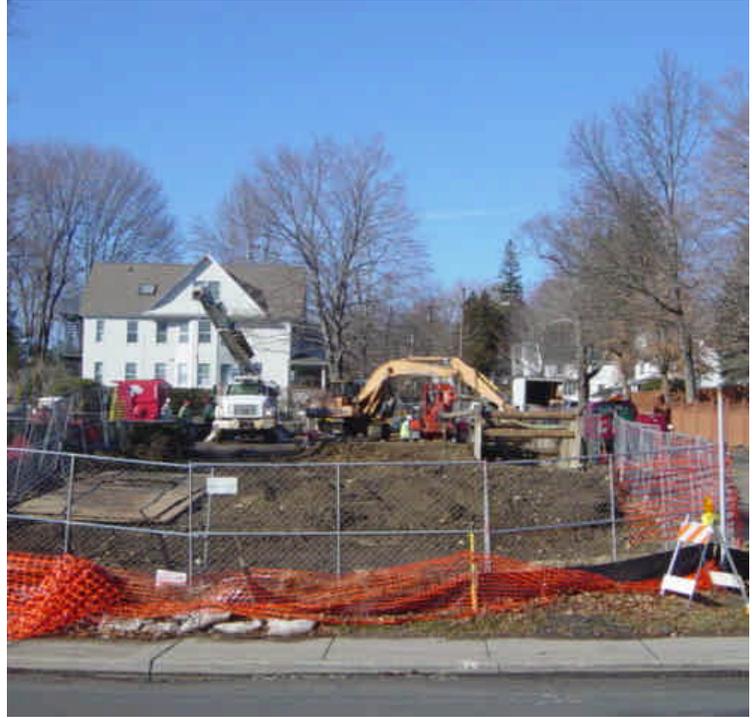
On the west side of the Saugatuck River, the silt fence along Lincoln Street needs repair.

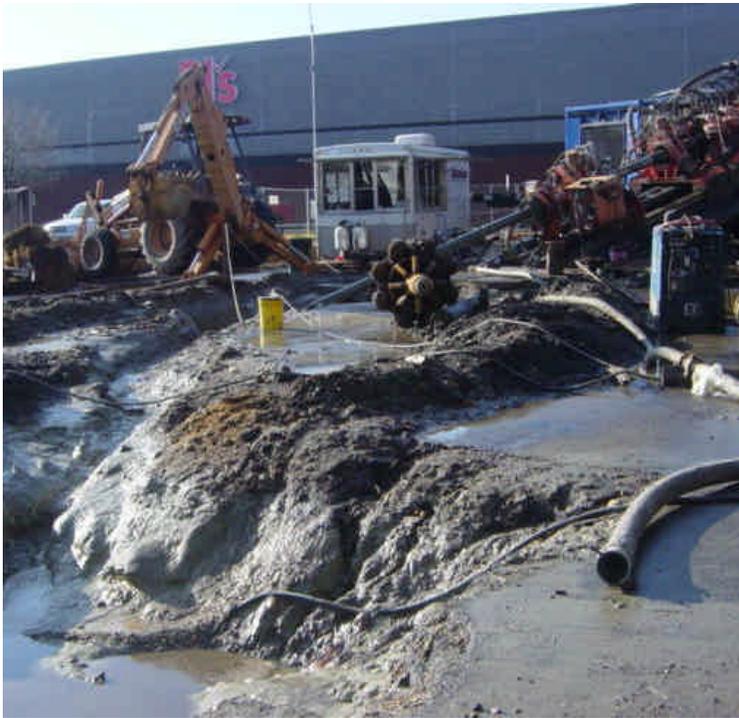
On the east side of the Housatonic River, most of the fluid had been pumped out of the drill pit while broken pipe was being removed from under the river. Large amounts of slurry remain on the pavement.

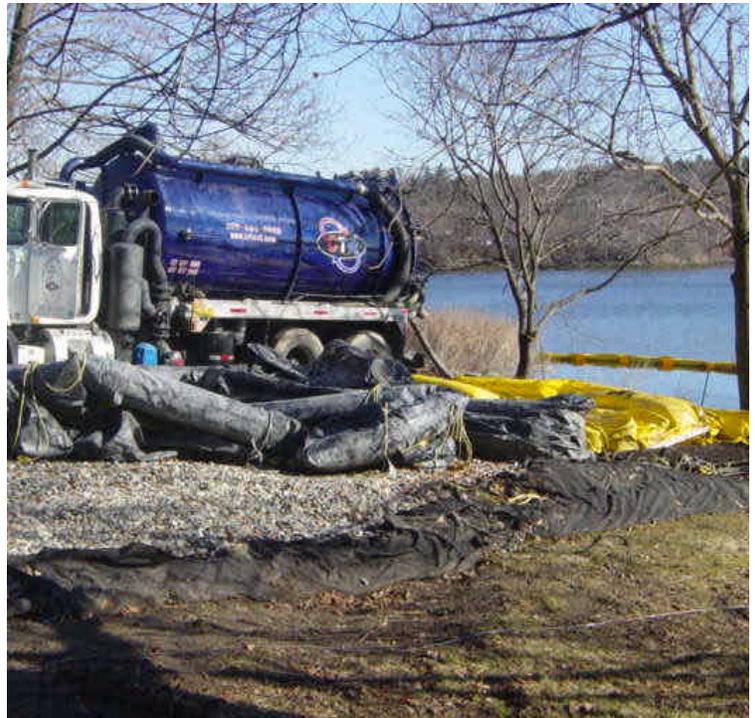
On the west side of the Saugatuck River, vacuum trucks have been staged in the park off Lincoln Street. The parking area remains stabilized with geotextile fabric and crushed stone. Minor sediment tracking from this area was observed. One of the booms on the Saugatuck River was visible in the background.
