Docket No. 272 – Development and Management Plan Inspection

Underground Line Watercourse and Railroad Crossings

Date: April 3, 2008

Location: Crossings of Watercourses and Railroads in Segments 3, 4a and 4b

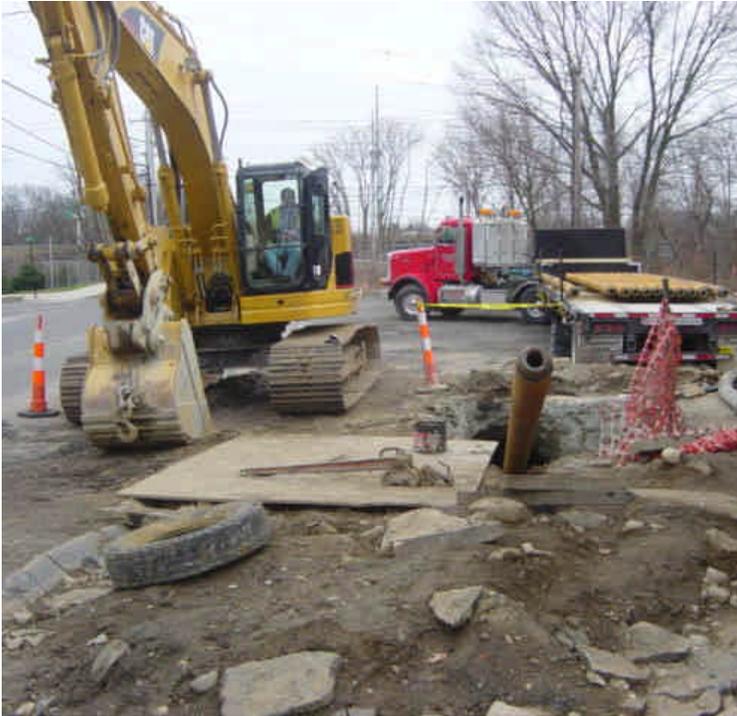
Drilling work is underway at the Metro North R.R. crossing in Milford. The staging area on the south side is located directly adjacent to Naugatuck Ave. A nearby catch basin was not protected with controls

<p>Haybales and a filter boom are in place around the staging area on the down gradient side of the staging yard. Silt fence also remains around the temporary access road, which has been cut for access to the boat launch. A catch basin near the staging area along Naugatuck Ave. was not protected. 3/28-4/03/08</p>	<p>Monitor and maintain sediment and erosion controls. Protect catch basin that is adjacent to drilling work along Naugatuck Ave. Adjust controls as field conditions change. 3/28-4/03/08</p>	<p>Catch basin needs attention.</p>
	<p>Minor sediment tracking was observed on Naugatuck Ave. near the temporary boat ramp</p>	<p>Sweep roadway as necessary to reduce sediment tracking 4/03/08</p>	<p>Needs regular attention.</p>

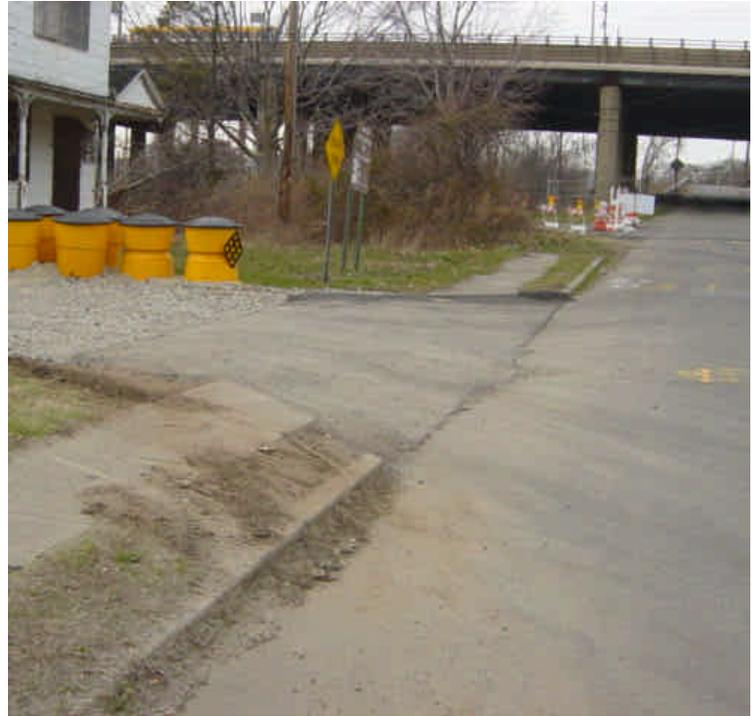
Minor sediment tracking was observed on Naugatuck Ave. near the temporary boat ramp entrance associated with the Metro North R.R. Crossing. Sweep as needed.

Metro North R.R. - Milford	Staging area has been established on the south side of the Metro North R.R. off Naugatuck Ave. Drilling is underway. A temporary access road has been cut to maintain access to the boat launch area. Some minor sediment tracking was observed. 4/03/08	Continue to monitor for tracking. See Erosion and Sediment Control section for more details. Sweep the area as needed. 4/03/08	Needs regular attention.

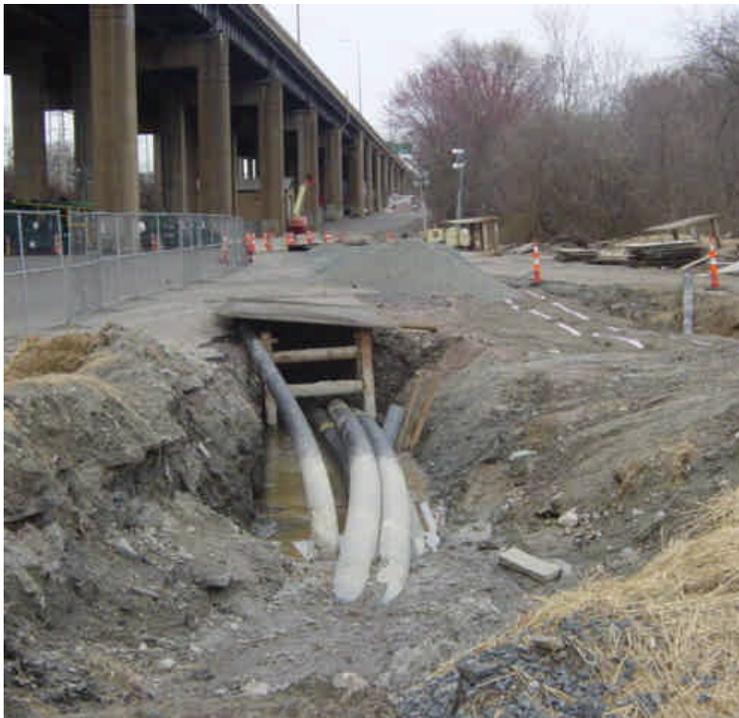
The drill pits remain open on the east side of the Housatonic River. Tie-in work is underway and the pits are scheduled to be backfilled within the next few weeks.

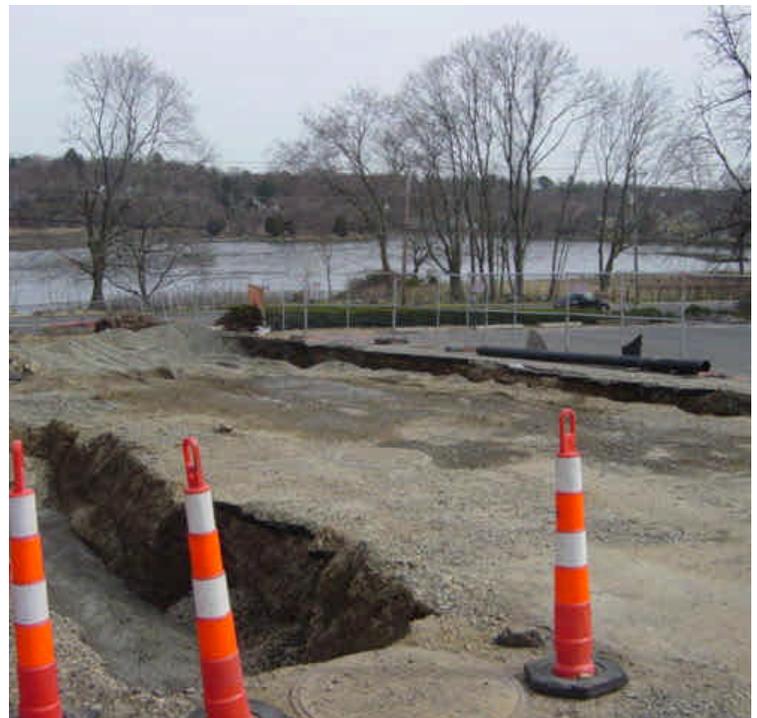
On the west side of the Saugatuck River, the tie-in work is nearing completion. Hand hole installation work is ongoing at the time of the inspection.
