Docket No. 272 – Development and Management Plan Inspection

Segment 2b Inspection

Date: April 5, 2007

Location: Segment 2b – Cheshire/Hamden Town Line to East Devon Substation

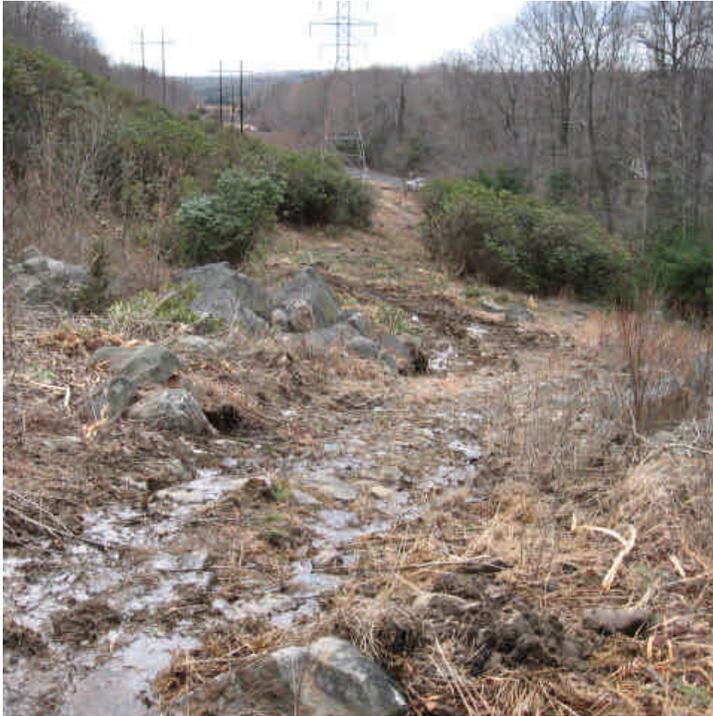
Downs Road (Bethany): General clearing has begun within the section of ROW accessed from Downs Rd.

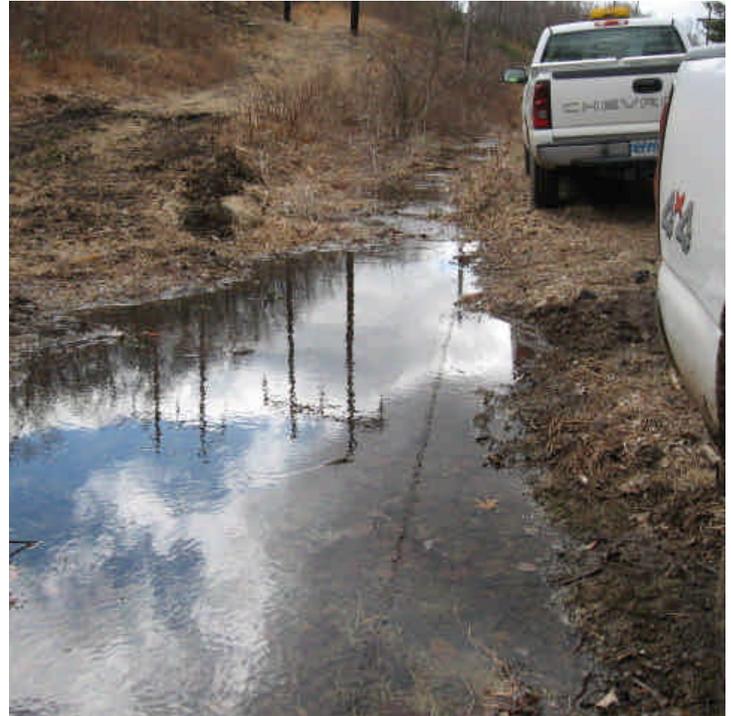
Downs Road (Bethany): Water was flowing through a drainage swale at the access point during the inspection. Timber mats may be needed for future access. Monitor for turbidity and install check dams if needed.

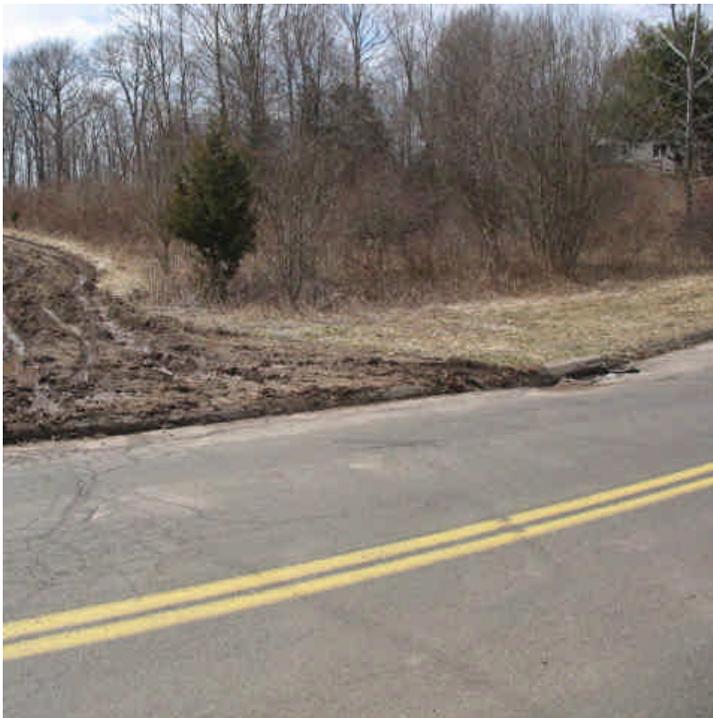
Old Lane Rd (Hamden): The silt sack remains intact within the catch basin immediately adjacent to the overhead access road, but curb inlet protection has not been provided.

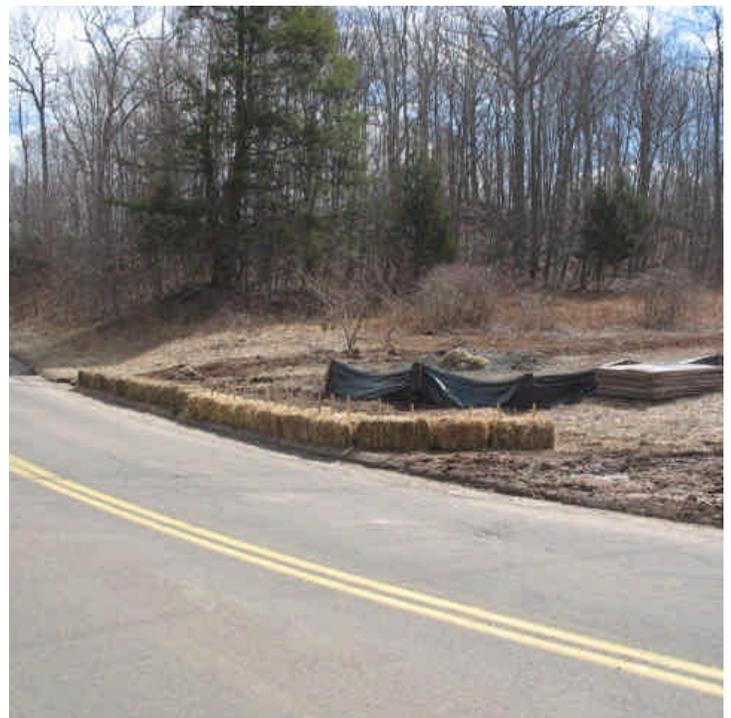
Old Lane Rd: Silt fence and haybales were installed here but the controls do not encompass all of the disturbed soil. The adjacent catch basin is not fully protected and still receives turbid run-off.

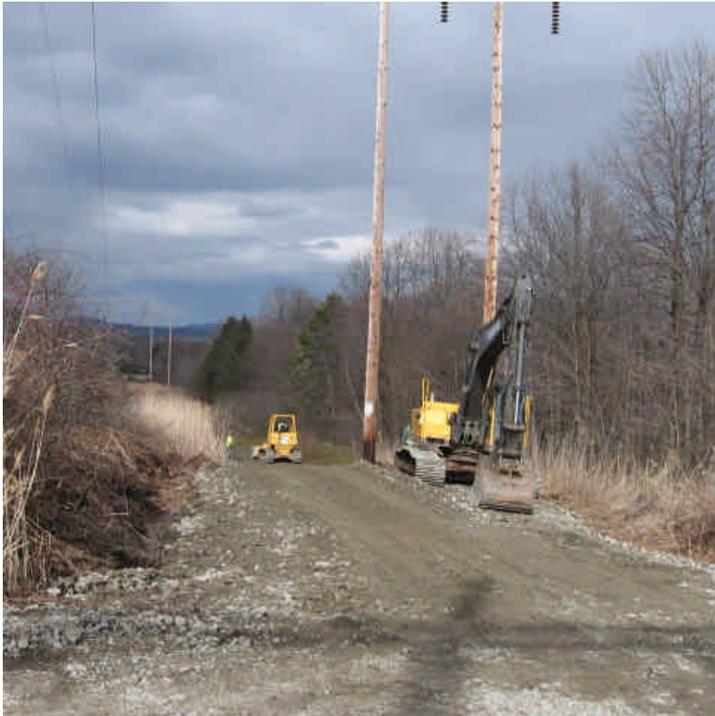
West Todd Street (Hamden): View of the constructed access road and clearing within the ROW.

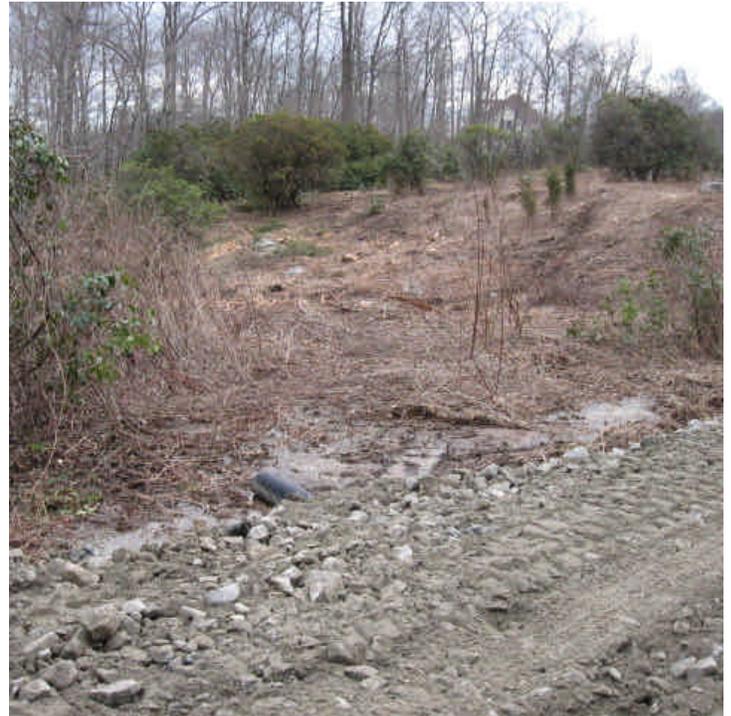
Tom Swamp/Arrow Rd (Hamden): Culverts were installed within the access road off Tom Swamp/Arrow Rd (west). Shrubs and small trees remain throughout the ROW here.

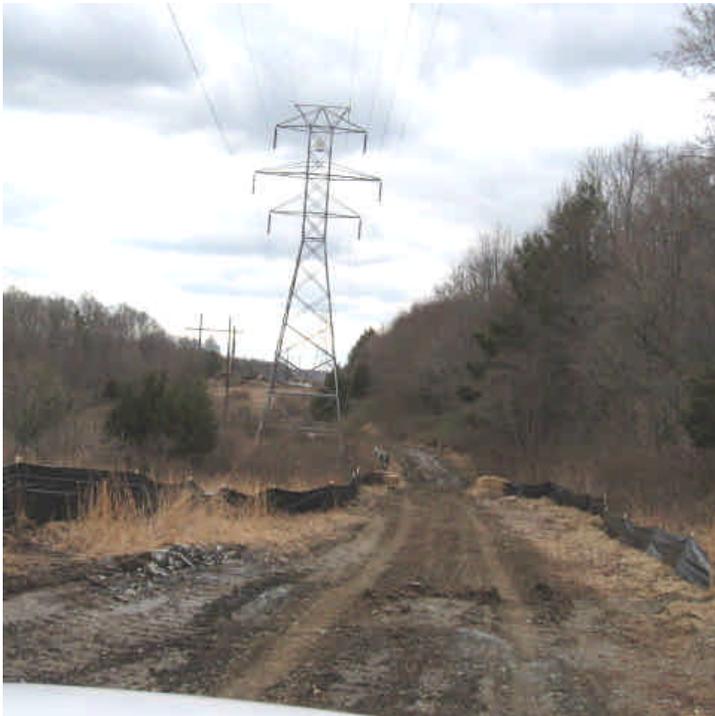
SCCRWA (Woodbridge): Silt fence and haybales are in place at wetland crossings here. Mulch has been applied to disturbed areas.

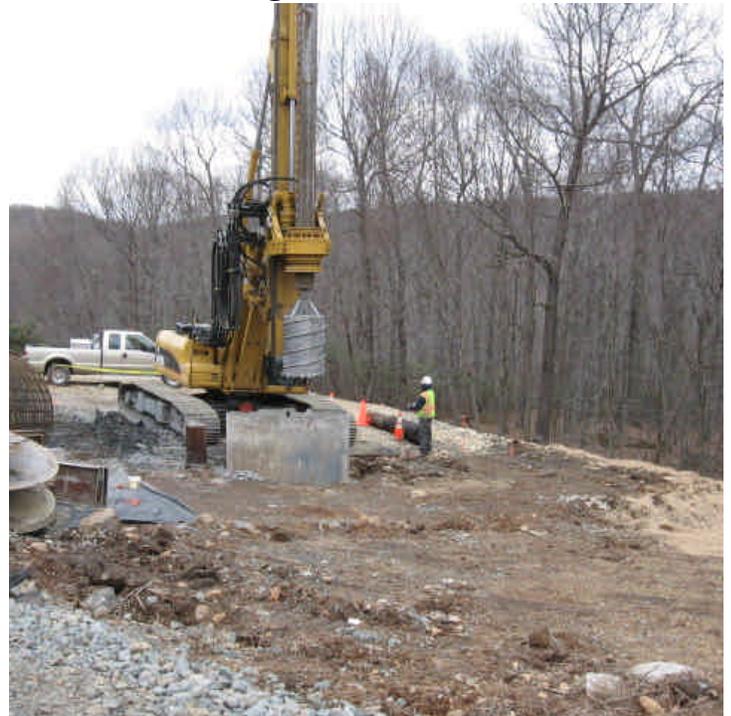
Cow Path Lane (Woodbridge): Foundation drilling/pouring has begun within the ROW here. Controls are in good shape.

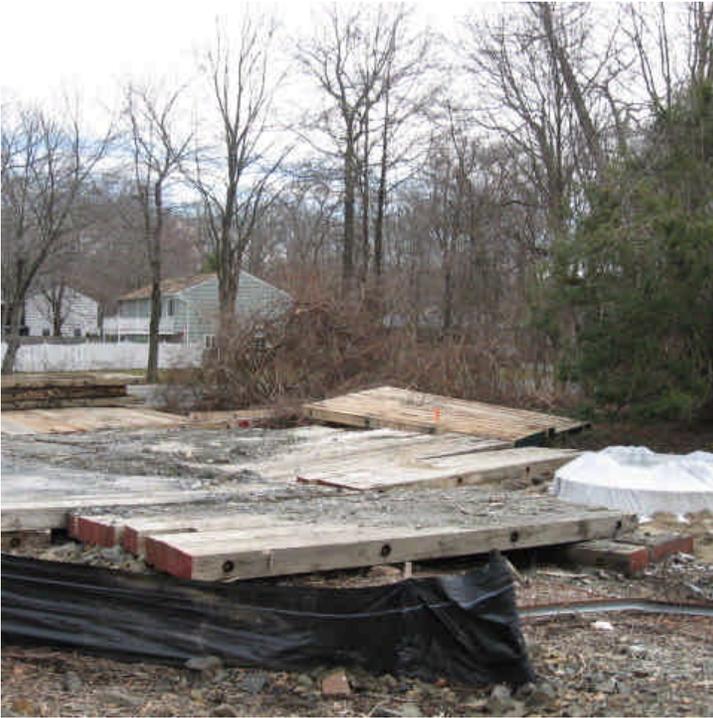
Pine Tree Drive (Orange): Some additional clearing was needed pad installation off Pine Tree (west). Mats were delivered for installation.

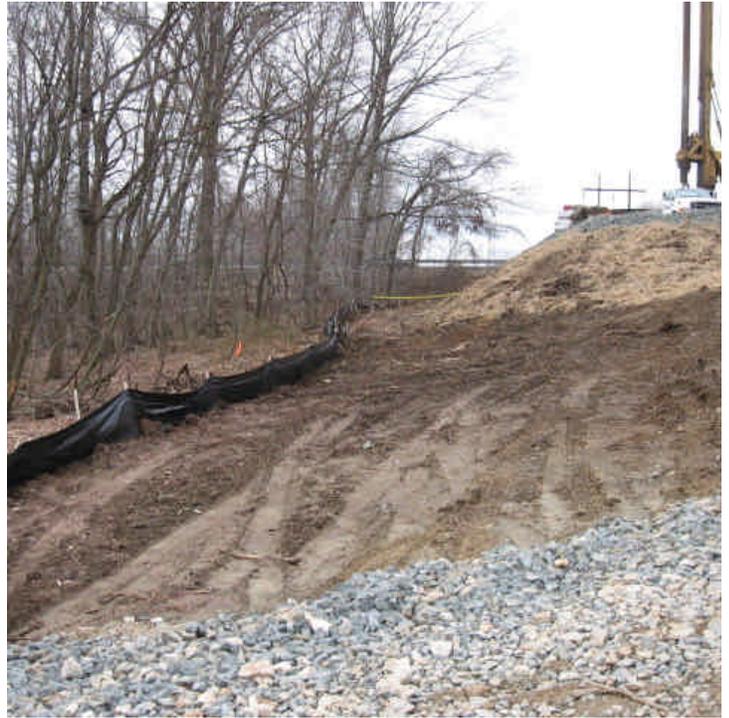
East Rutland Rd (Milford): Drilling was in progress at the time of inspection. Silt fence was installed downgradient of the work area.

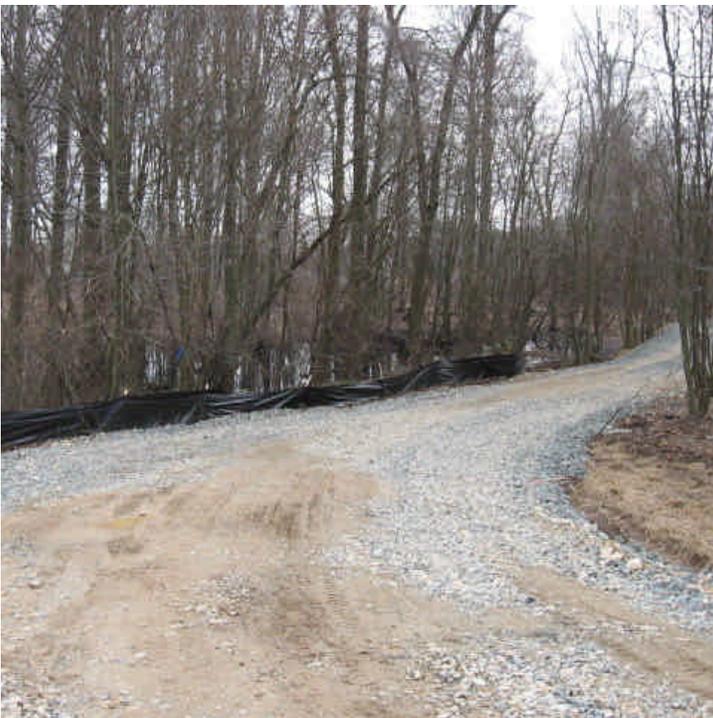
East Rutland Rd: Silt fence was installed along the stone access road adjacent to the wetland.

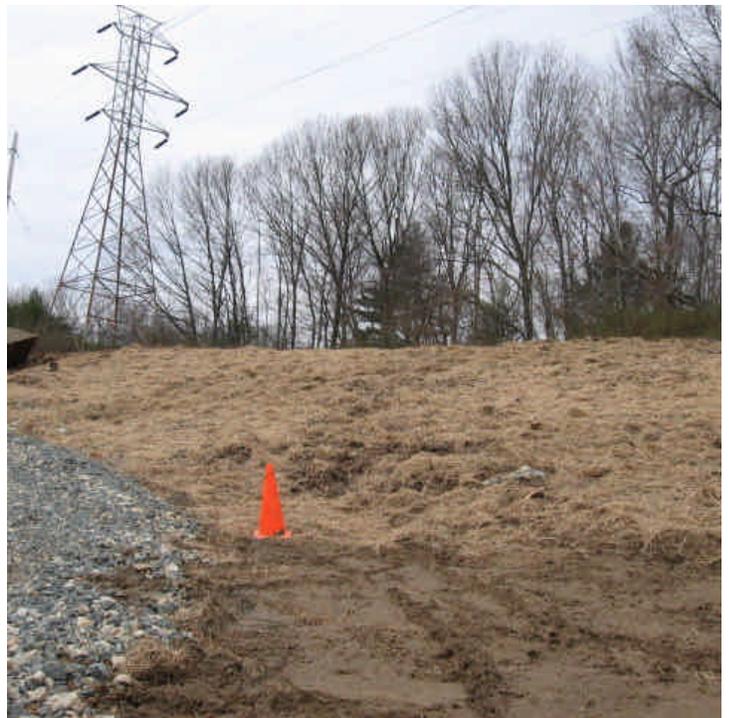
East Rutland Rd: Mulch is in place along disturbed slopes.
