**Docket No. 272 – Development and Management Plan Inspection**

**Segment 2a Inspection**

**Date:** December 27, 2006

**Location:** Segment 2a – Beseck Switching Station to Cheshire/Hamden Town Line

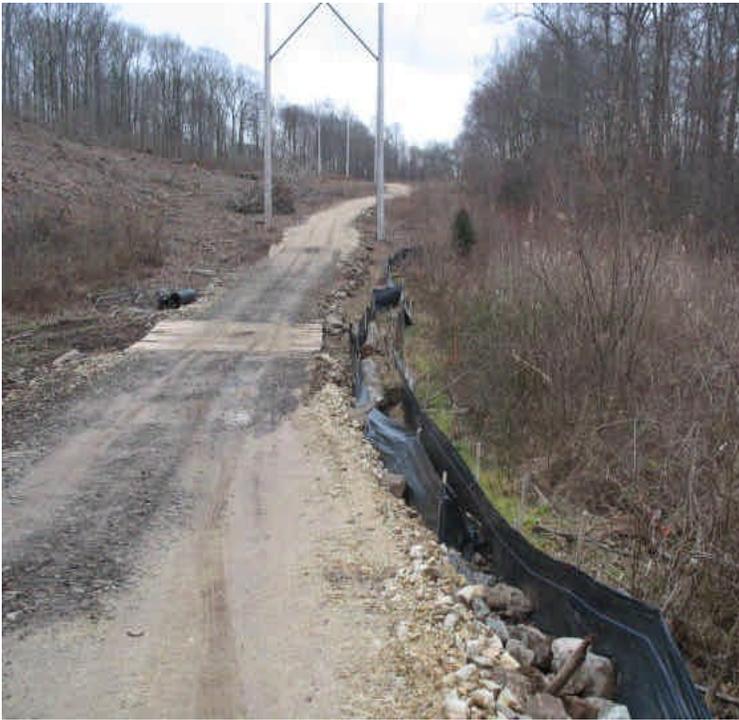
**View of access road, mats, and erosion controls off High Hill Rd. at a non-federally jurisdictional wetland crossing**

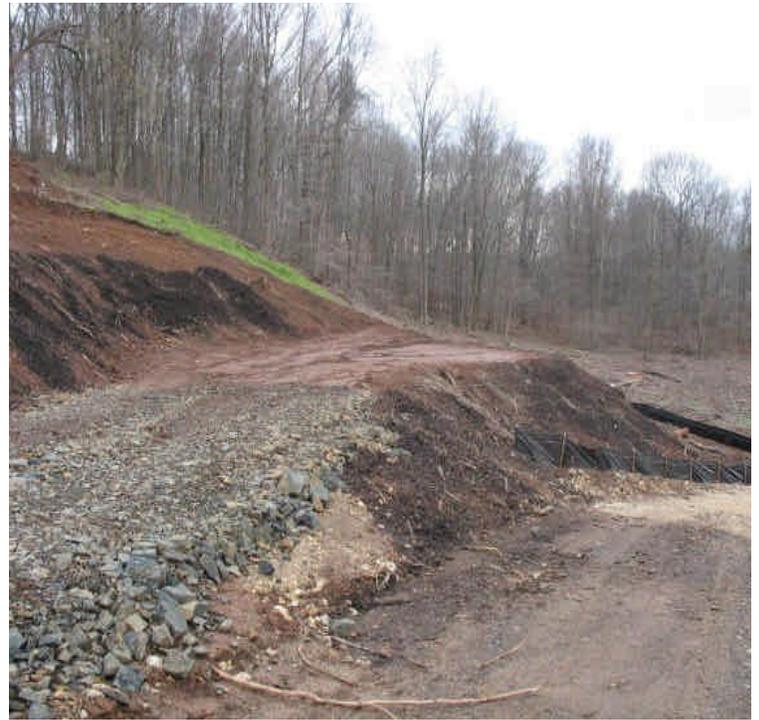
**New staging areas prepared for pole construction. Temporary stabilization measures (mulch) are in place.**

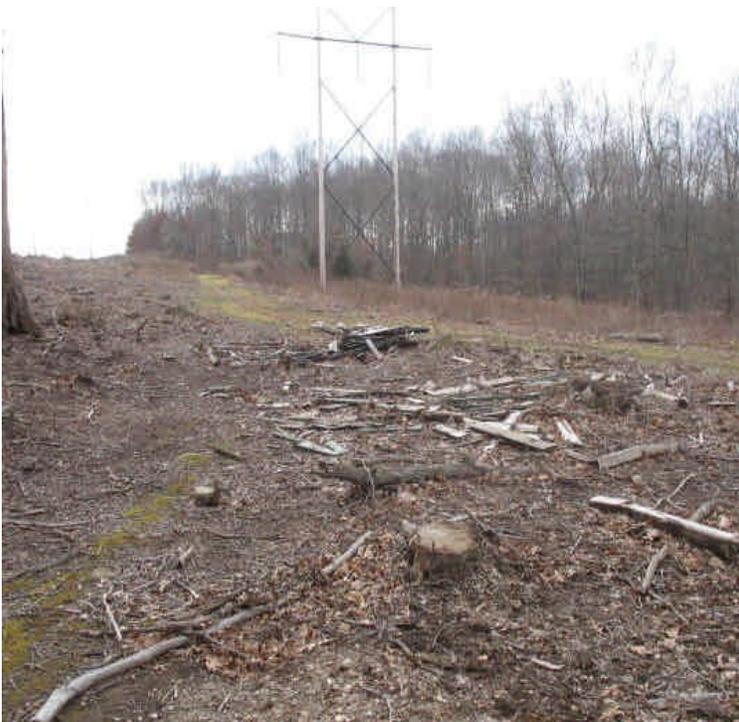
<b>Some non-project jurisdictional debris dumping was noted at a few access points, including off Stony Brook Rd. 11/27-12/27/06</b>	<b>None. Noted for the record. 12/27/06</b>	NA

**ROW off Stony Brook Rd. Non-project related debris had been dumped in this area.**

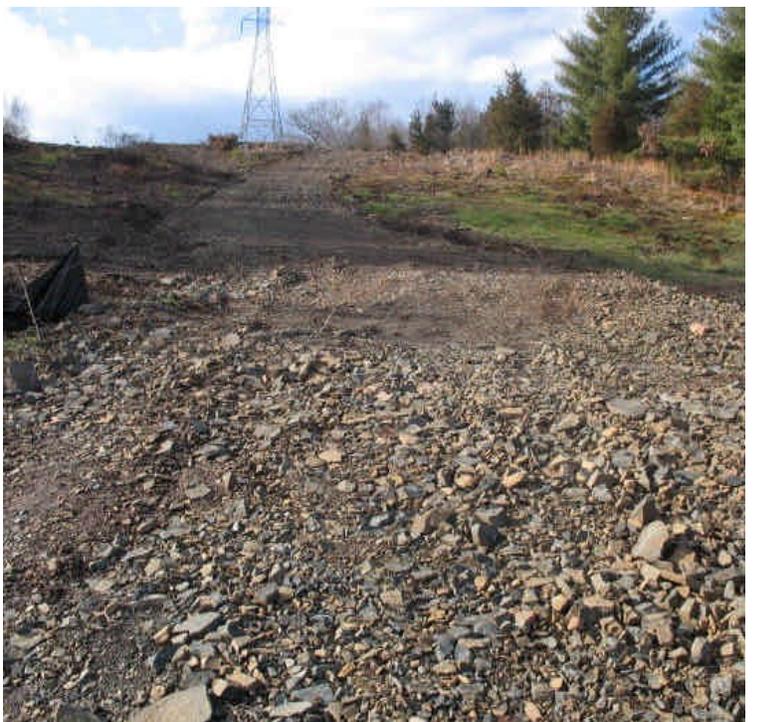
**Eroded gullies/washouts were repaired; the new access road and silt fence were installed off South Turnpike. Continue to monitor this slope for run-off issues.**

<p><b>S. Turnpike + Merritt Parkway Area</b></p>	<p>The slope where gullies/washouts were repaired did not have any new erosion. Silt fence remains in place above the riprap slope and culvert. 12/27/06</p>	<p>Monitor access road slope for future washout or erosion issues, add controls/diversions if needed. 12/27/06</p>	<p>NA</p>
<p><b>Mansion Rd.</b></p>	<p>An existing riprap slope and culvert are present near the entrance from the road. 12/27/06</p> <p>Haybales installed at downgradient edge of the ROW entrance look secure, however sediment from run-off has accumulated at the</p>	<p>Continue to monitor and place controls in this area if traffic increases and adjacent soil becomes disturbed. 12/27/06</p> <p>Continue to monitor area and remove sediment. 11/27-12/27/06</p>	<p>NA</p> <p>Needs attention when feasible.</p>

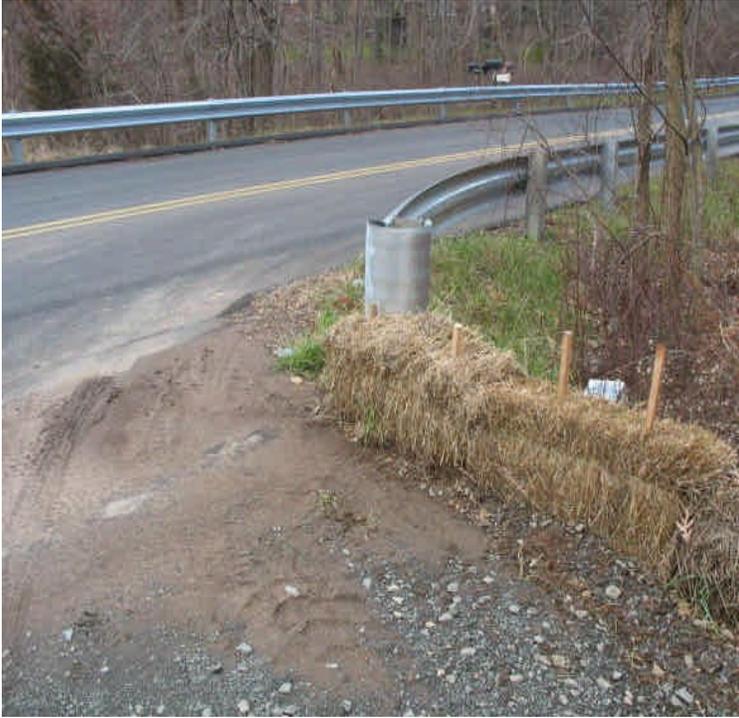
<b>No sediment tracking noted on Mansion Rd. Some sediment build-up</b>	<b>Continue to monitor and sweep entrance as needed. Sediment should</b>	<b>Needs attention when feasible.</b>

**Sediment accumulation should be removed from the haybales at the ROW entrance off Mansion Rd.**

Areas of Inspection	Observation	Recommended Action	Corrected Action
<p><b>Access roads and adjacent roadways (continued)</b></p> <p><b>Mansion Rd</b></p> <p><b>Old Farm Road</b></p>	<p><b>was noted at the entrance to Mansion Rd. This sediment is accumulating at and around the haybales and is migrating towards the roadway. 11/27-12/27/06</b></p> <p><b>Old Farm Rd. and driveways on the ROW continue to be swept as needed. Plywood is being used to reduce impact to the driveways from equipment crossing. Two driveways have some minor marks from equipment 12/27/06</b></p> <p><b>Access road construction is now complete. Some minor run-off continues to be noted from the filled portion of the small, NFJ wetland. 12/18-12/27/06</b></p>	<p><b>be removed before it reaches the roadway 11/27-12/27/06</b></p> <p><b>Continue to monitor for sediment on roadway and driveways; continue to use rubber mats or plywood to protect driveways. 12/27/06</b></p> <p><b>Monitor wetland run-off and controls as needed. 12/18-12/27/06</b></p>	 <p><b>Roadway was swept. Plywood is used to protect driveways from equipment damage (proactively).</b></p> <p><b>NA at this time.</b></p>

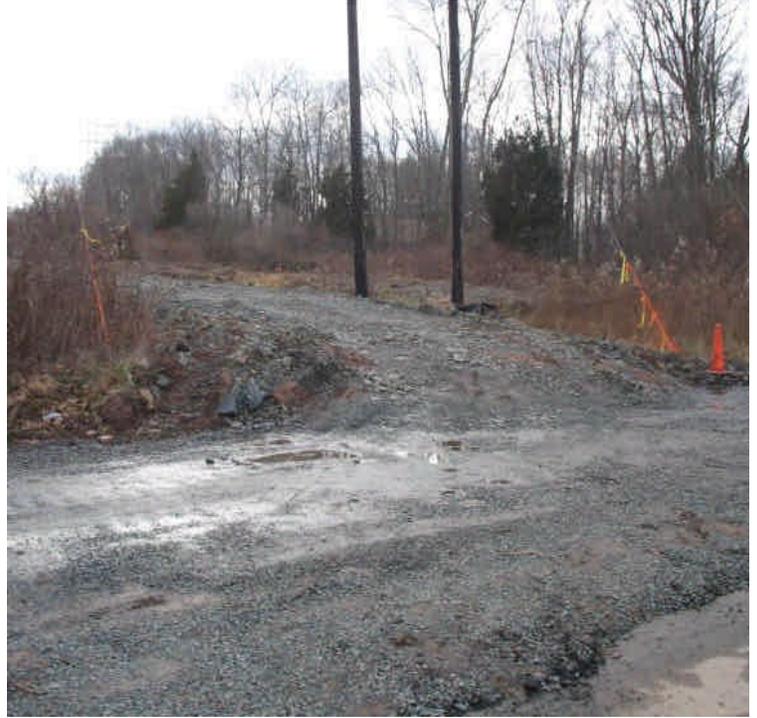
**Continue to monitor run-off seeping from non-federally jurisdictional wetland crossing off Old Farm Rd.**

Areas of Inspection	Observation	Recommended Action	Corrected Action
<p><b>Old Farm Rd.</b></p>	<p>haybales and some is migrating around them. 11/27-12/27/06</p> <p>Some displaced run-off from the small NFJ wetland finger continues flowing along the driveway toward Old Farm Rd. Sedimentation is not an issue at this time. 12/18-12/27/06</p> <p>Silt fence is in place above the NFJ wetland on both sides of the access drive. A small section of silt fence on east side of drive has fallen down. 12/27/06</p>	<p>Monitor potential run-off areas and add controls or diversions as needed. 12/18-12/27/06</p> <p>Monitor controls and repair the fallen section of silt fence. 12/27/06</p>	<p>NA.</p> <p>Needs attention when feasible.</p>
<p><b>Inland Wetland and Watercourse encroachment and mitigation</b></p>	<p>Jurisdictional wetlands will not be accessed until the ACOE permit is in hand. 8/24-12/27/06</p> <p>Small NFJ wetlands are being accessed for crossing. 12/27/06</p>	<p>Continue to monitor wetlands and erosion controls. 12/27/06</p> <p>Mats are in place where appropriate. 12/11-12/27/06</p>	<p>NA</p> <p>NA</p>

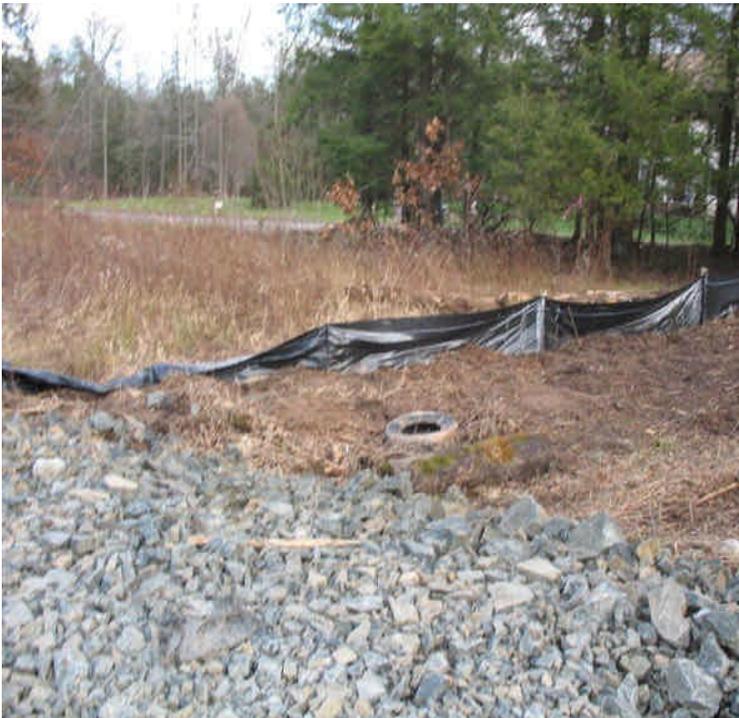
**A small section of silt fence, located upgradient from the non-federally jurisdictional wetland finger off Old Farm Rd., needs maintenance when feasible.**

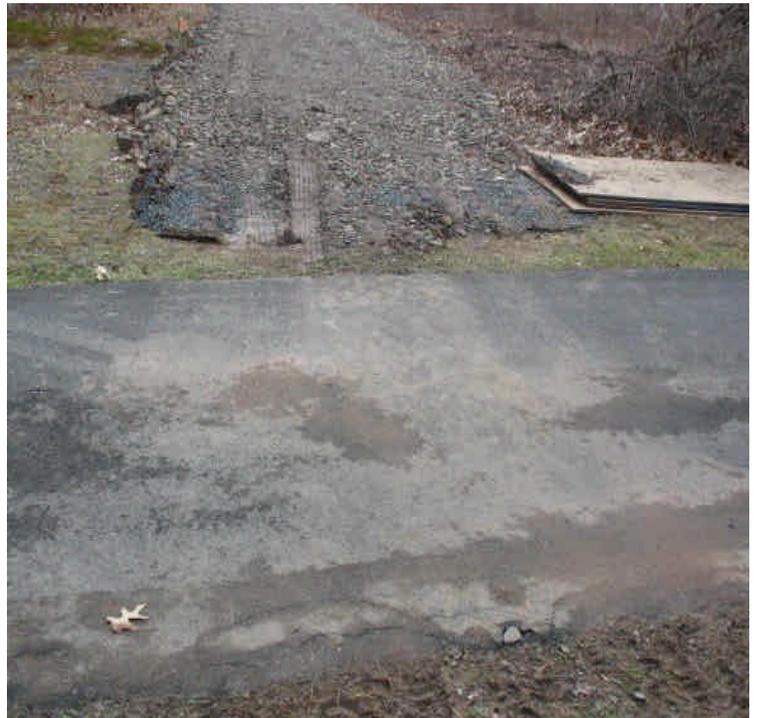
**Plywood was used to protect driveways from equipment crossing on the ROW off Old Farm Rd. The minor sediment tracking noted last week was no longer present.**
