ENVIRONMENTAL INSPECTION REPORT

MIDDLETOWN – NORWALK 345-KV PROJECT: UI Portion – Town of Stratford, City of Bridgeport

The United Illuminating Company

Connecticut Siting Council Docket No. 272

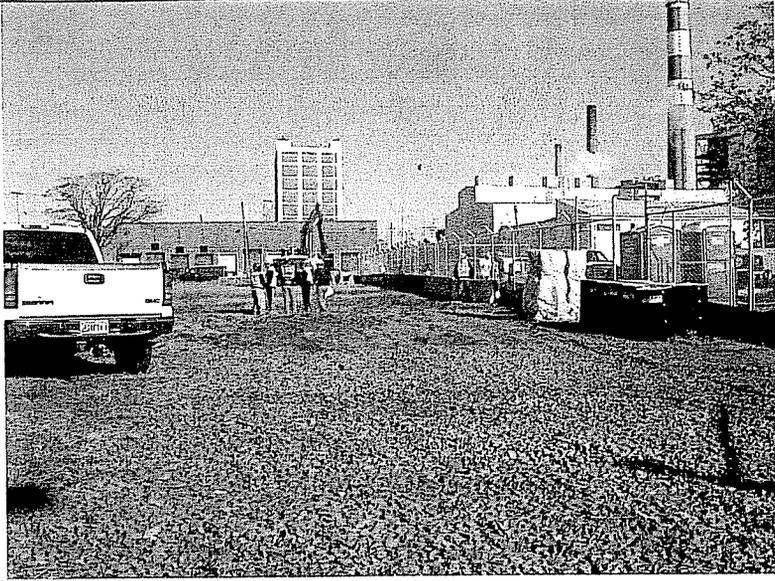
Photo 10-13-1: Singer Substation, view to north, anti-tracking pad, jersey barriers, and drums in preparation for commencement of site work.

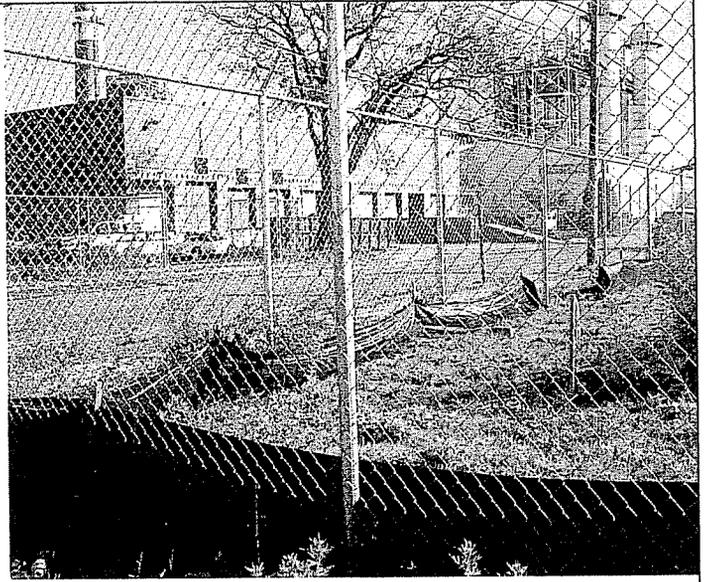
CONSTRUCTION ACTIVITY / LOCATION	FIELD OBSERVATIONS (PHOTO REF. NO.)	RECOMMENDATIONS	CORRECTIVE ACTIONS
Singer Substation – October 13	Contractor mobilizing equipment to the site and preparing temporary soil stockpile areas. No earth-moving activities performed. Gravel anti-tracking pads installed at site entrances off Henry and Atlantic streets. Contractor and UI trailers / parking areas established. (Photo 10-13-1	N/A	N/A
	Silt fence was installed around entire substation site, inside the existing chain link fence. This fence was installed prior to contractor mobilization, in conjunction with the erection of the chain link fence. In some areas, silt fence had fallen down or had holes. (Photos 10-13-2 through4)	Replace or supplement silt fence as needed to maintain an effective erosion / sedimentation barrier	Informed UI (R. Pinto, C. Maresca) of need to replace silt fence. UI advised that the fence would be repaired or replaced as soon as possible.

Photo 10-13-2: Singer Substation, view of silt fence in need of repair, northwest corner of site

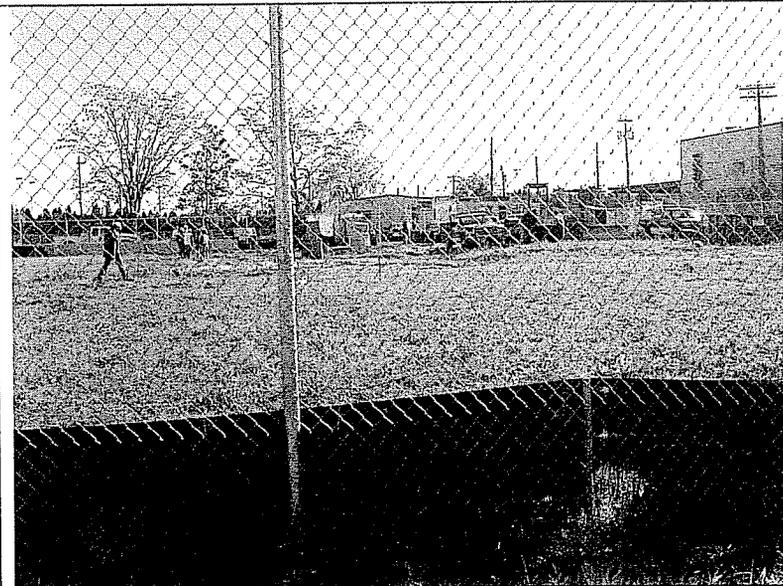
Photo 10-13-3: Singer Substation, view to east from Main Street. Silt fence in need of repair.

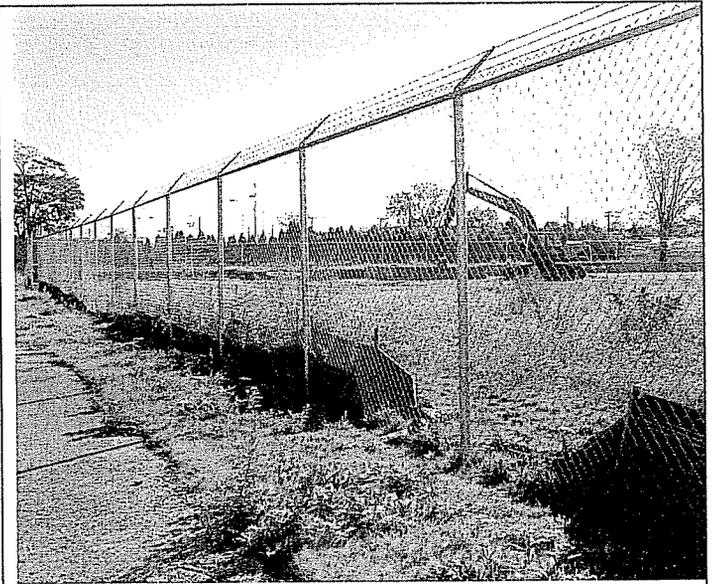
Photo 10-13-4: Singer Substation, view of site from northwest corner, silt fence in need of repair.

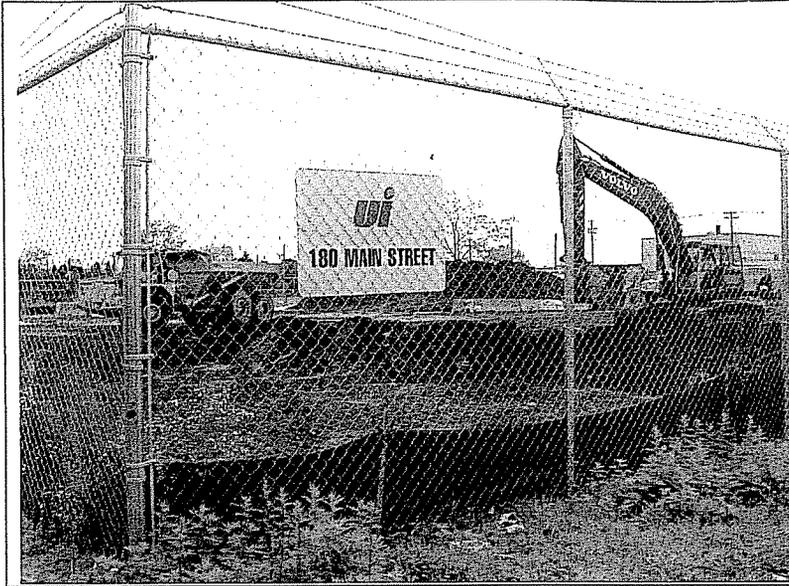
Singer Substation – October 19	Silt fence around site repaired or supplemented with a second row of silt fence in certain areas. No areas of erosion / sedimentation observed, although there was standing water evident on-site from the previous days' rain.	None	N/A
	Site cleared of vegetation during soil stripping.	None	N/A
	Excavation at substation building area ongoing. Urban rubble in excavated soil will be disposed of off site.	None	N/A
	Temporary Soil Stockpile Areas (SSAs) contained within Jersey barriers; includes top soil layers stripped from site, as well as soil from substation footprint excavation. Soil placed on plastic. Temporary soil stockpile areas not involved in ongoing excavation protected with plastic sheeting.	None	N/A
	10 55-gallon drums filled with soil excavated from small area of site where lead contamination was detected during sampling. Drums placed within Jersey barrier containment area until manifested/transported off site for ultimate disposal.

Photo 10-19-1: Singer Substation, building excavation. Silt fence on northwest corner of site repaired.

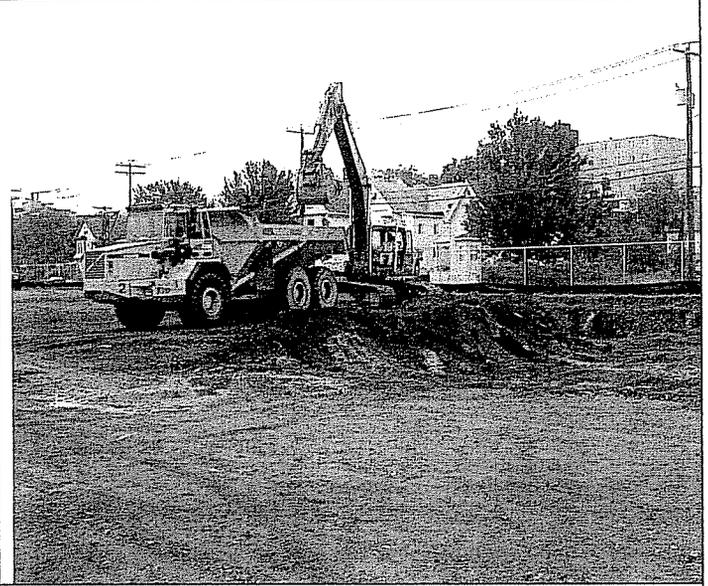
Photo 10-19-2: Singer Substation, excavation for substation building.

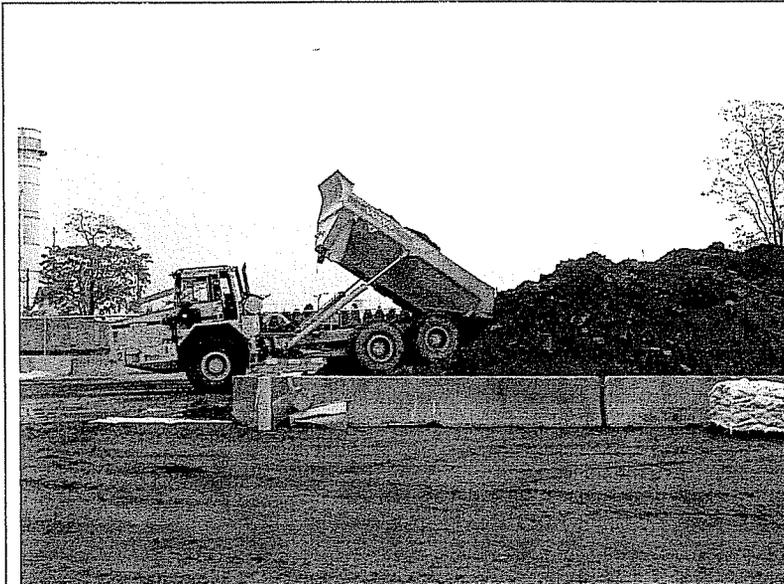
Photo 10-19-3: Singer Substation, excavated soil placed in temporary on-site Spoil Storage Area.

Removal of stockpiled soil. The week of October 23, spoil temporarily stockpiled on-site and unsuitable for use in the substation construction will be transported off-site for ultimate disposal. Current plans call for transport to Phoenix in Waterbury, CT. Soil disposal will proceed at a rate of an estimated 300 tons of soil per day (about 20 truck loads), all next week.

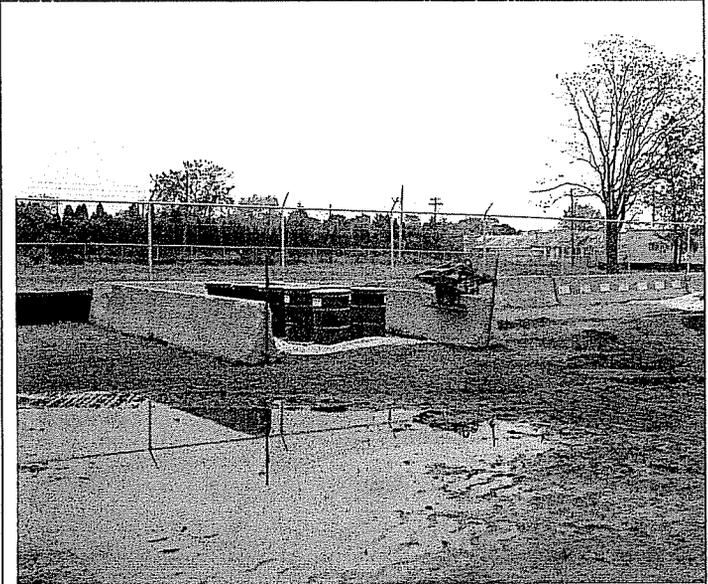
Photo 10-19-4: Singer Substation, containment area for temporary storage of excavated soils (10 55-gallon drums) containing lead.

The 10 55-gallon drums of soils contaminated with lead (and considered hazardous) will be manifested and transported off-site for appropriate disposal upon completion of analytical testing to confirm the soil contaminant levels.
