Docket No. 272 – Development and Management Plan Inspection

Segment 4b Underground Line

Date: February 1, 2007

Location: Fairfield/Westport Town Line to Westport Avenue in Norwalk

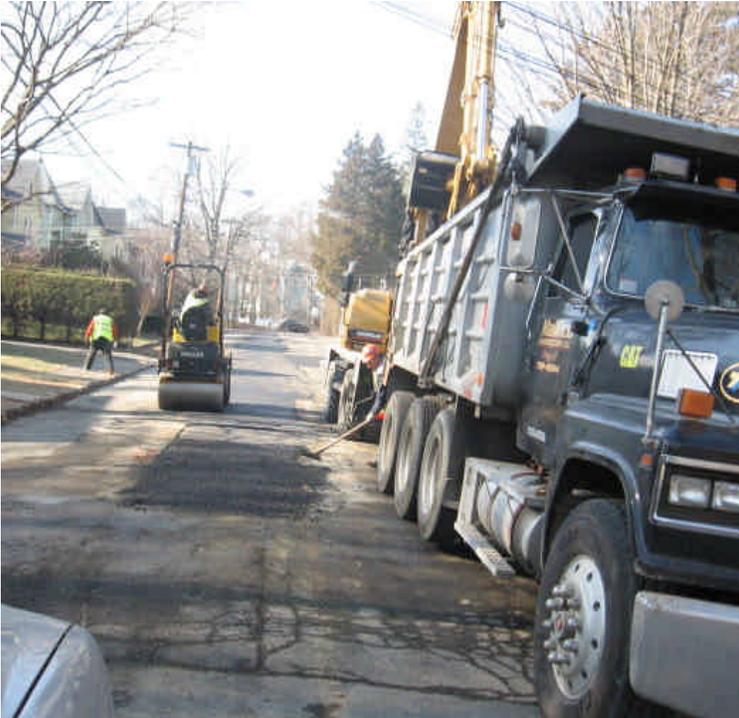
Photograph of completed trench along Lincoln St. being covered/patched with asphalt.

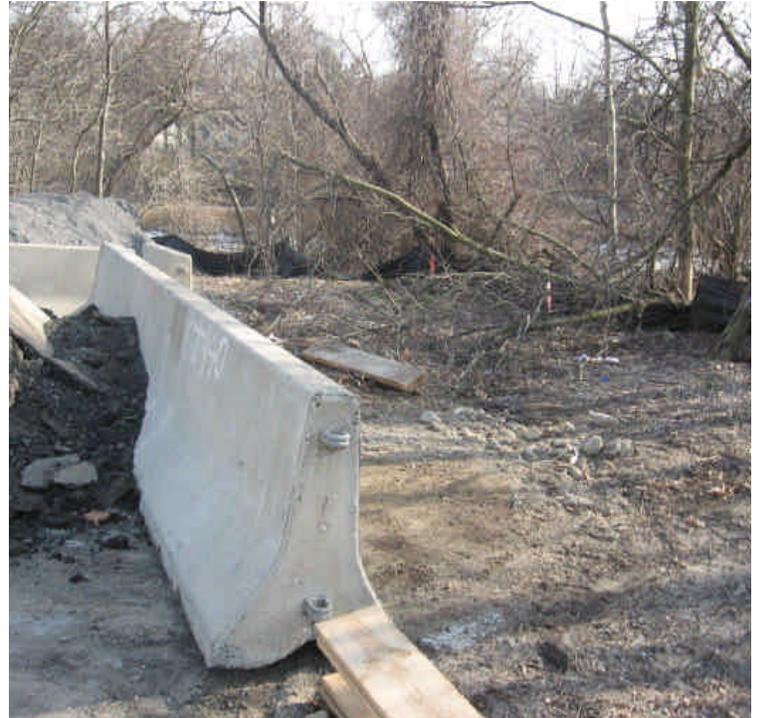
Silt fence along the Imperial Ave. laydown yard has been compromised by falling branches (natural causes) in a few locations. Perimeter controls should be re-established.

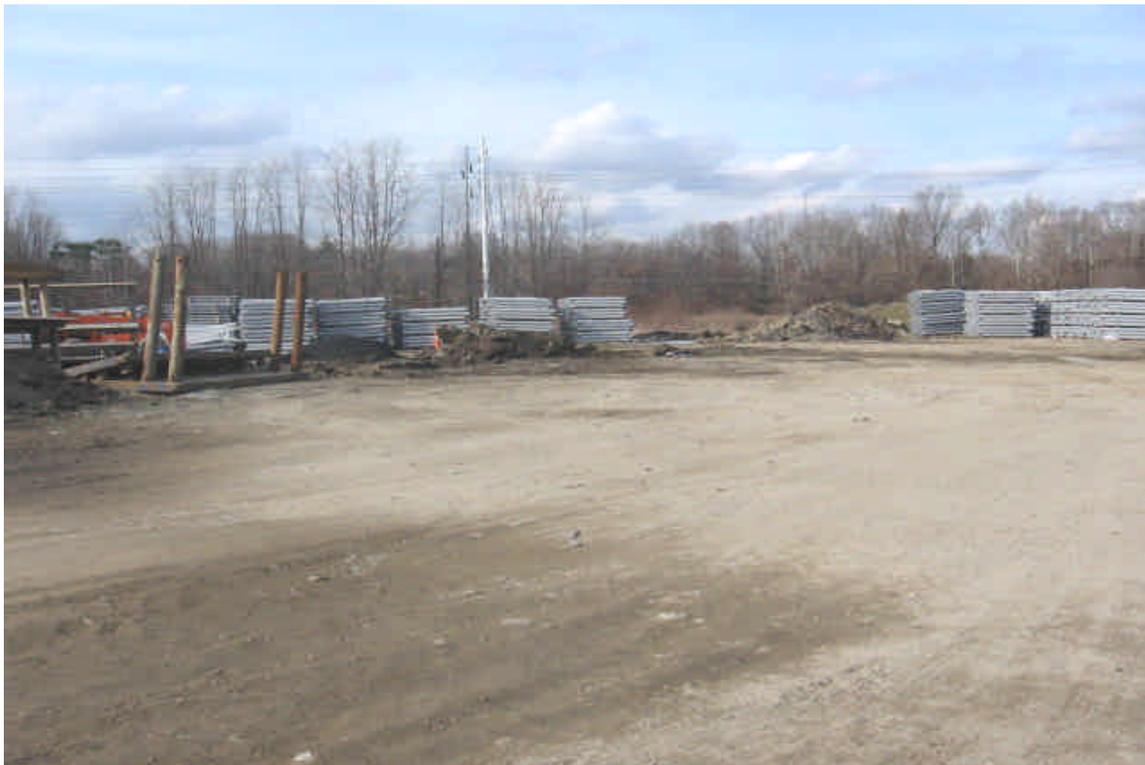
Kings Highway Lay-down Yard (Off Kings Highway) – (Currently being used for Segment 4a and 4b operations.)	The majority of the concrete wash-out basin materials has been removed from the site. One small pile of sediment remains. 2/1/07	Continue removing any materials that are no longer necessary in this area. Contractor states that washout containment will not be	Efforts were noted to remove the basin materials.

No issues were noted at the Kings Highway lay-down yard. The remnants of the concrete washout basin include a small soil stockpile which will continue to be removed from the site.
