**Docket No. 272 – Development and Management Plan Inspection**

**Segment 2b Inspection**

**Date:** January 26, 2007

**Location:** Segment 2b – Cheshire/Hamden Town Line to East Devon Substation

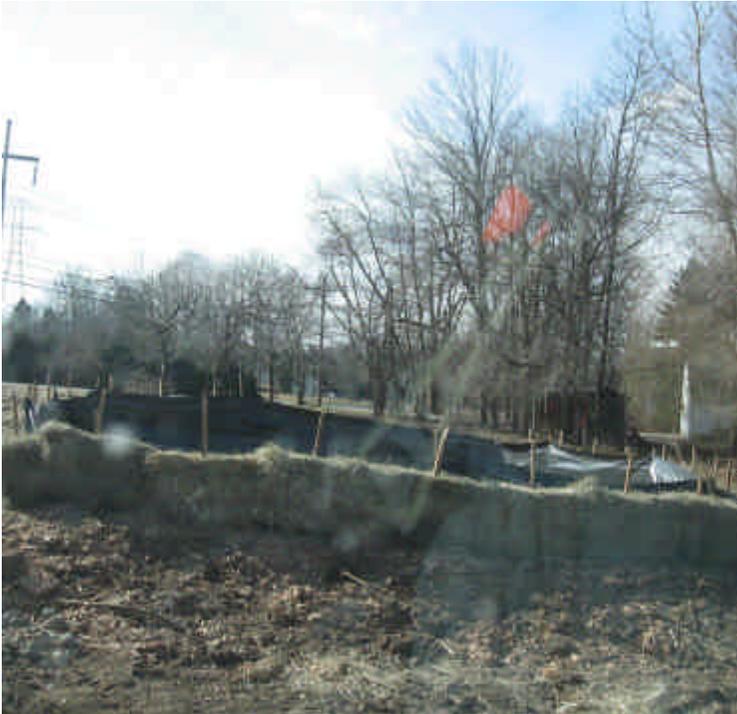
**Dewatering basin constructed off Russell Ave. Water from other nearby work areas are being trucked to this location for containment/filtration. Filter socks are located downgradient.**

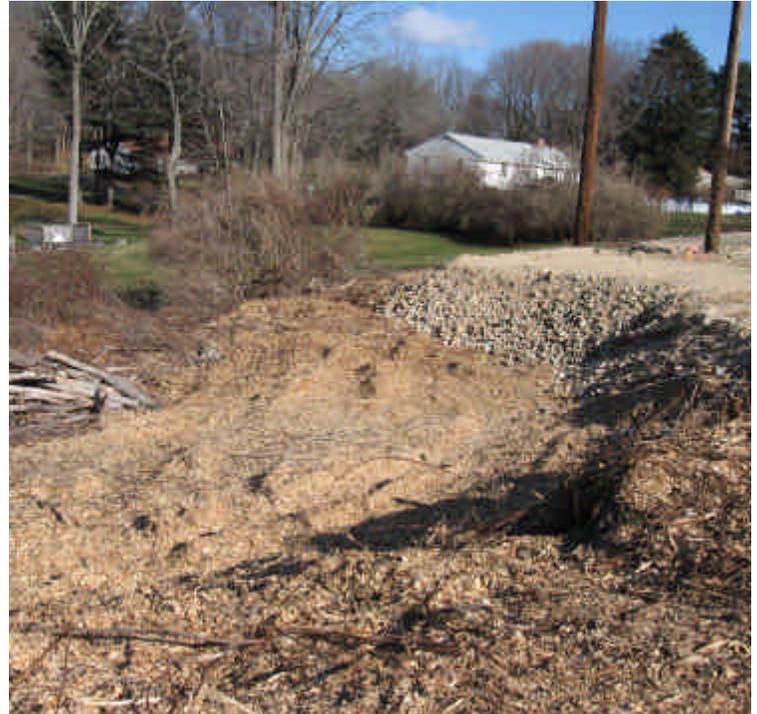
**The pile of wood chips remains in a “depression” along the ROW off Hunting Hill Place. File should be removed or spread appropriately when feasible.**

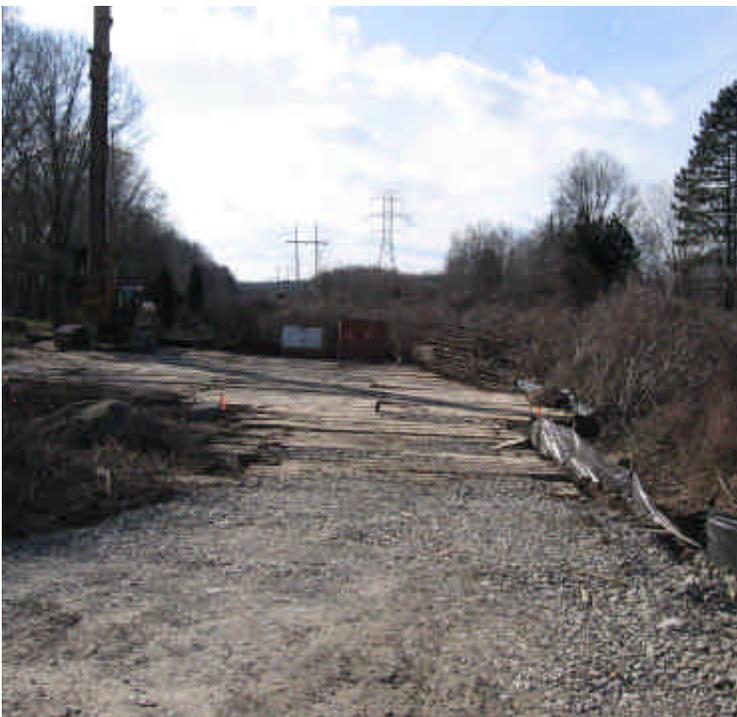
**A new crane pad was installed off Racebrook Rd. in an approved wetland location. Silt fence was installed along the pad.**

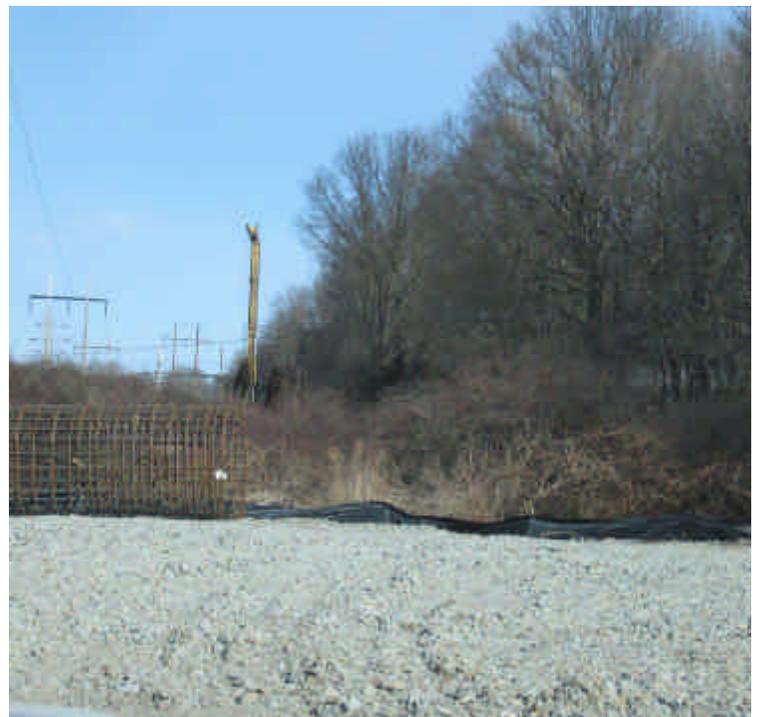
**View of a stone pad installed off Edward Court. Silt fence is also in place but drilling has not begun yet.**

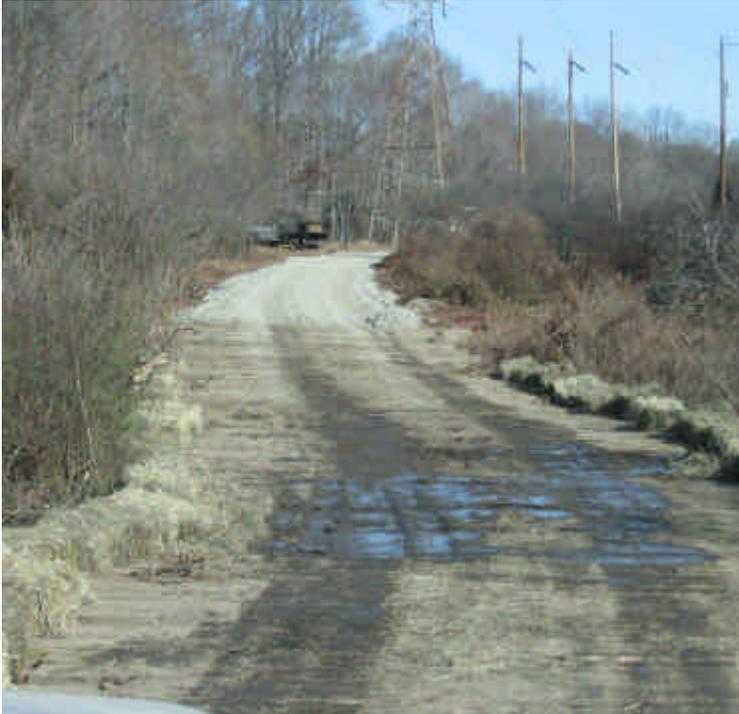
**View of access road construction in a wetland area off Pine Tree Dr. (east). Timber mats and haybales were in place along the crossing.**

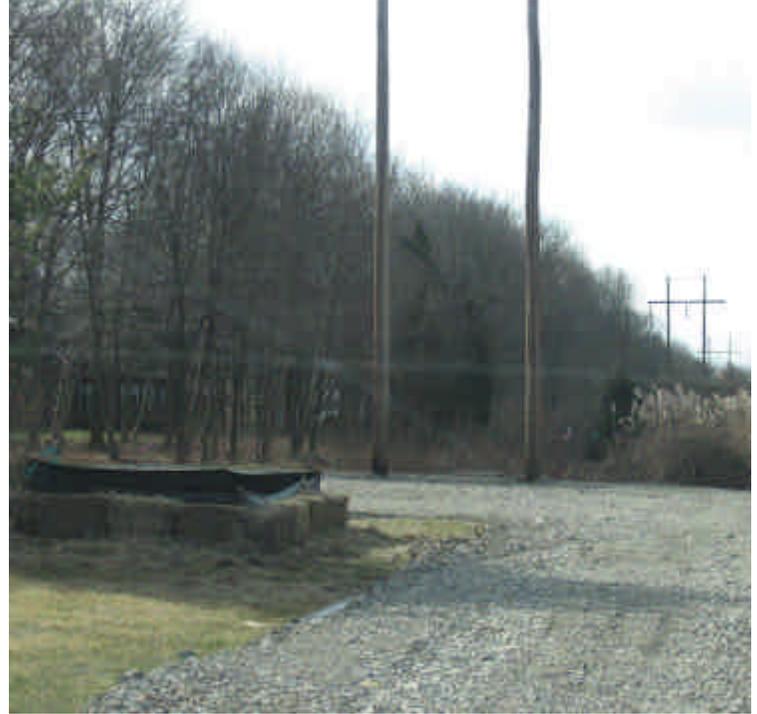
**View of a stone pad constructed off Pine Tree Dr. (west) adjacent to a wetland area. A dewatering basin has also been set up proactively. Monitor carefully while in use.**

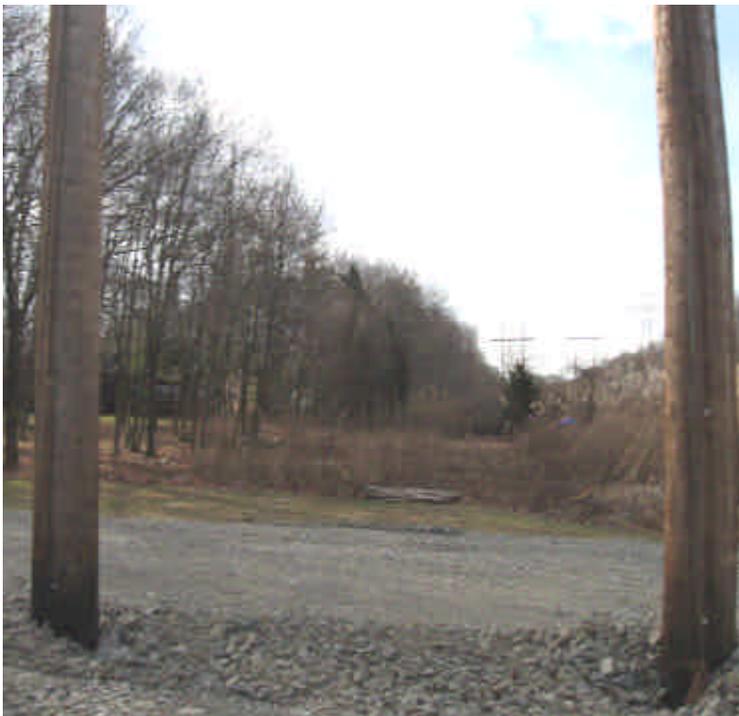
**View of the ROW off Pine Tree Dr (west) where some clearing was needed and done by hand in the wetland area.**

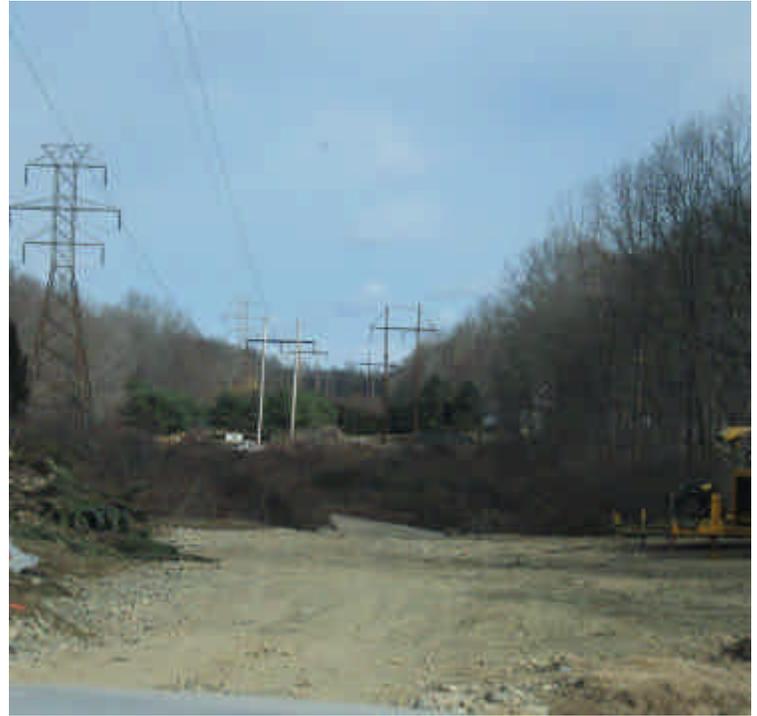
**Overall view of Treat Lane. The access road here will be extended to the wetland area.**

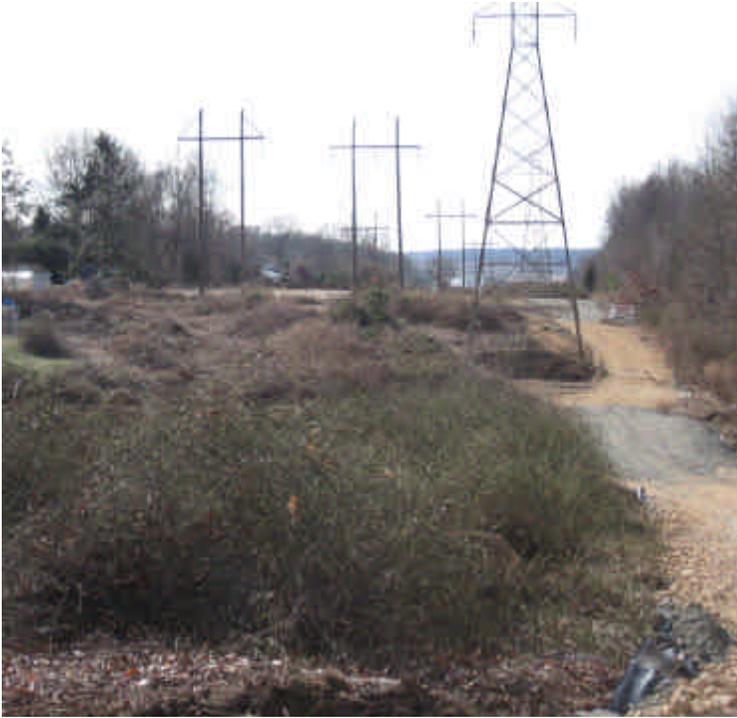
**View of access road and clearing in the ROW section between Plains Rd to Oronoque Rd.**

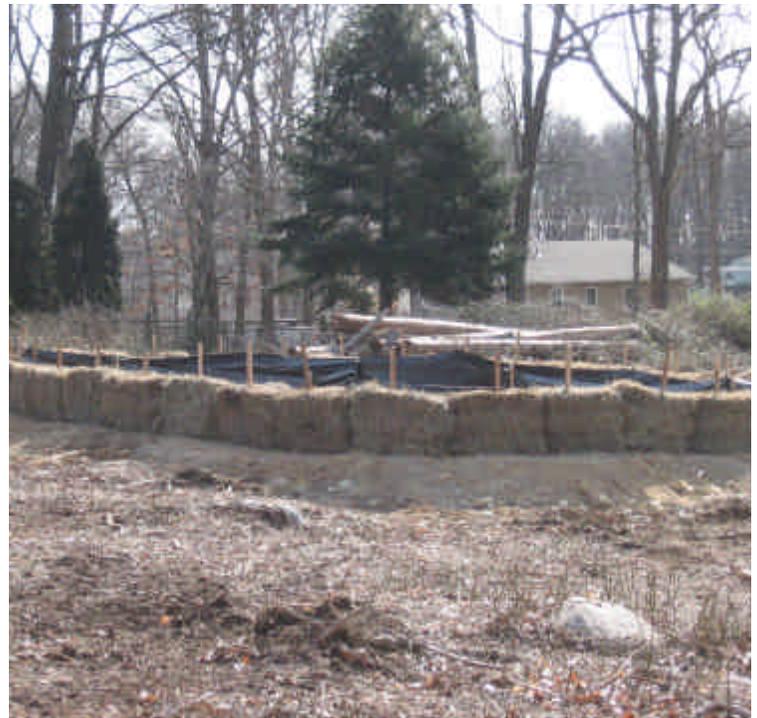
**A dewatering basin was constructed in this section proactively.**

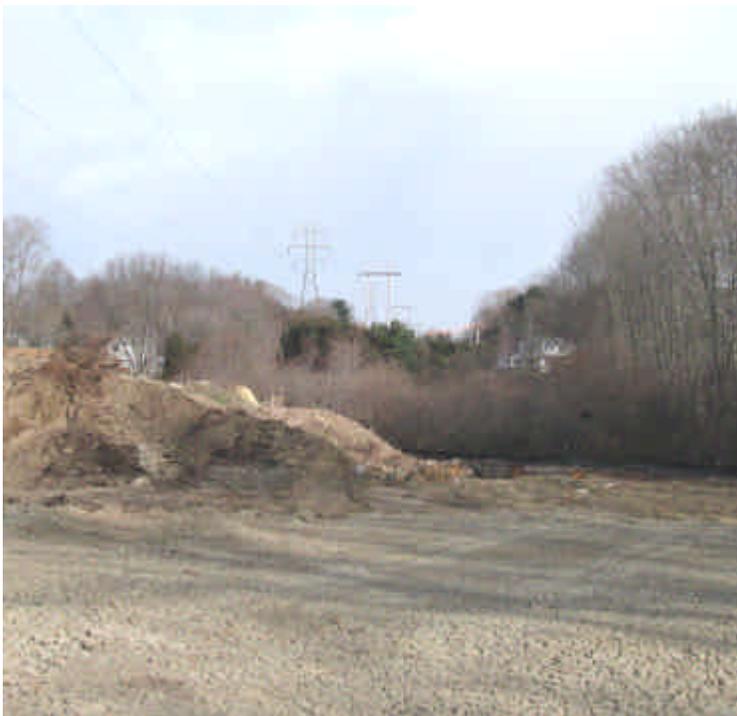
**View of clearing stone pad construction and spoil pile along the ROW off Woodruff Rd. Silt fence was installed downgradient of the stockpile.**

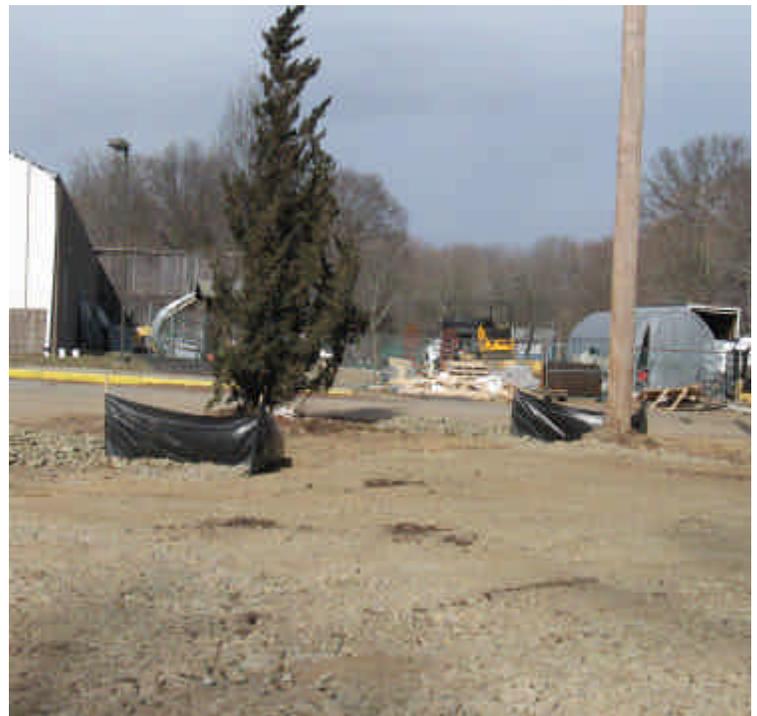
**Another view off Woodruff Rd. Stone and silt fence check dams were in place along the ROW.**

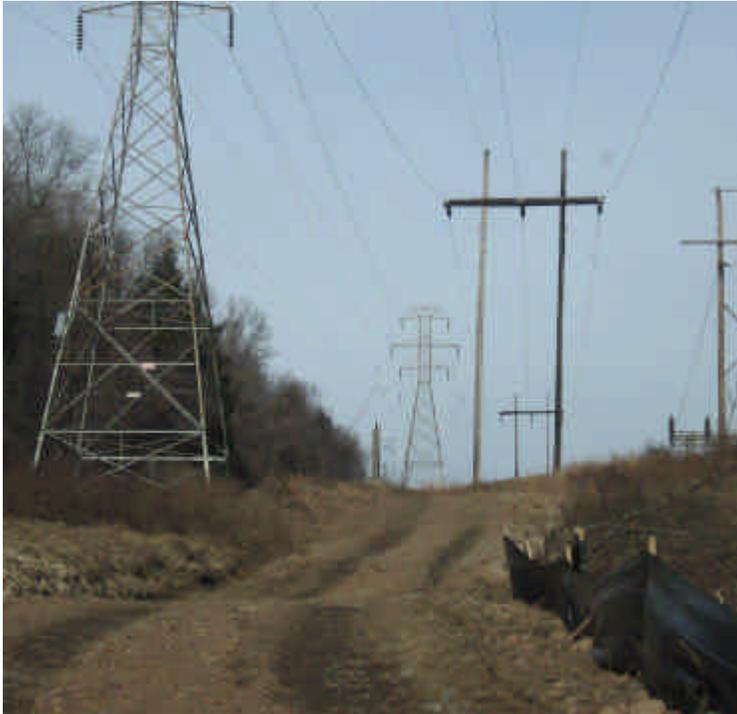
**Clearing and access road construction appear complete in the Glen Dam section of the ROW. Some structures were being removed and silt fence was in place along the access road in appropriate areas.**

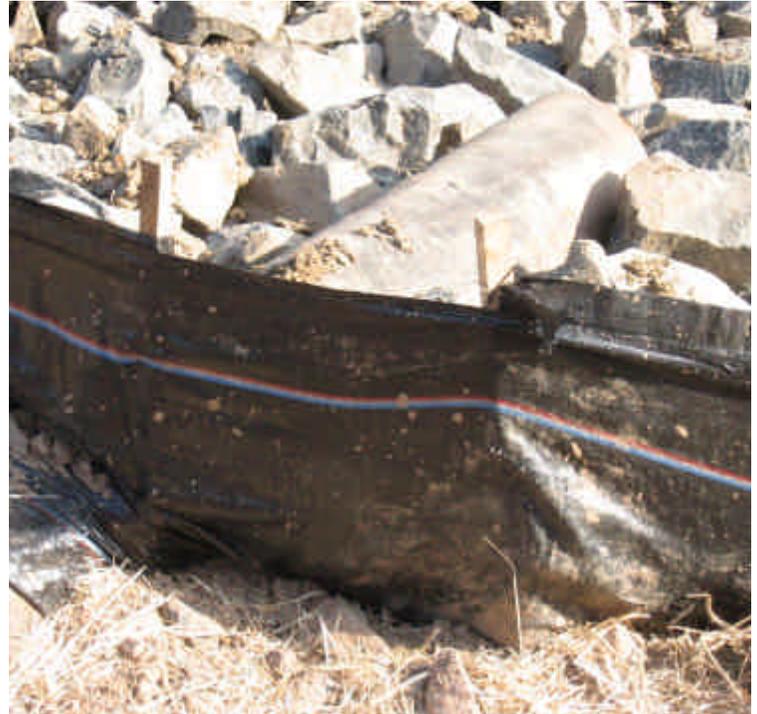
**A culvert and riprap outlet was installed in the access road in the Glen Dam section of ROW.**

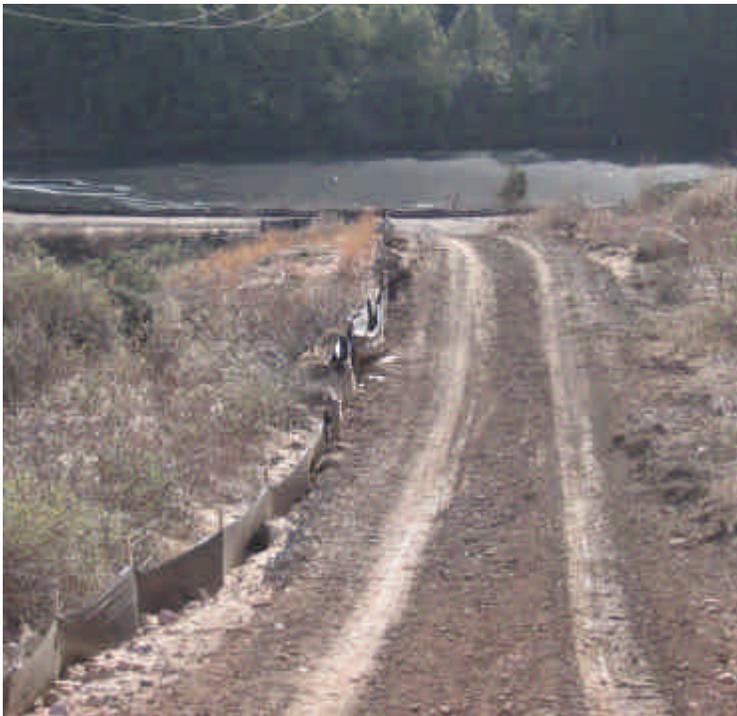
**Looking towards Glen Dam Reservoir from the access road. Silt fence is in place and mulch was spread on some of the disturbed soil areas. Monitor the area carefully during construction.**

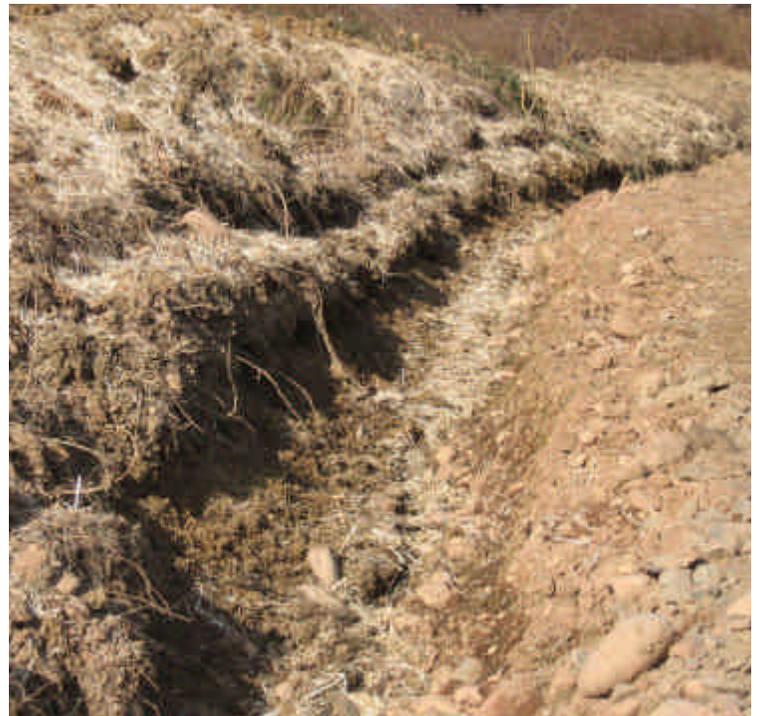
**Mulch was placed on disturbed slopes near the access road. Continue to watch for and mitigate erosion in this area.**
