Docket No. 272 – Development and Management Plan Inspection

Segment 2b Inspection

Date: July 12, 2007

Location: Segment 2b – Cheshire/Hamden Town Line to East Devon Substation

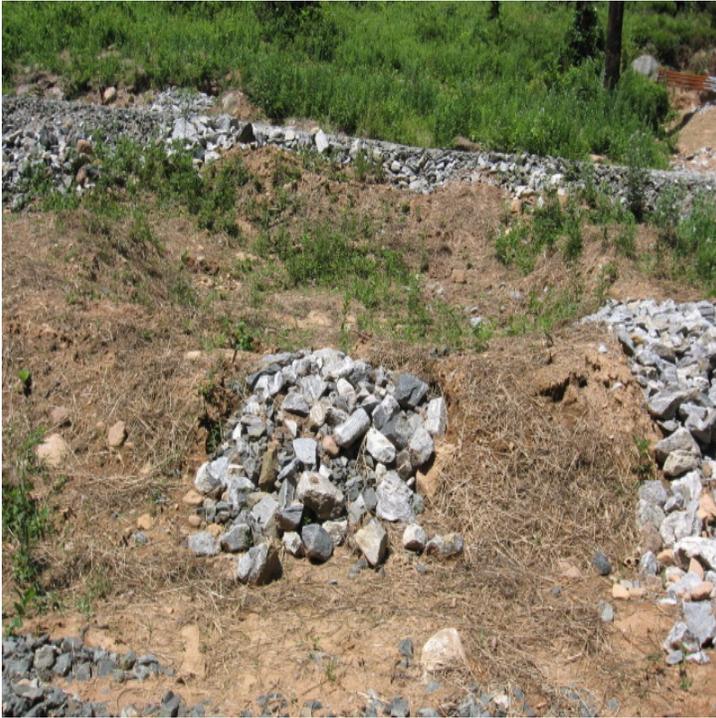
West Todd St (Hamden): The wall of this check dam had been washed-out by heavy rains in previous weeks. It has since been repaired and stabilized with stone.

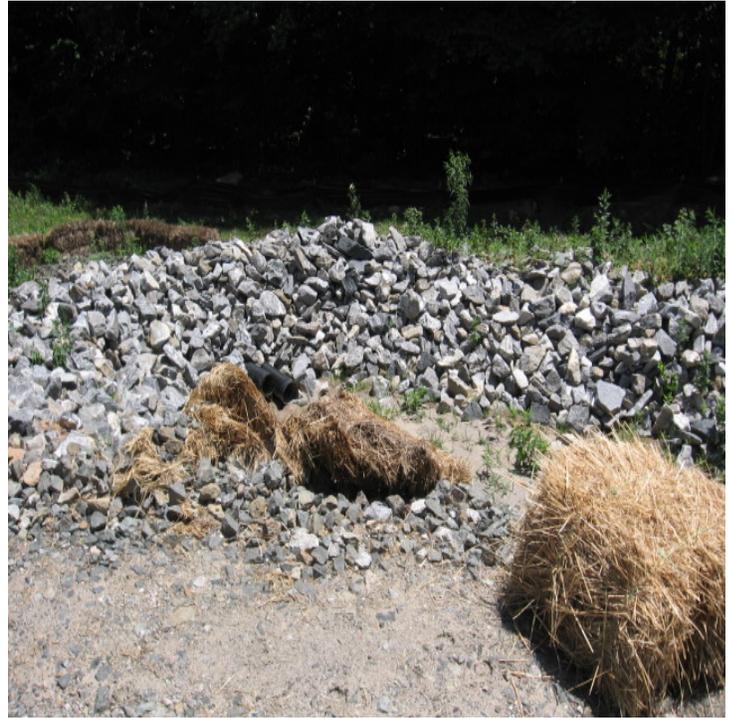
West Todd St: View of a stone sediment trap with minor sediment accumulation.

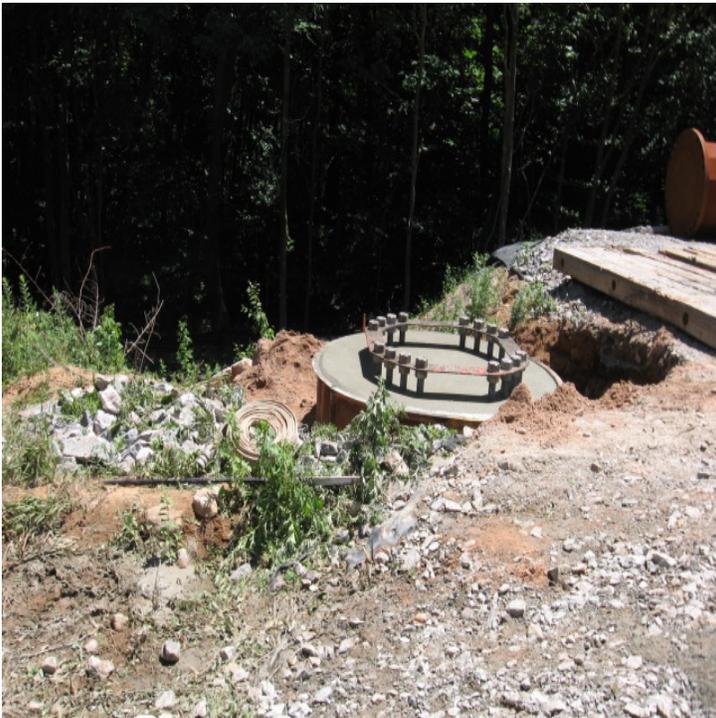
West Todd St: View of a newly installed foundation. Erosion controls remain intact here.

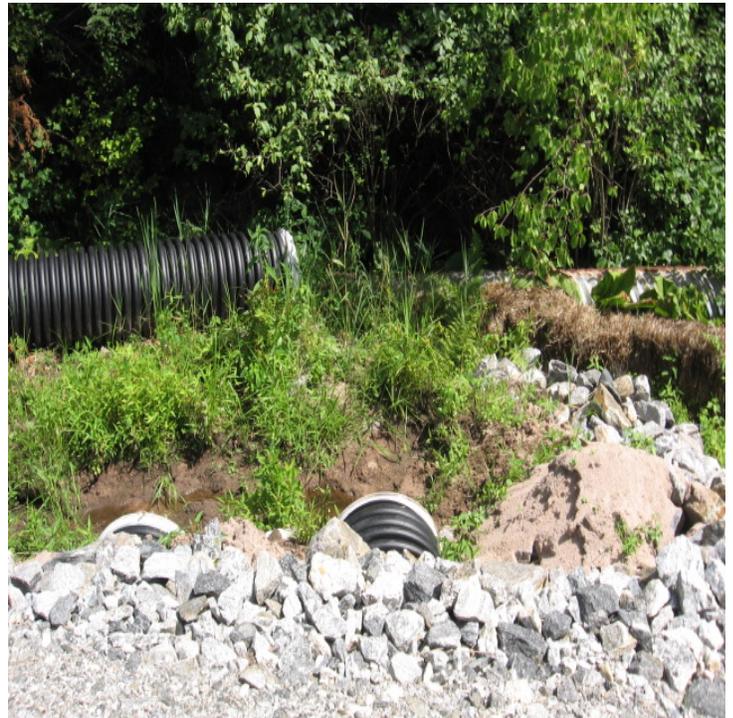
West Todd St (east): A gap remains in the haybales at this culvert outlet. The accumulated sediment within the stone trap is stabilizing with vegetation. Culvert pipe sections should be removed from the wetland area.

Areas of Inspection	Observation	Recommended Action	Corrected Action
Old Lane Road	flow off the ROW (4/27/07). This only occurs during large rain events and wetland resource areas were not affected by this off site flow. 7/12/07	Although good efforts were made to control stormwater flow, continue to improve the on-site containment. 7/12/07	
	A gap remains in the haybale line at the culvert outlet off West Todd (east). Sediment within the stone trap has begun to stabilize with vegetation. Some sediment remains in the adjacent wetland from previous rain events. 7/12/07	Repair and reinforce controls. Carefully remove sediment from wetland if it is greater than 2” in depth. Although sediment within the stone trap has stabilized with vegetation it should be removed when feasible to maintain function and capacity. 7/12/07	Needs attention
	Culvert pipe sections remain in the wetland here. 7/12/07	Culvert pipe sections should be removed from the wetland area as soon as feasible. 7/12/07	Needs attention
