**Docket No. 272 – Development and Management Plan Inspection**

**Segment 1b (Royal Oaks Bypass) Inspection**

**Date:** June 4, 2007

**Location:** Segment 1b (Royal Oaks Bypass)

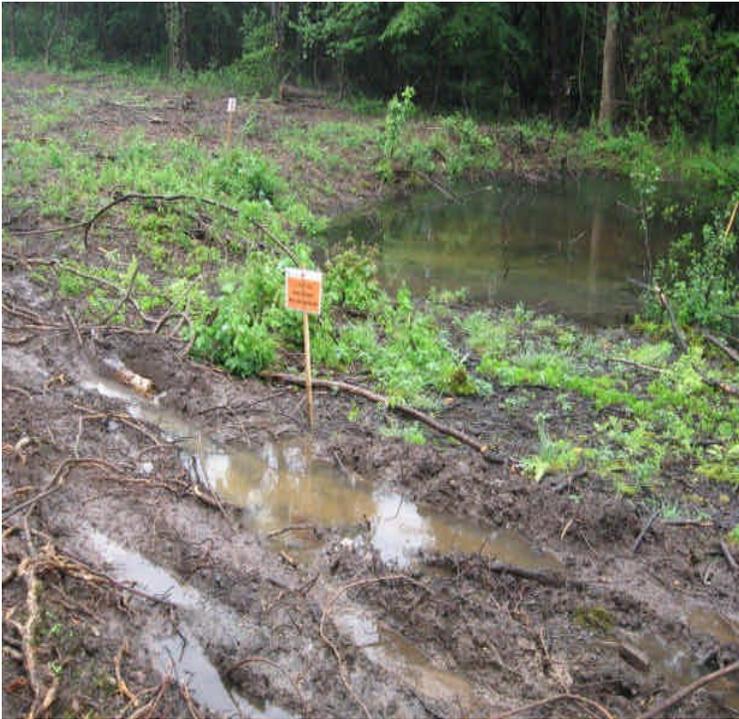
**Turbid water flowing into the pond from the equipment ruts created last week between Rte 17 and Black Walnut Drive. Access in this area had previously been avoided. Controls are needed. Also, confirm that the “entering wetland” sign is actually at the boundary and not within the wetland.**

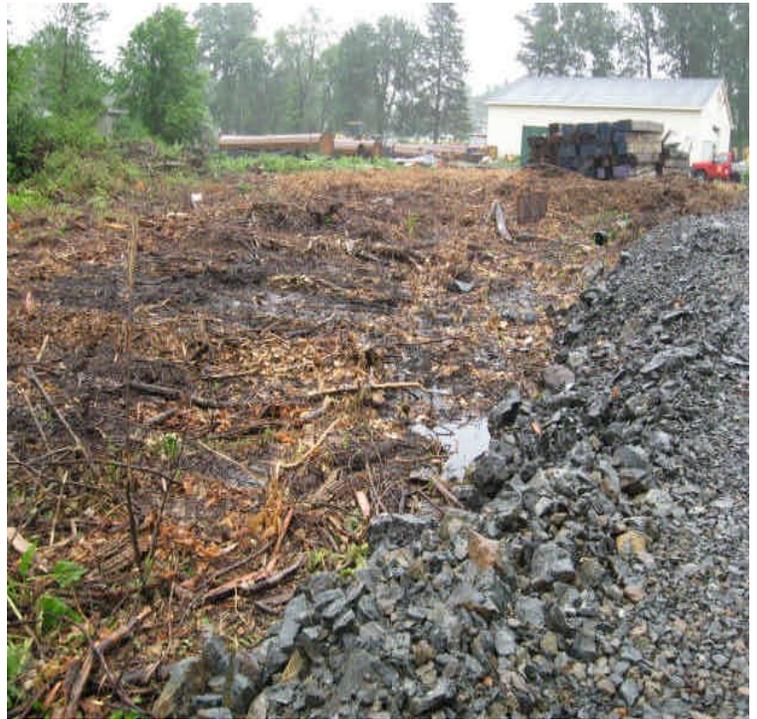
**Site entrance within the receiving yard. Seed disturbed areas as soon as possible.**

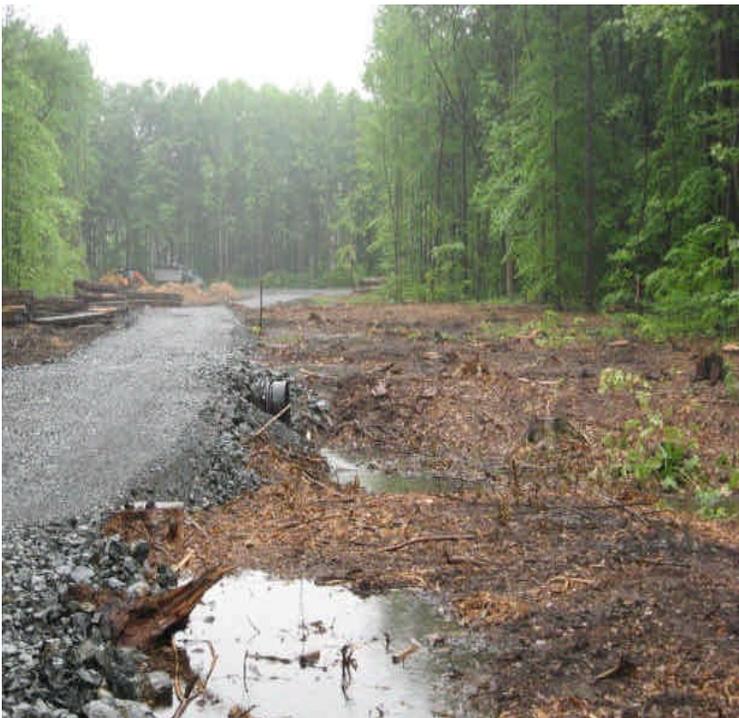
**View along the ROW at clearing and pad sites looking toward Little Lane.**

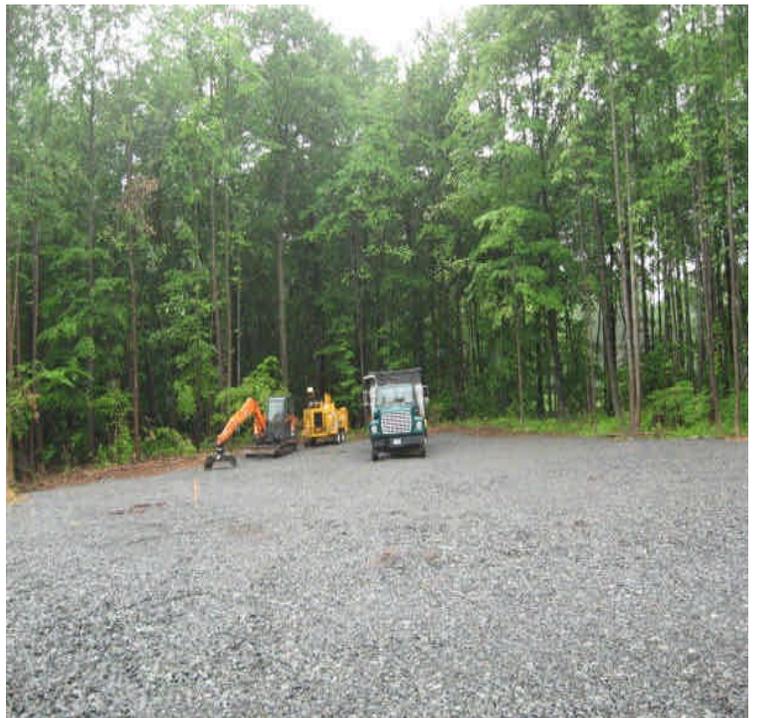
**Equipment was stored within the watershed protection area. Confirm this was not part of parcel 18-8 (Middletown Water Dept. owned land)**

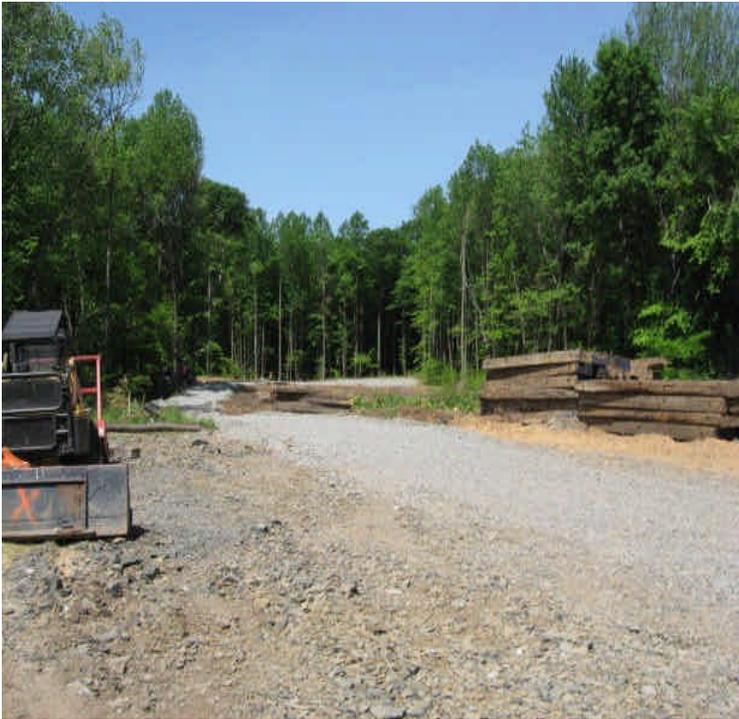
**ROW access road installed moving west from the contractor yard off Rt 17.**

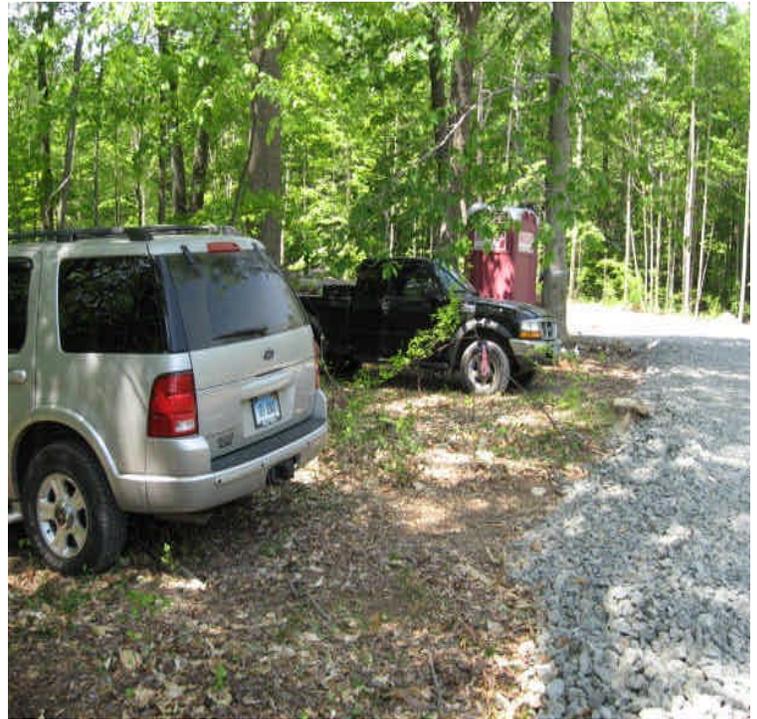
**Two vehicles parked adjacent to the wetland boundary at the watershed protection area.**

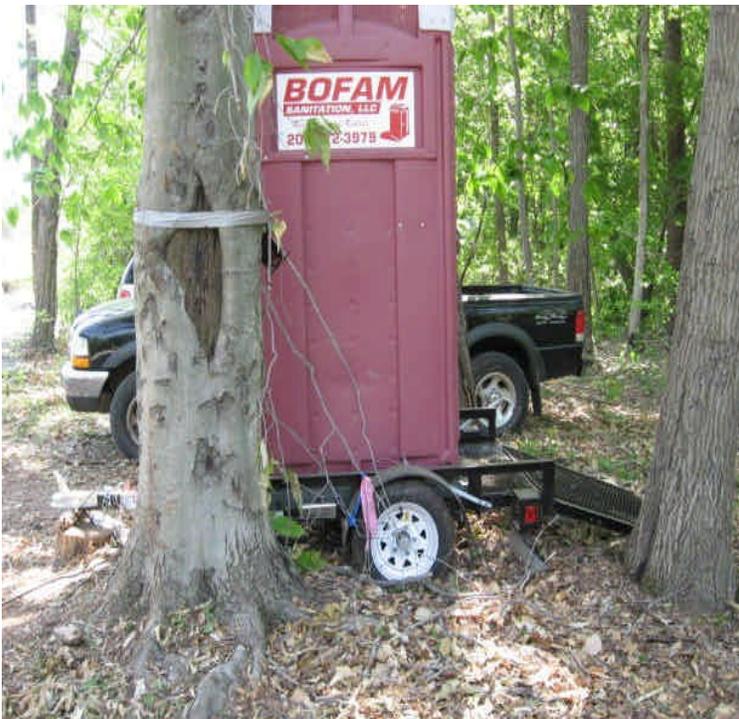
**Portable sanitary facility located immediately at the wetland boundary in the watershed protection area. Note pink & blue wetland flagging. Vehicles and facility should be relocated.**

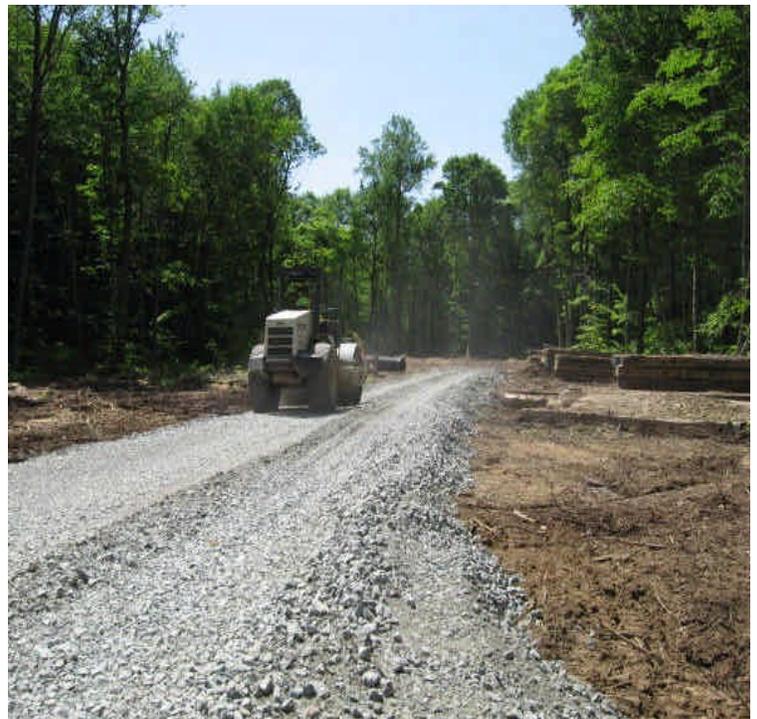
**Access road construction continues into watershed protection area. Clearing has stopped at low impact area after the last pad site from this access.**
