**Docket No. 272 – Development and Management Plan Inspection**

**Segment 2b Inspection**

**Date:** June 7, 2007

**Location:** Segment 2b – Cheshire/Hamden Town Line to East Devon Substation

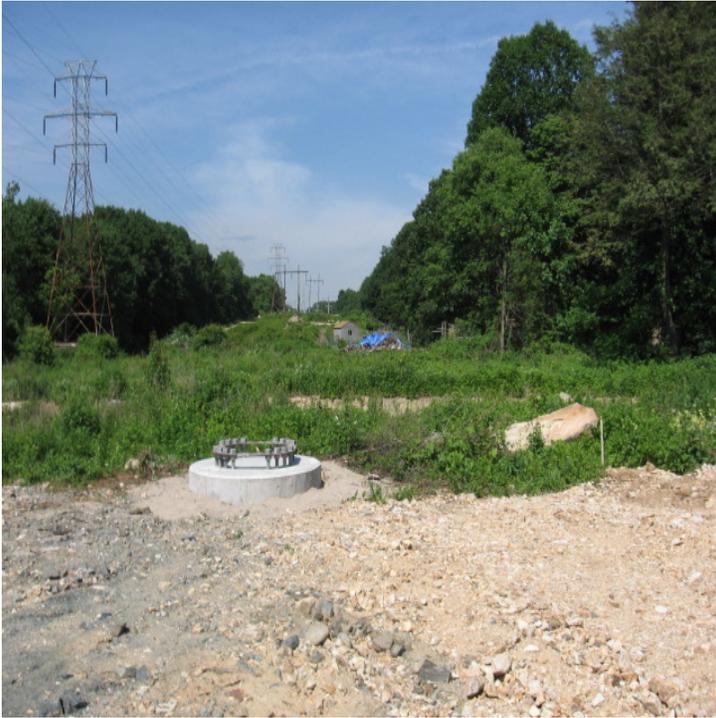
Oronoque Road (Milford): Foundation drilling/pouring is complete in this section.

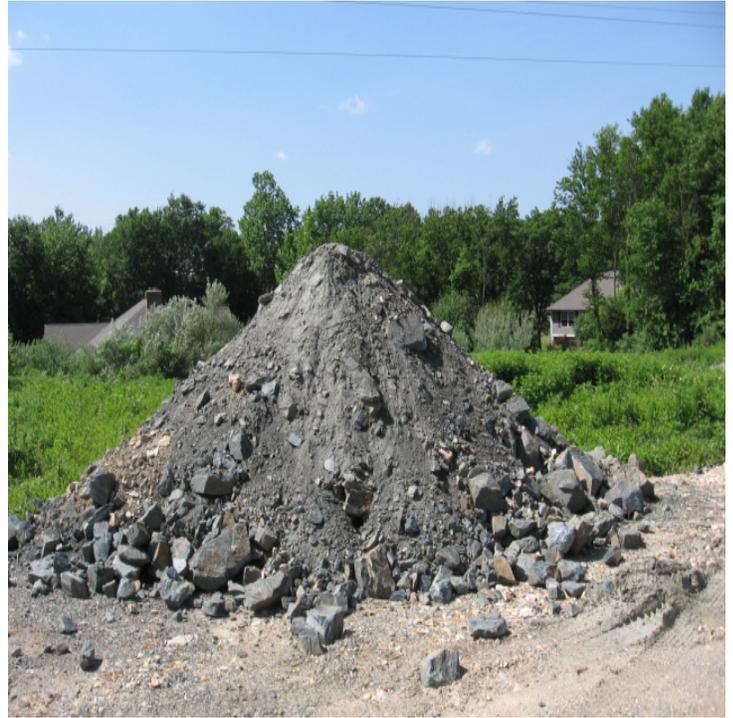
Oronoque Road (Milford): Spoil piles were placed within the limits of the crane pad work area and appear to be contained on site.

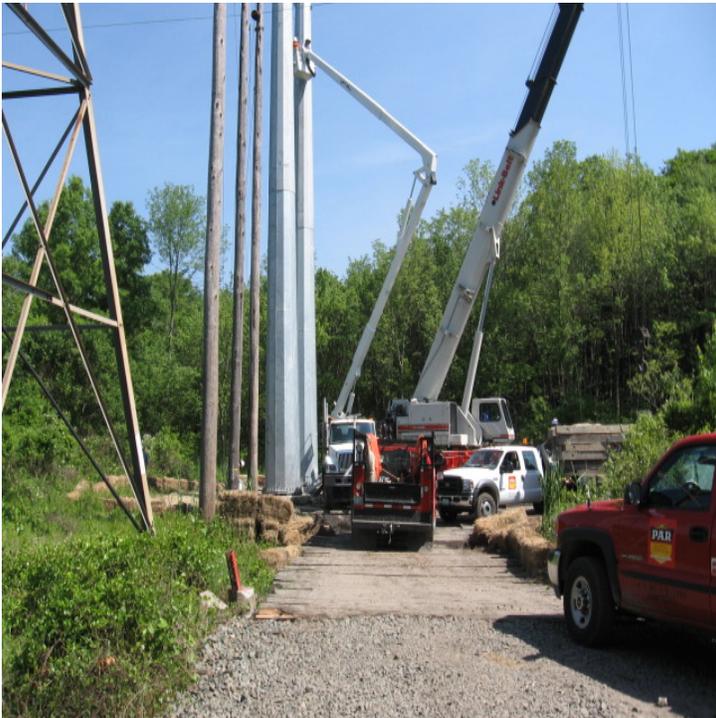
West River Street (Milford): Installation of structure #3836. Proper control measures (timber mats, hay bales and filter socks) remain in place.

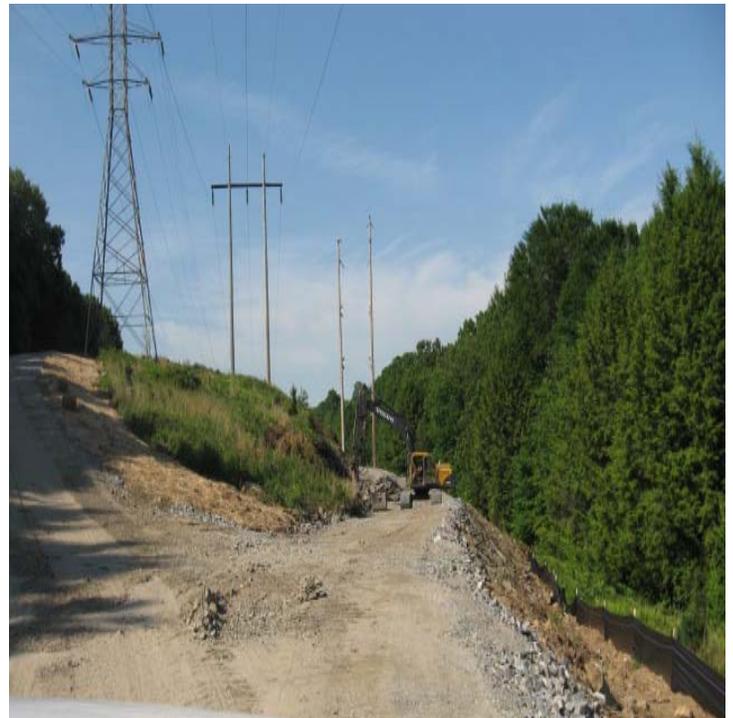
Route 69 (Bethany): Access road/crane pad construction continues in this section. Proper control measures are being installed as work progresses.

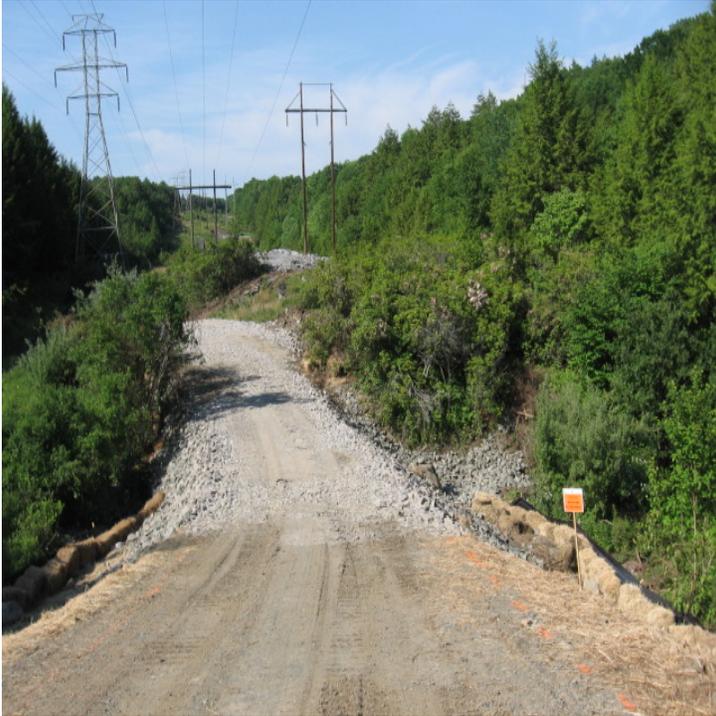
Route 69 (Bethany): Stone was added to portions of the access road and haybales and silt fence are in place at the wetland crossing.

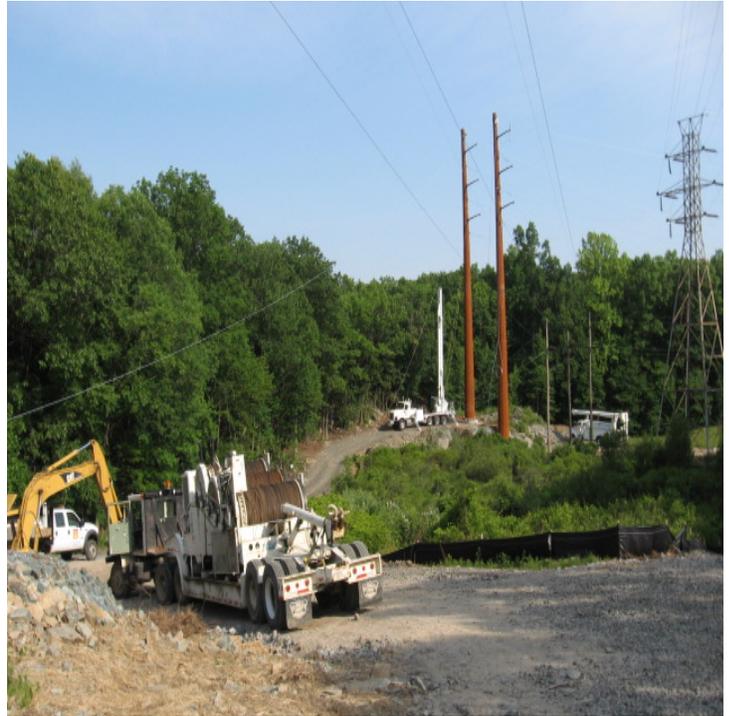
Route 34 (Orange): Initial stages of line installation.

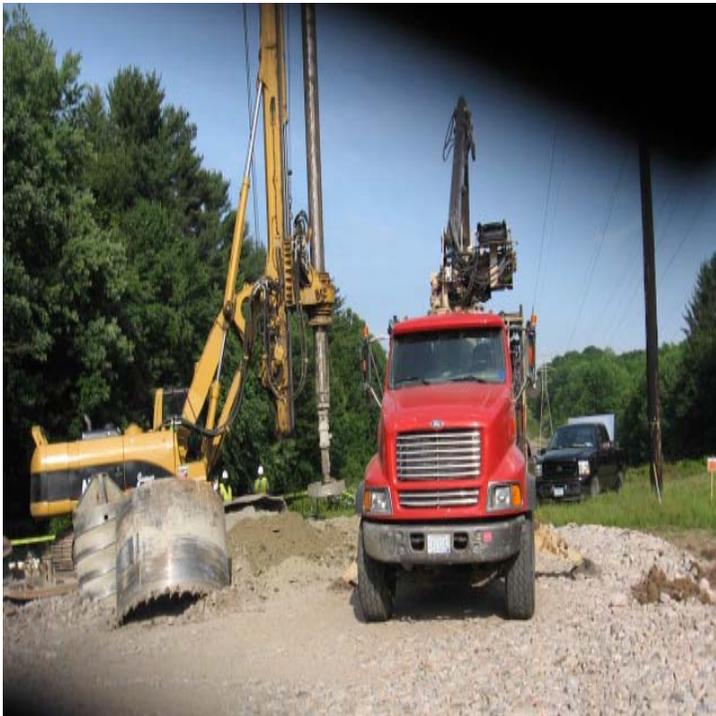
Dogburn Road (Orange): Foundation drilling continues in this section. Proper erosion controls are in place.

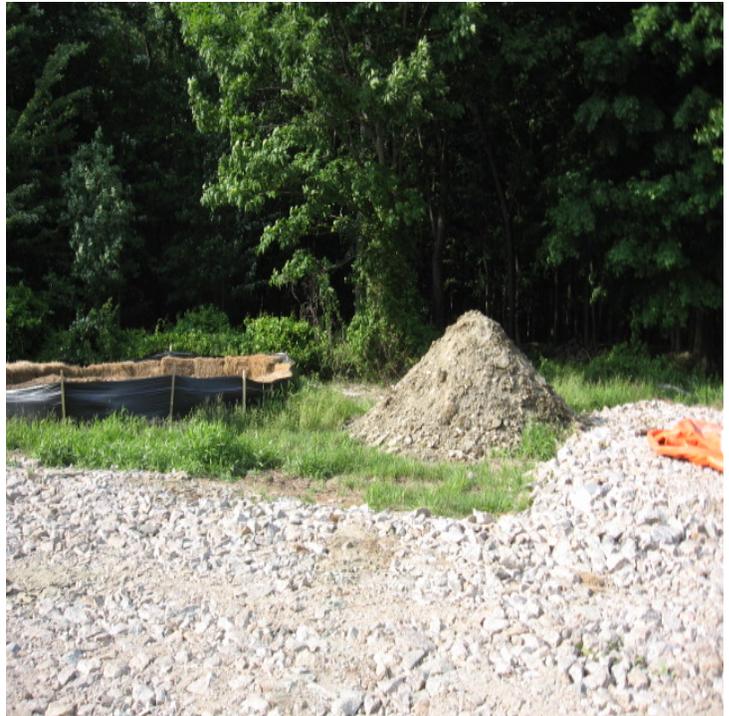
Dogburn Road (Orange): Dewatering basins remain intact and spoil piles appear to be contained on site.
