**Docket No. 272 – Development and Management Plan Inspection**

**Segment 2b Inspection**

**Date:** June 15, 2007

**Location:** Segment 2b – Cheshire/Hamden Town Line to East Devon Substation

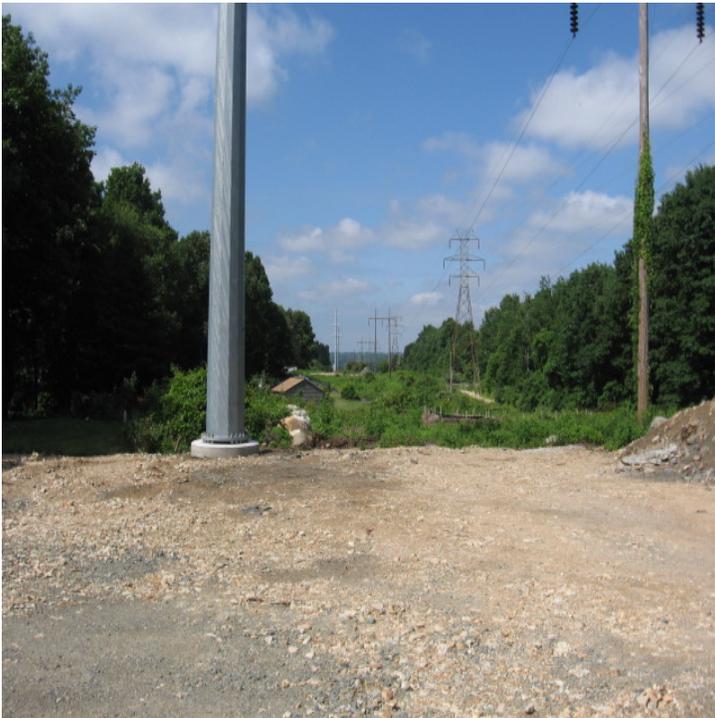
Oronoque Road (Milford): Structure installation is complete in this section. Spoil piles remain contained on site

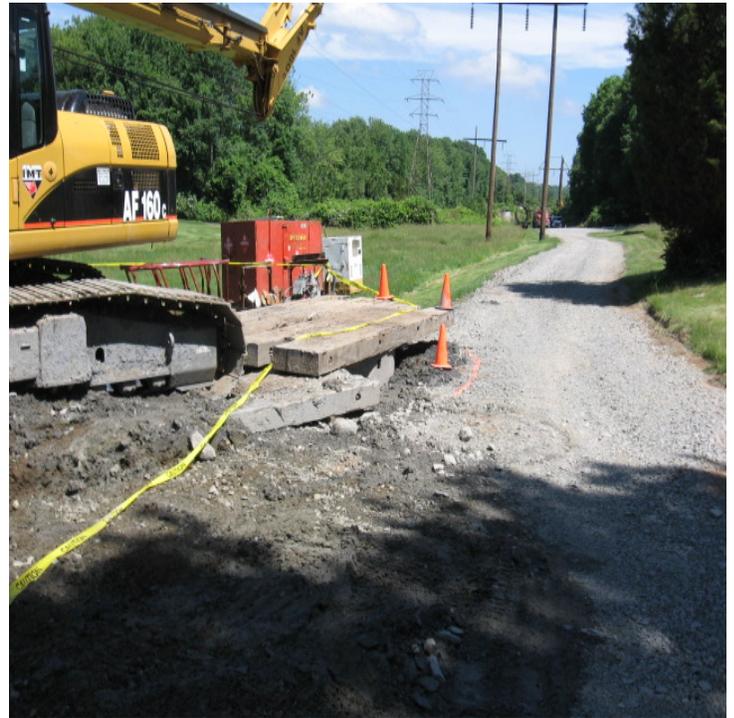
Oak Lane Country Club (Woodbridge): Foundation drilling has begun in this section.

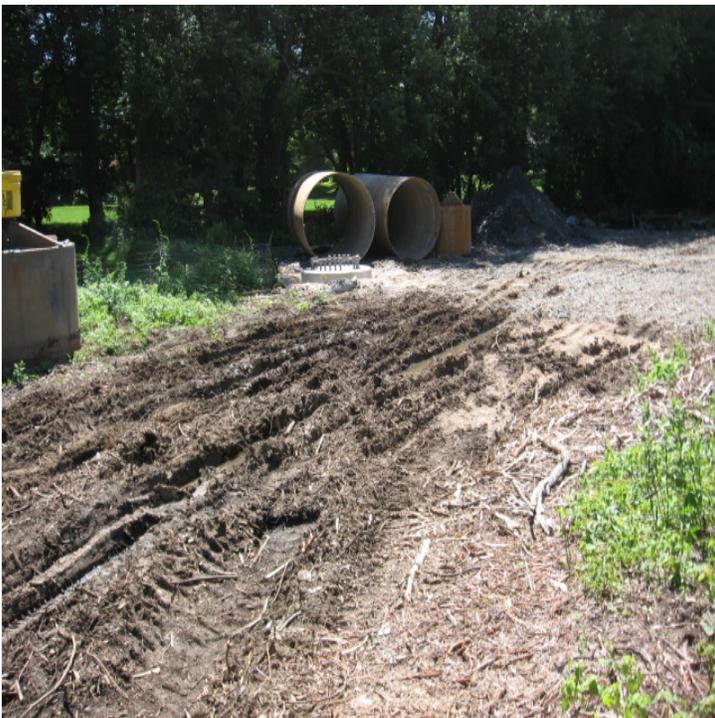
Salem Road (Woodbridge): Foundation drilling/pouring is complete in this section, but rutting and spoils remain.

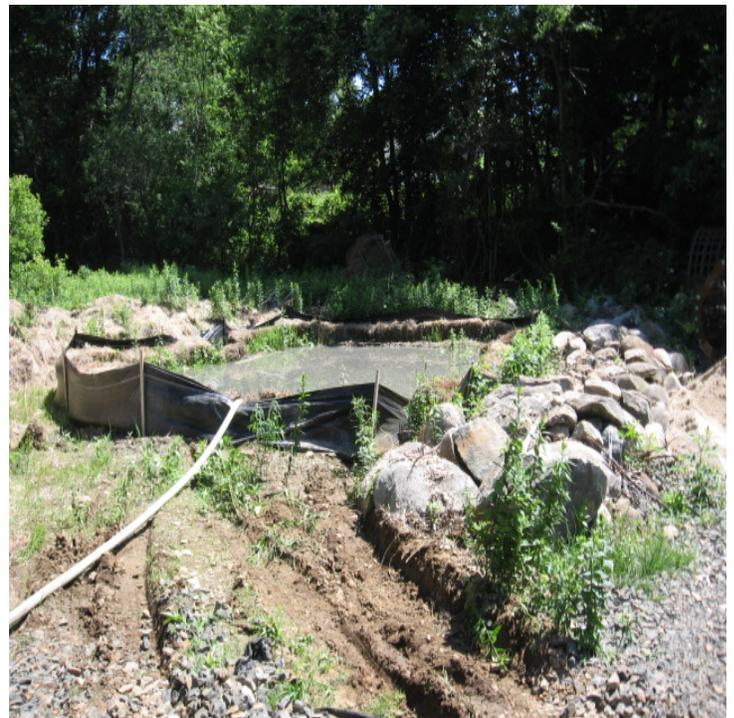
Brookwood Drive (Woodbridge): Dewatering basins were installed proactively and used properly during foundation drilling.

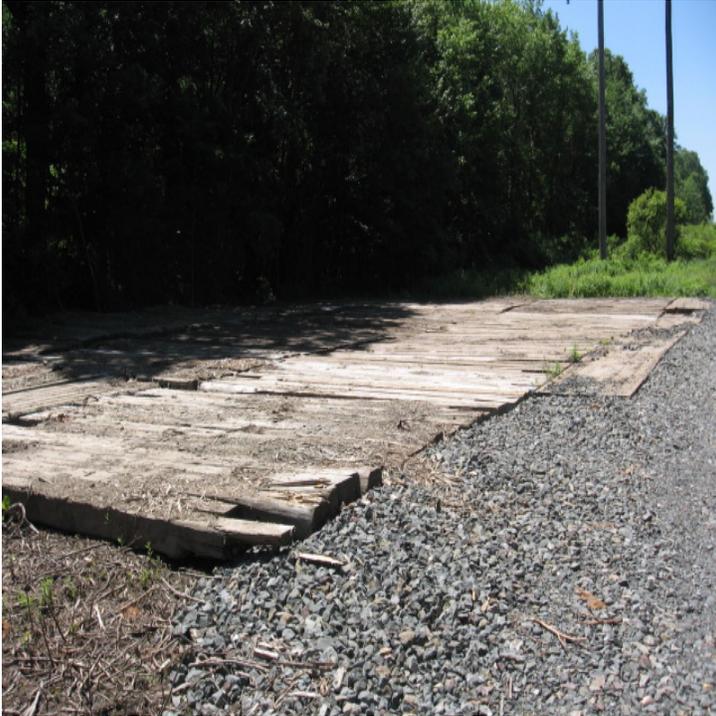
Manville Road (Woodbridge): Drilling/foundation work has not yet begun in this section but proper controls (timber mats and silt fence) are in place.

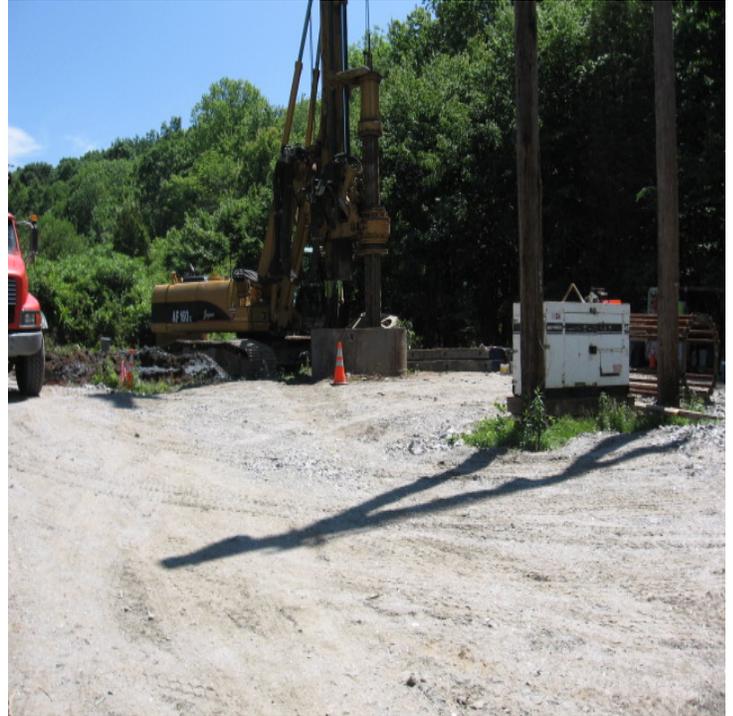
B'Nai Jacob (Woodbridge): Foundation drilling continues in this section.

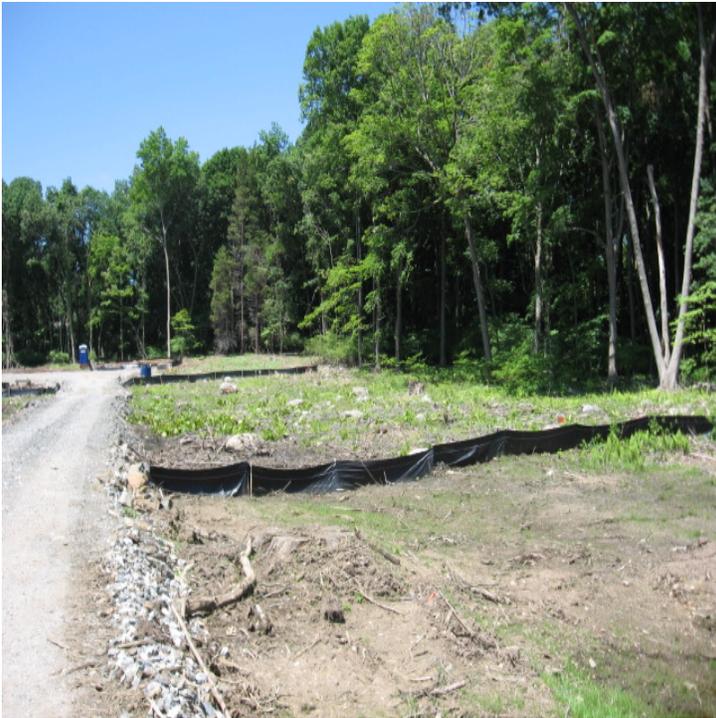
B'Nai Jacob (Woodbridge): Temporary stabilization measures were noted in the previously cleared wetland here this week. Erosion controls remain intact.

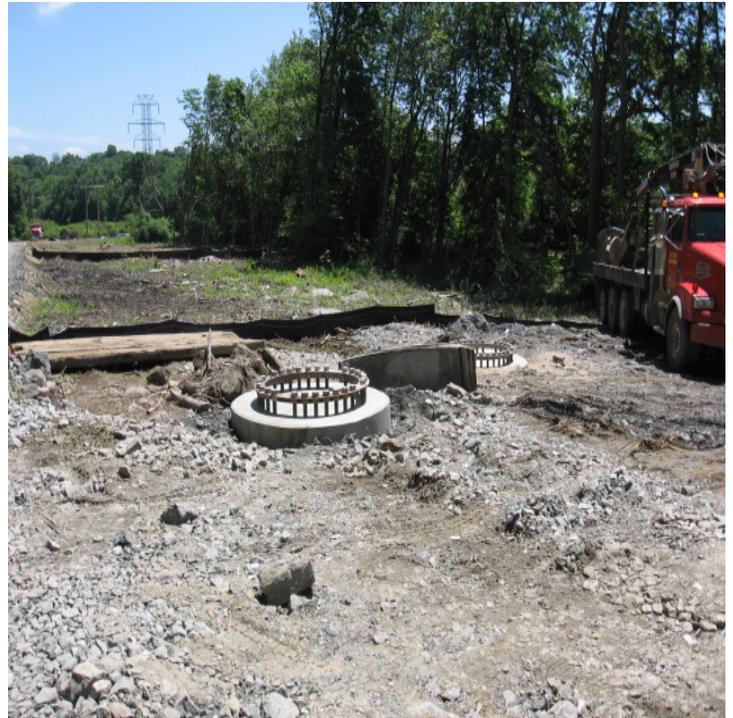
B'Nai Jacob: Two foundations were installed here this week (#3919) The vehicle shown should be parked at least 100 feet away from the wetland if feasible.

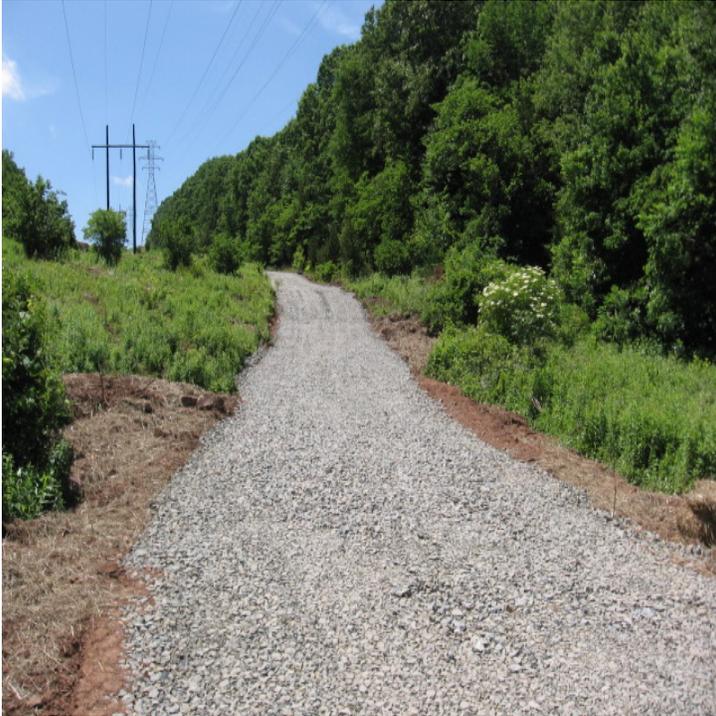
Brooksvale Ave. (Bethany): A stone access road has been constructed in this section and disturbed soils have been temporarily stabilized with hay mulch. Low trees and shrubs were retained during clearing.

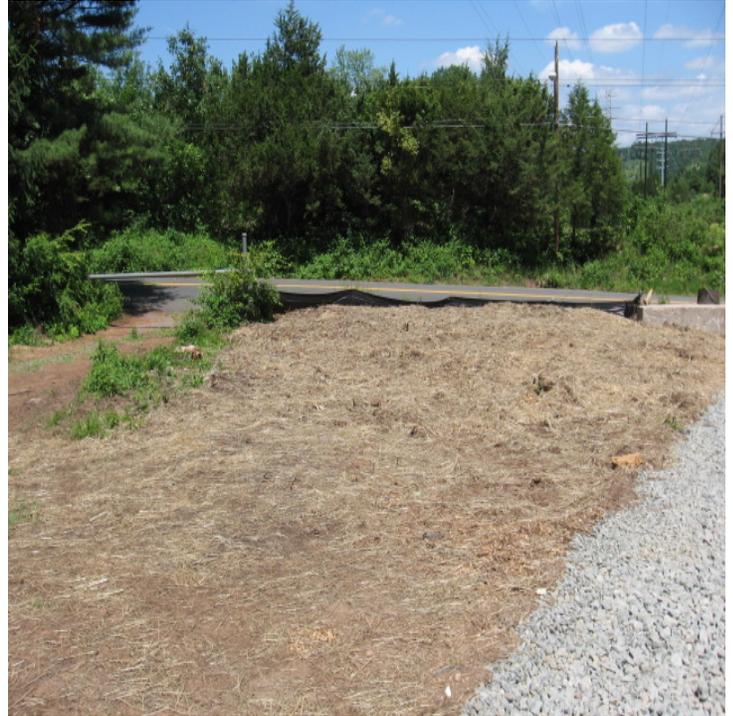
Brooksvale Ave: A new access point was constructed in this section to avoid the pre-existing flow path encountered at the original access point here.

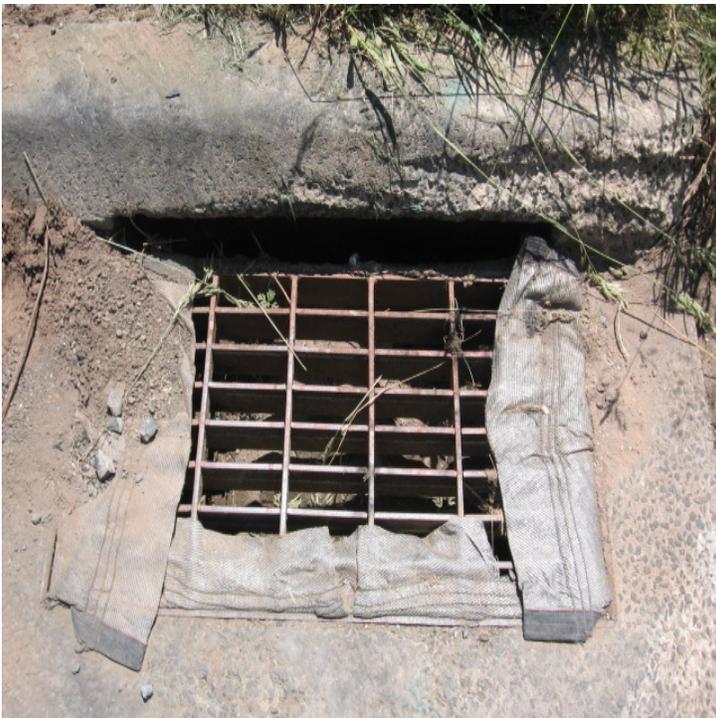
Old Lane Rd (Hamden/Cheshire line): The "silt-sak" remains intact within the catch basin located directly adjacent to the overhead access road here, but curb drop inlet protection may be needed.

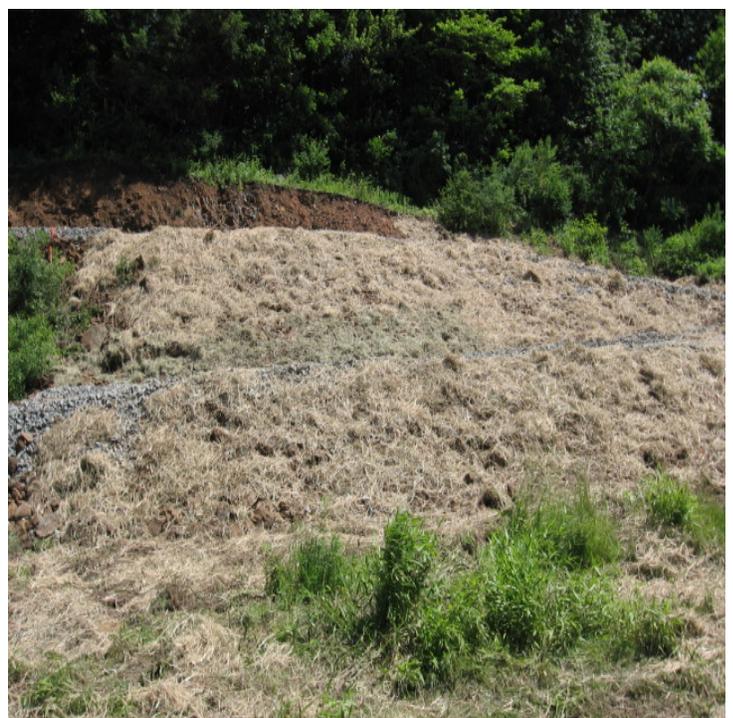
Old Lane Rd: Hay mulch was applied to soils disturbed during access road construction here.
