Docket No. 272 – Development and Management Plan Inspection

Segment 1b (Royal Oaks Bypass) Inspection

Date: March 19, 2007

Location: Segment 1b (Royal Oaks Bypass)

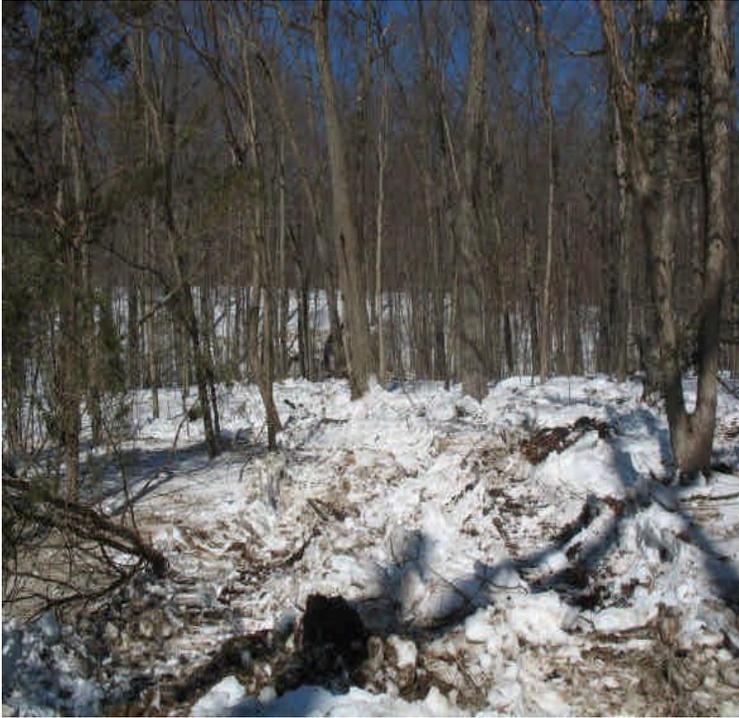
View of the harvester machine entrance off the existing ROW to begin clearing the new section.

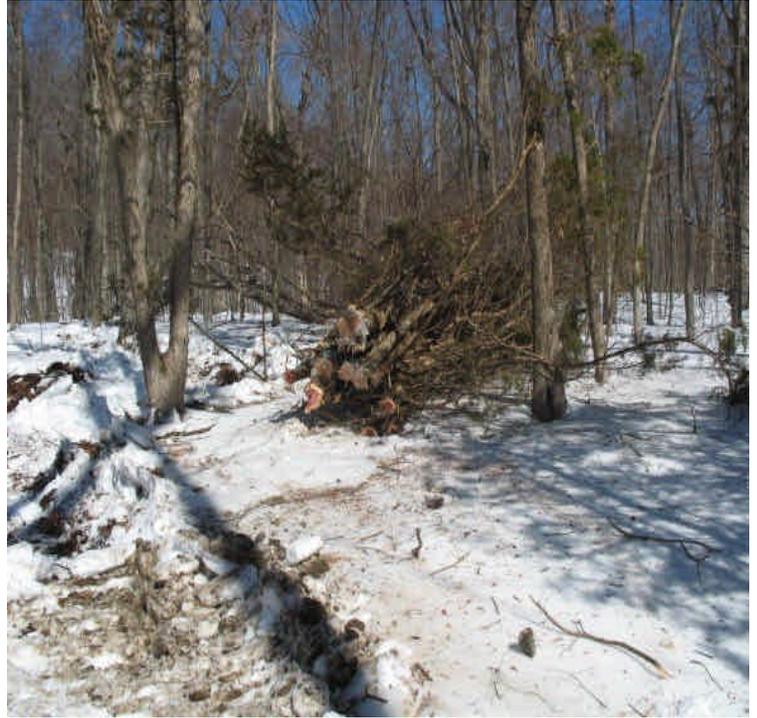
Selective cutting along the timber harvest line to maintain a boundary. Trees were being stockpiled for removal and chipping.

Areas of Inspection	Observation	Recommended Action	Corrected Action
	of inspection. Trees were stockpiled for removal or chipping. 3/19/07	the extent feasible in accordance with the D&M Plan. 3/19/07	
Dewatering	Dewatering is not being performed at this time. 3/19/07	None	NA
Blasting	No blasting is proposed at this time. 3/19/07	None	NA
Spills, soils and material storage	No spills/drips were found on site. Operators have been advised to use spill controls when working on equipment. 3/19/07 Spill cleanup materials were available on site. Spill kits move from site to site with equipment. 3/19/07	Always use spill control materials when working on equipment and during refueling. Replace as needed. 3/19/07 Continue to use and restock materials as needed. 3/19/07	NA NA
Additional Observations	NA	NA	NA

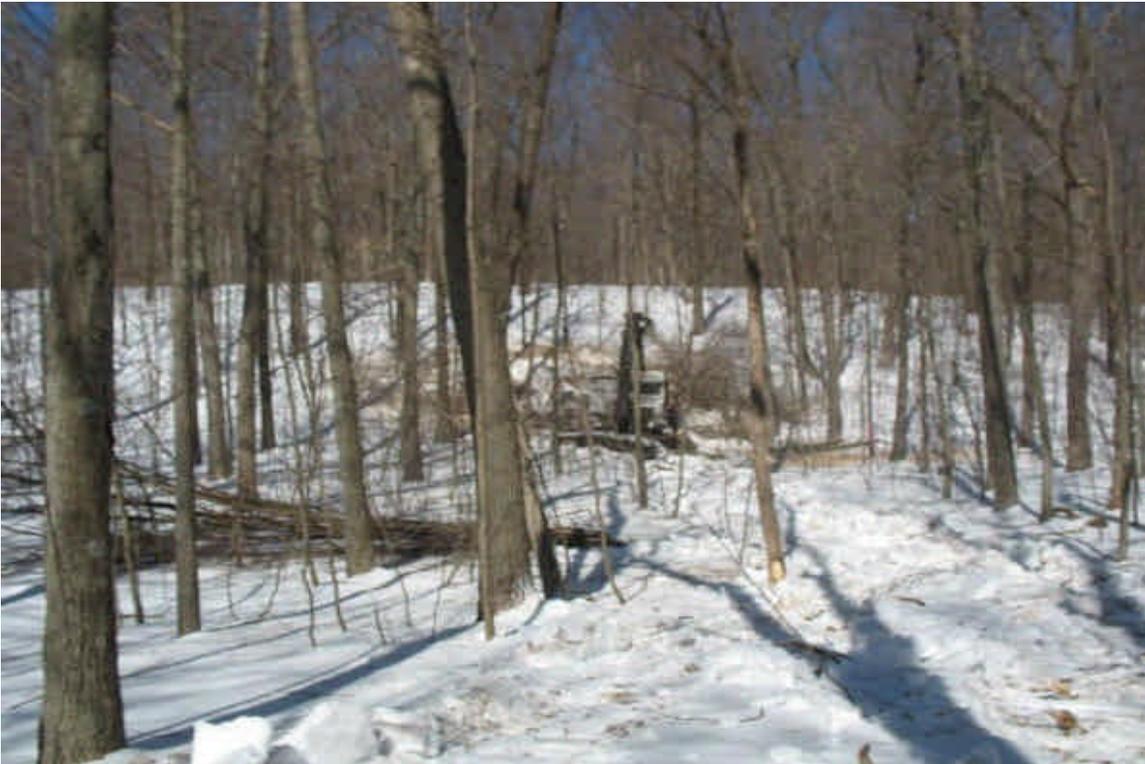
View of tree cutting along the timber harvest boundary. Clearing on this section of the project began the day of the inspection.
