**Docket No. 272 – Development and Management Plan Inspection**

**Segment 4b Underground Line**

**Date:** March 6, 2007

**Location:** Fairfield/Westport Town Line to Westport Avenue in Norwalk

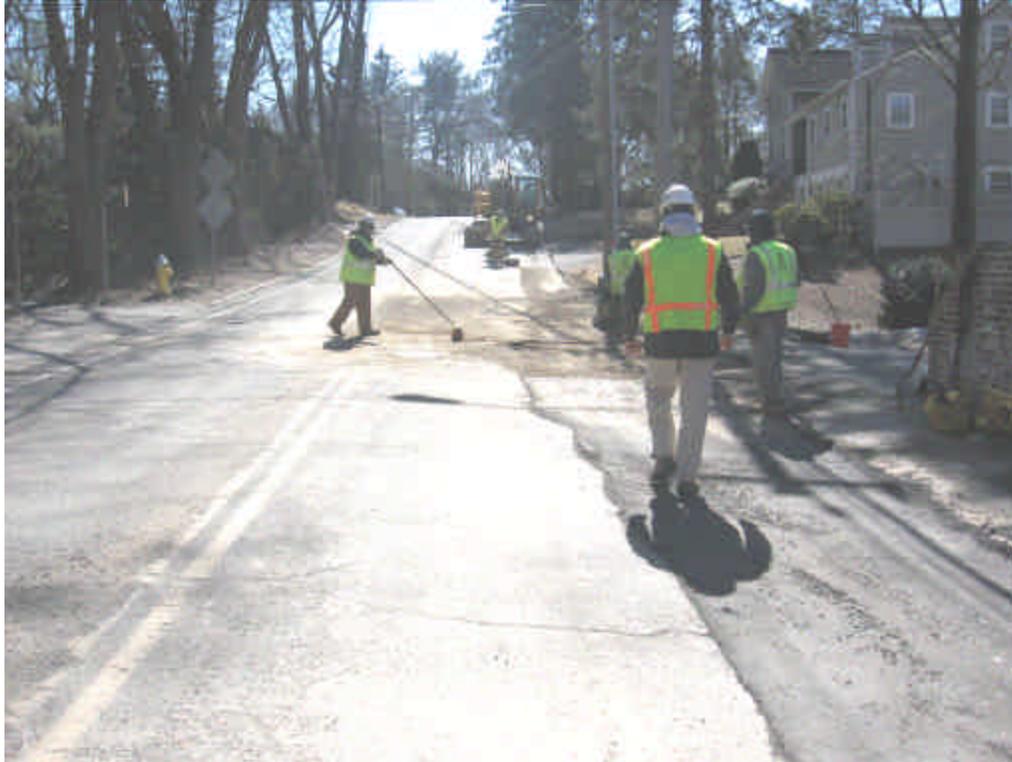
**Trench restoration activities were being conducted along Imperial Ave. during this week's inspection.**

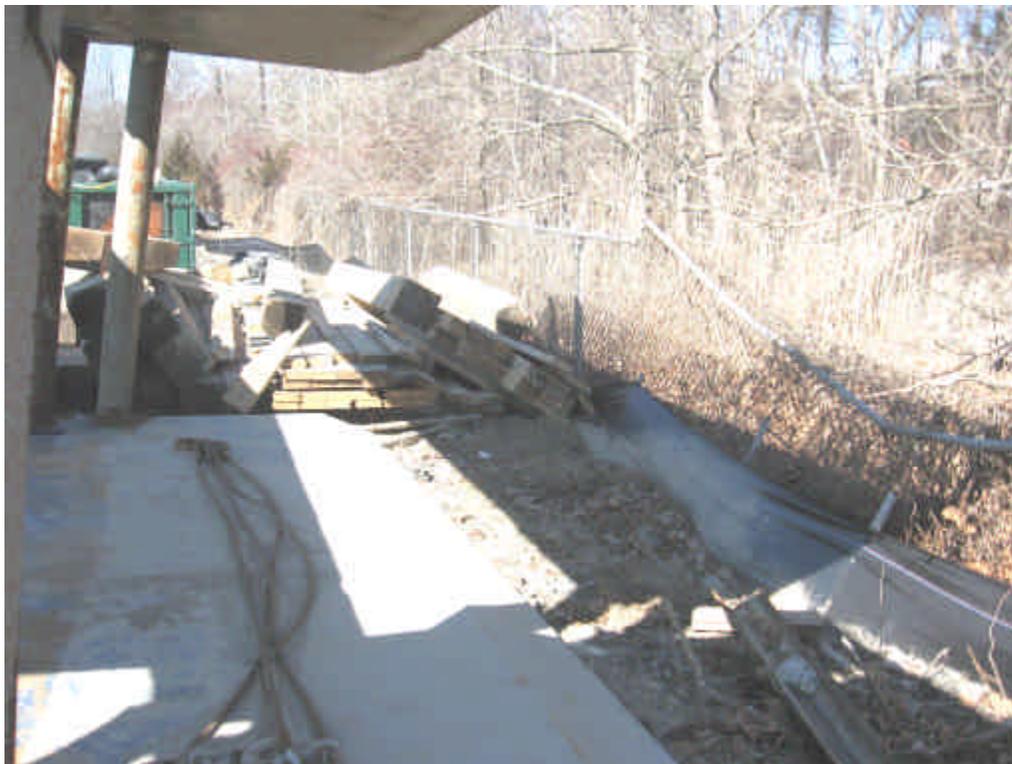
**Material stockpile (wood pallets) has compromised the perimeter controls at the Kings Highway lay-down yard. Pull materials back and restore the silt fence.**
