Docket No. 272 – Development and Management Plan Inspection

Segment 2b Inspection

Date: June 29, 2007

Location: Segment 2b – Cheshire/Hamden Town Line to East Devon Substation

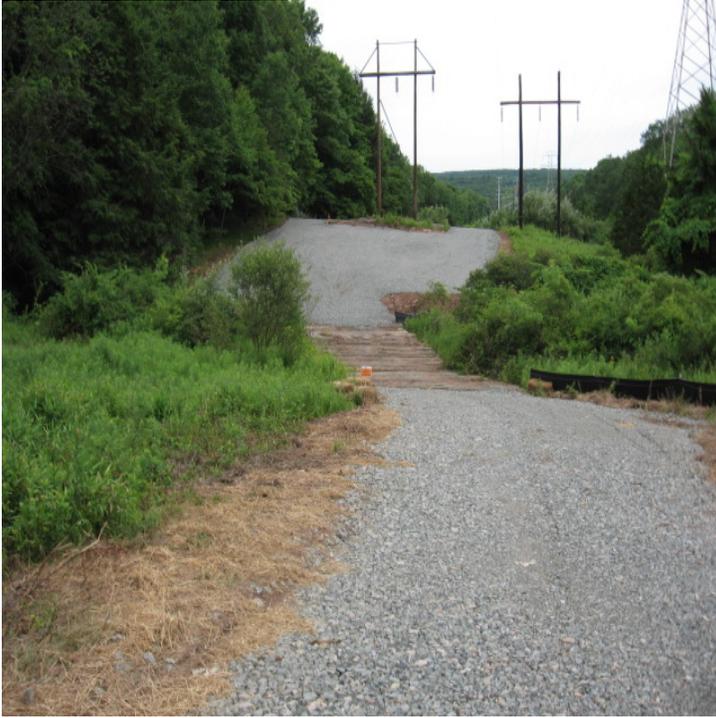
Old Lane Rd (Hamden): Timber mats were installed at the wetland crossing here. Disturbed soils have been mulched and silt fence/haybale controls are in place along the wetland boundary.

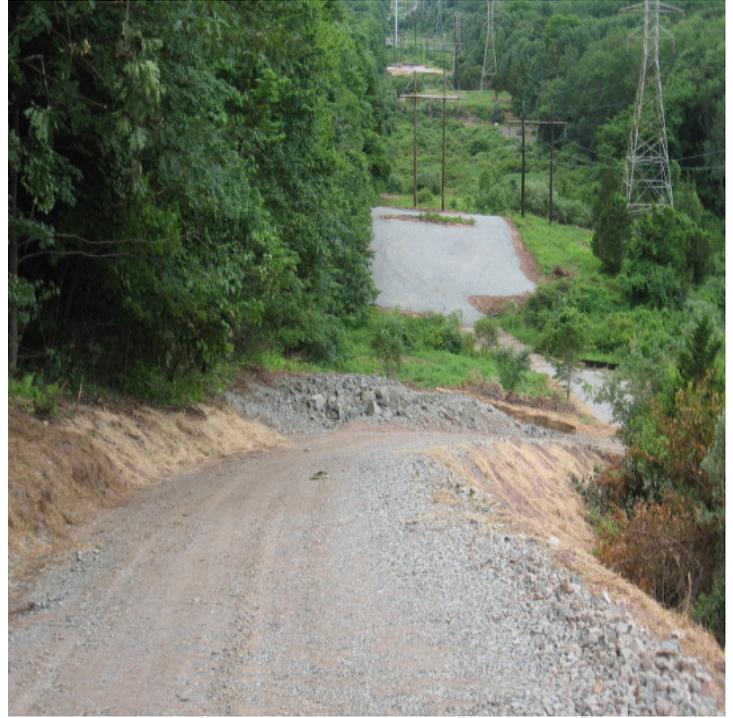
Old Lane Rd: A drainage swale, stone check dams, and a stone-lined filtration basin were constructed to control and filter stormwater flow in this section. Additional stone check dams may be needed to slow flow here.

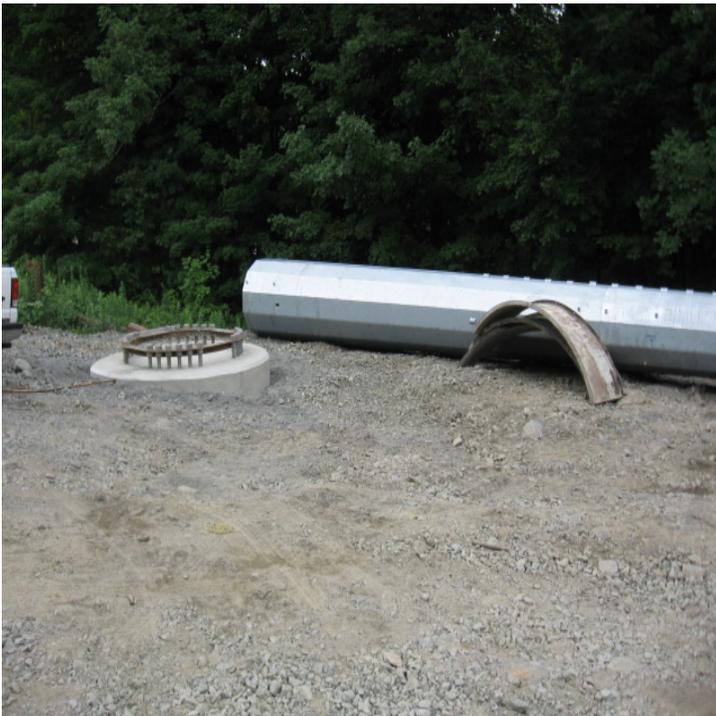
Center Rd (Woodbridge): Foundation work is complete and the structure has been delivered for installation.

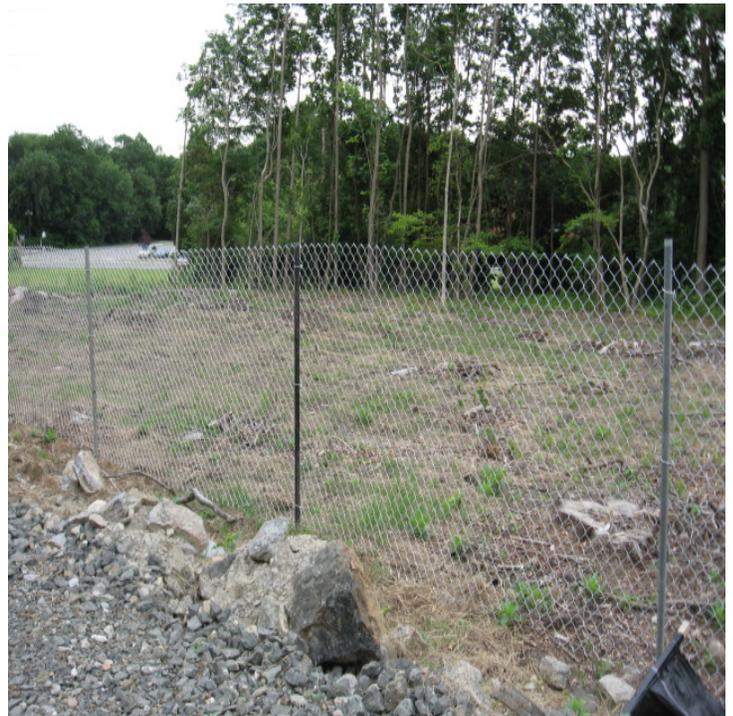
B'Nai Jacob (Woodbridge): A perimeter fence has been installed through the wetland, along the access road here.
