**Docket No. 272 – Development and Management Plan Inspection**

**Segment 1b (Royal Oaks Bypass) Inspection**

**Date:** October 15, 2007

**Location:** Segment 1b (Royal Oaks Bypass)

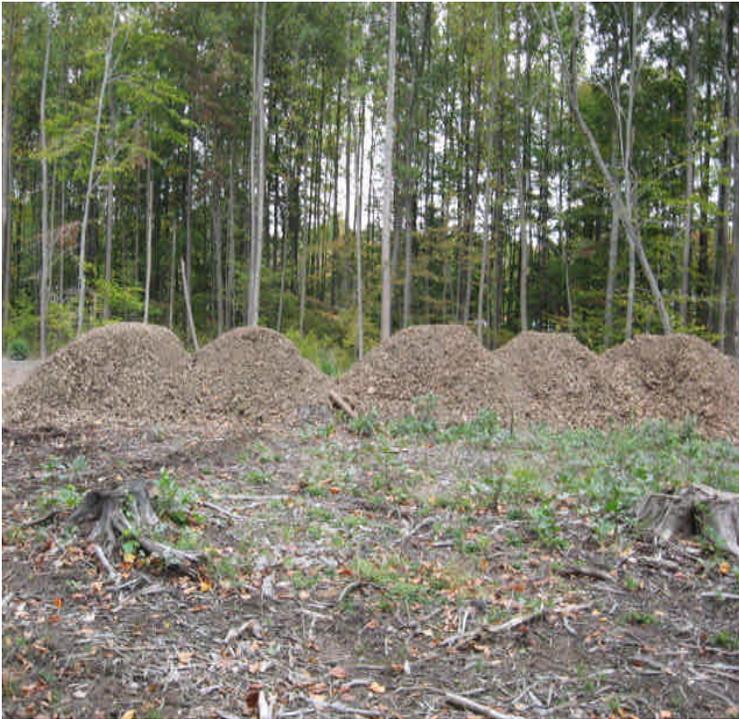
**Soil stockpiles for grading line-pull sites were located upgradient from a wetland. Controls should be added to protect adjacent wetlands.**

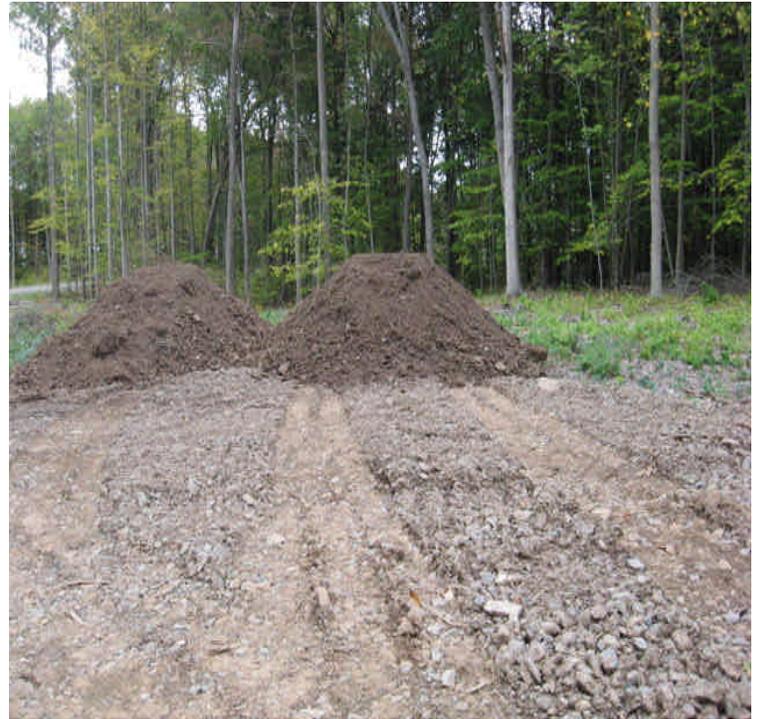
**View of additional stockpiles left for grading pull sites. Controls should be added upgradient from the adjacent wetlands.**

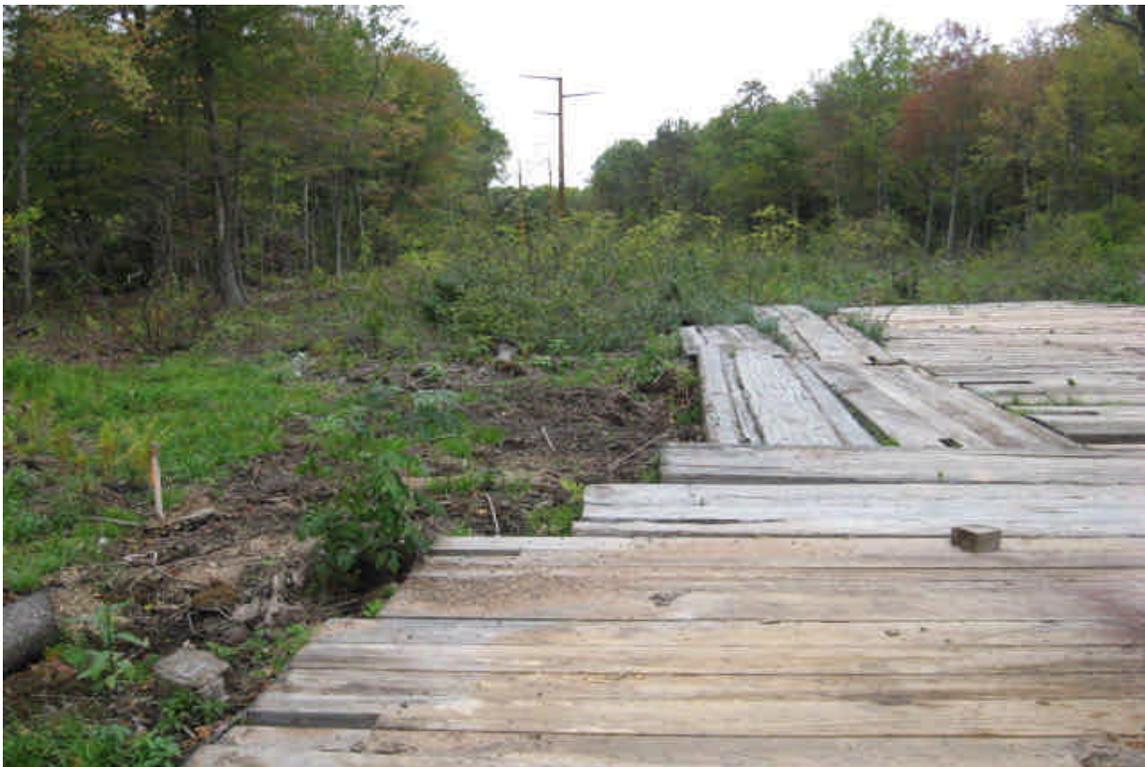
**Equipment ruts have been repaired and soils have been regraded. Monitor for stabilization.**
