Wildlife Habitat Survey

Stepstone 35L Substation

Stepstone Hill Road
Guilford, Connecticut

August 2006

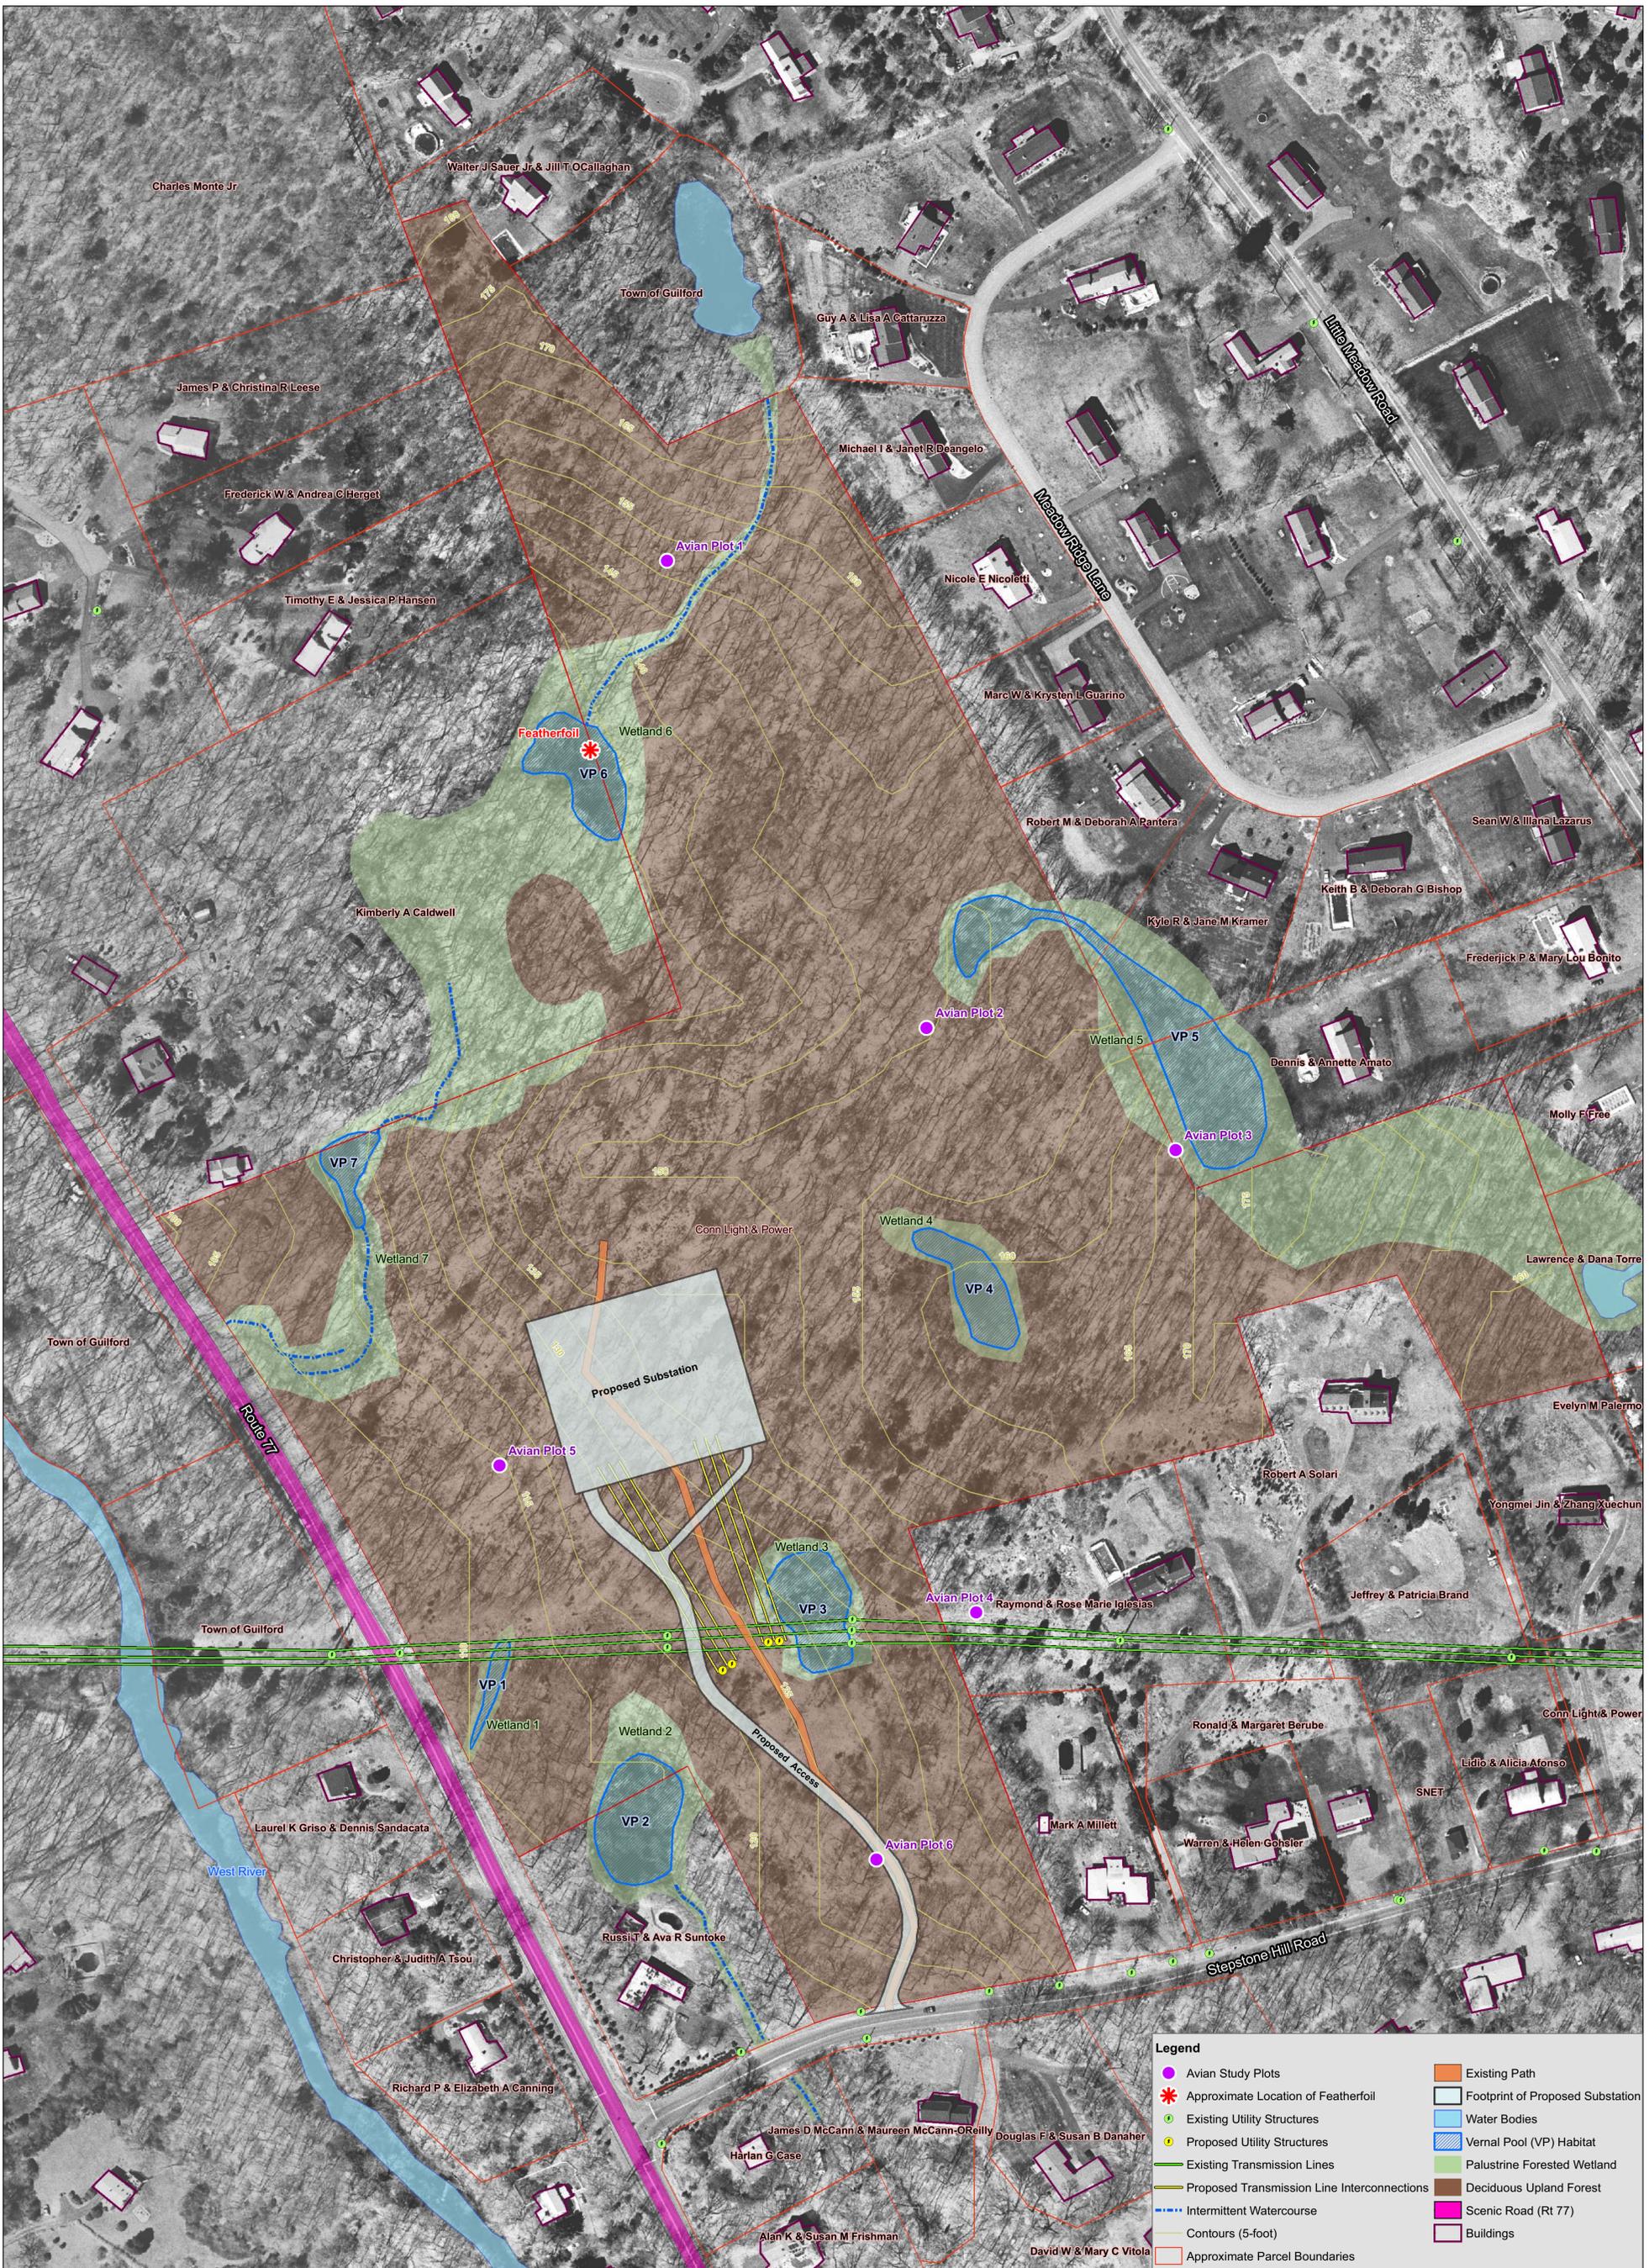
Figure 2: Habitat Assessment/Existing and Proposed Conditions Map

The Property was segmented into three major habitat types, which were delineated using upland and wetland boundaries and dominant vegetative cover types. The boundaries of each habitat type are outlined in Figure 2, Habitat Assessment\Existing and Proposed Conditions Map. The three habitat types identified are deciduous upland forest, palustrine forested wetland and vernal pool. The dominant tree, shrub and herbaceous layers of each habitat were identified and documented on a Vanasse Hangen Brustlin, Inc. (VHB) Wildlife Habitat Evaluation Checklist, included in Appendix A of this report.

There are seven palustrine forested wetland areas on the Property (Wetlands 1 – 7 depicted on Figure 2). These wetlands primarily function to receive and store groundwater and surface runoff, recharge groundwater and provide production export and wildlife habitat. All of the wetland areas on the property are seasonally inundated and provide varying degrees of vernal pool habitat. Wetlands 3 and 4 are part of a large wetland system that facilitates the movement of water from an area north of the Property westward to the West River and as such additionally function to provide nutrient removal, retention and transformation. Most of the wetlands on the Property offer visual quality and aesthetic value especially during the growing season and during the late winter/early spring period due to the vernal pool habitats.

Three major habitat types exist on the property, which are deciduous upland forest, deciduous wetland forest and vernal pool. The majority of the Property is deciduously forested with the exception of the disturbed transmission line ROW. Of the wetland forest habitat, seven wetland areas exist in various locations on the Property. Each of the wetland areas contain vernal pool habitat which provide varying degrees of amphibian breeding habitat quality. Woods roads that traverse the Property appear to be free from excessive ATV usage. An informal paint-ball course is situated in the northern extent of the Property.

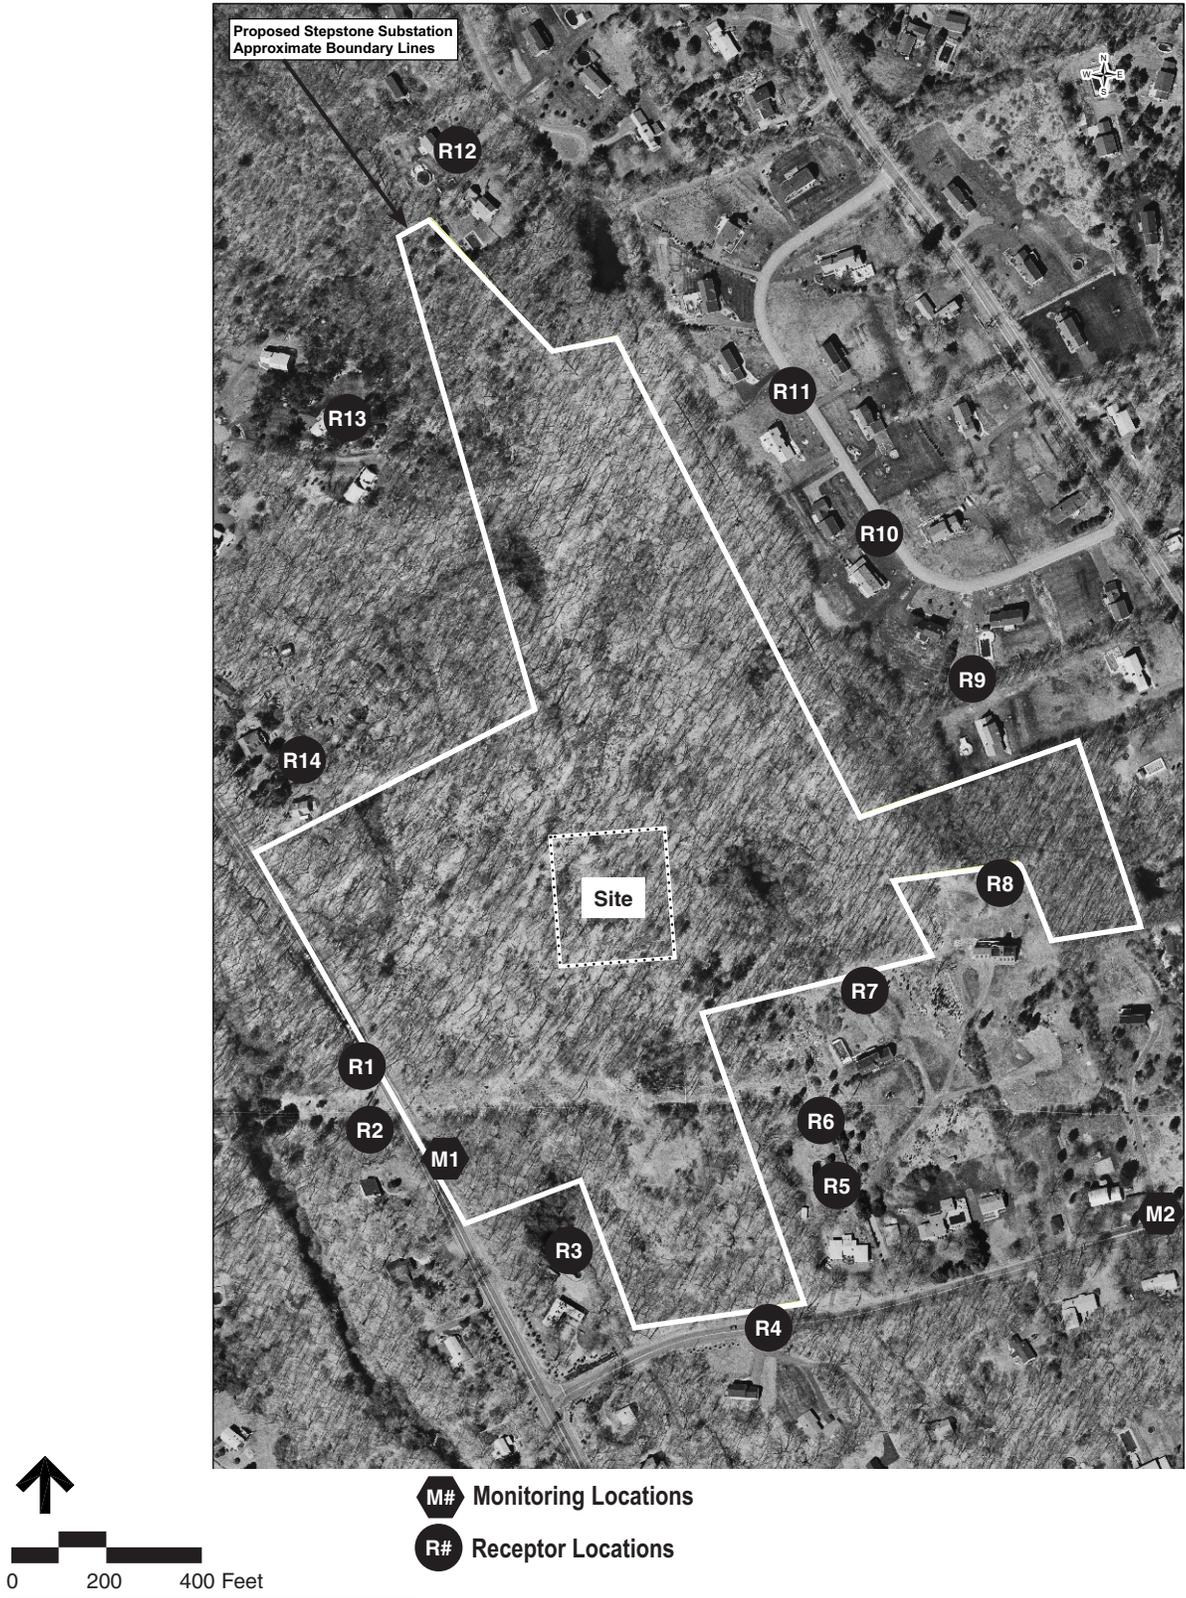
Noise Monitoring and Receptor Locations Figure 1

Land use in the vicinity of the Property is predominately residential. The receptor and existing conditions noise monitoring locations used in the noise analysis are presented in Figure 1.

The monitoring data was used to establish existing conditions and represent the areas that may experience the greatest noise impact associated with the Substation.
