CONNECTICUT SITING COUNCIL

Date: April 20, 2015

Re: Managing Temporary Linear Impacts Associated with Transmission Line Upgrades as it Pertains to Wetland-Dependent Biodiversity.

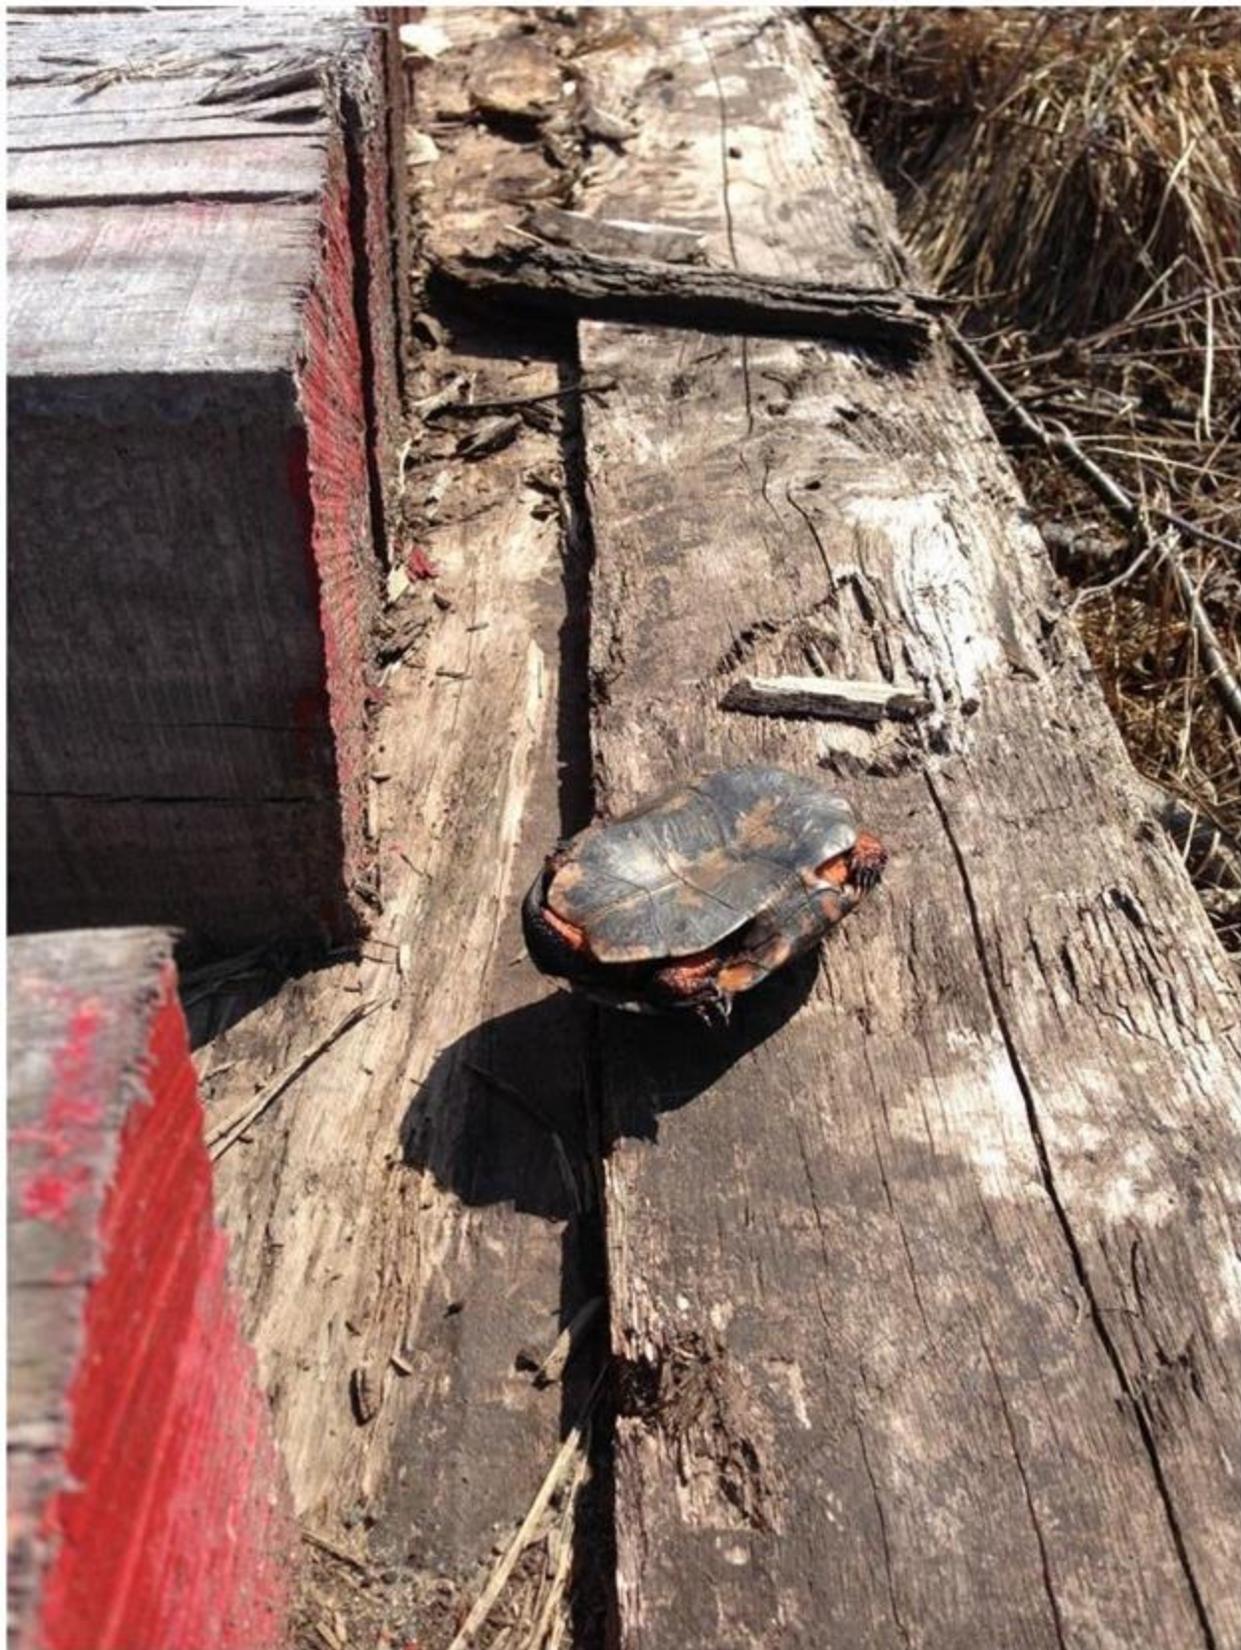
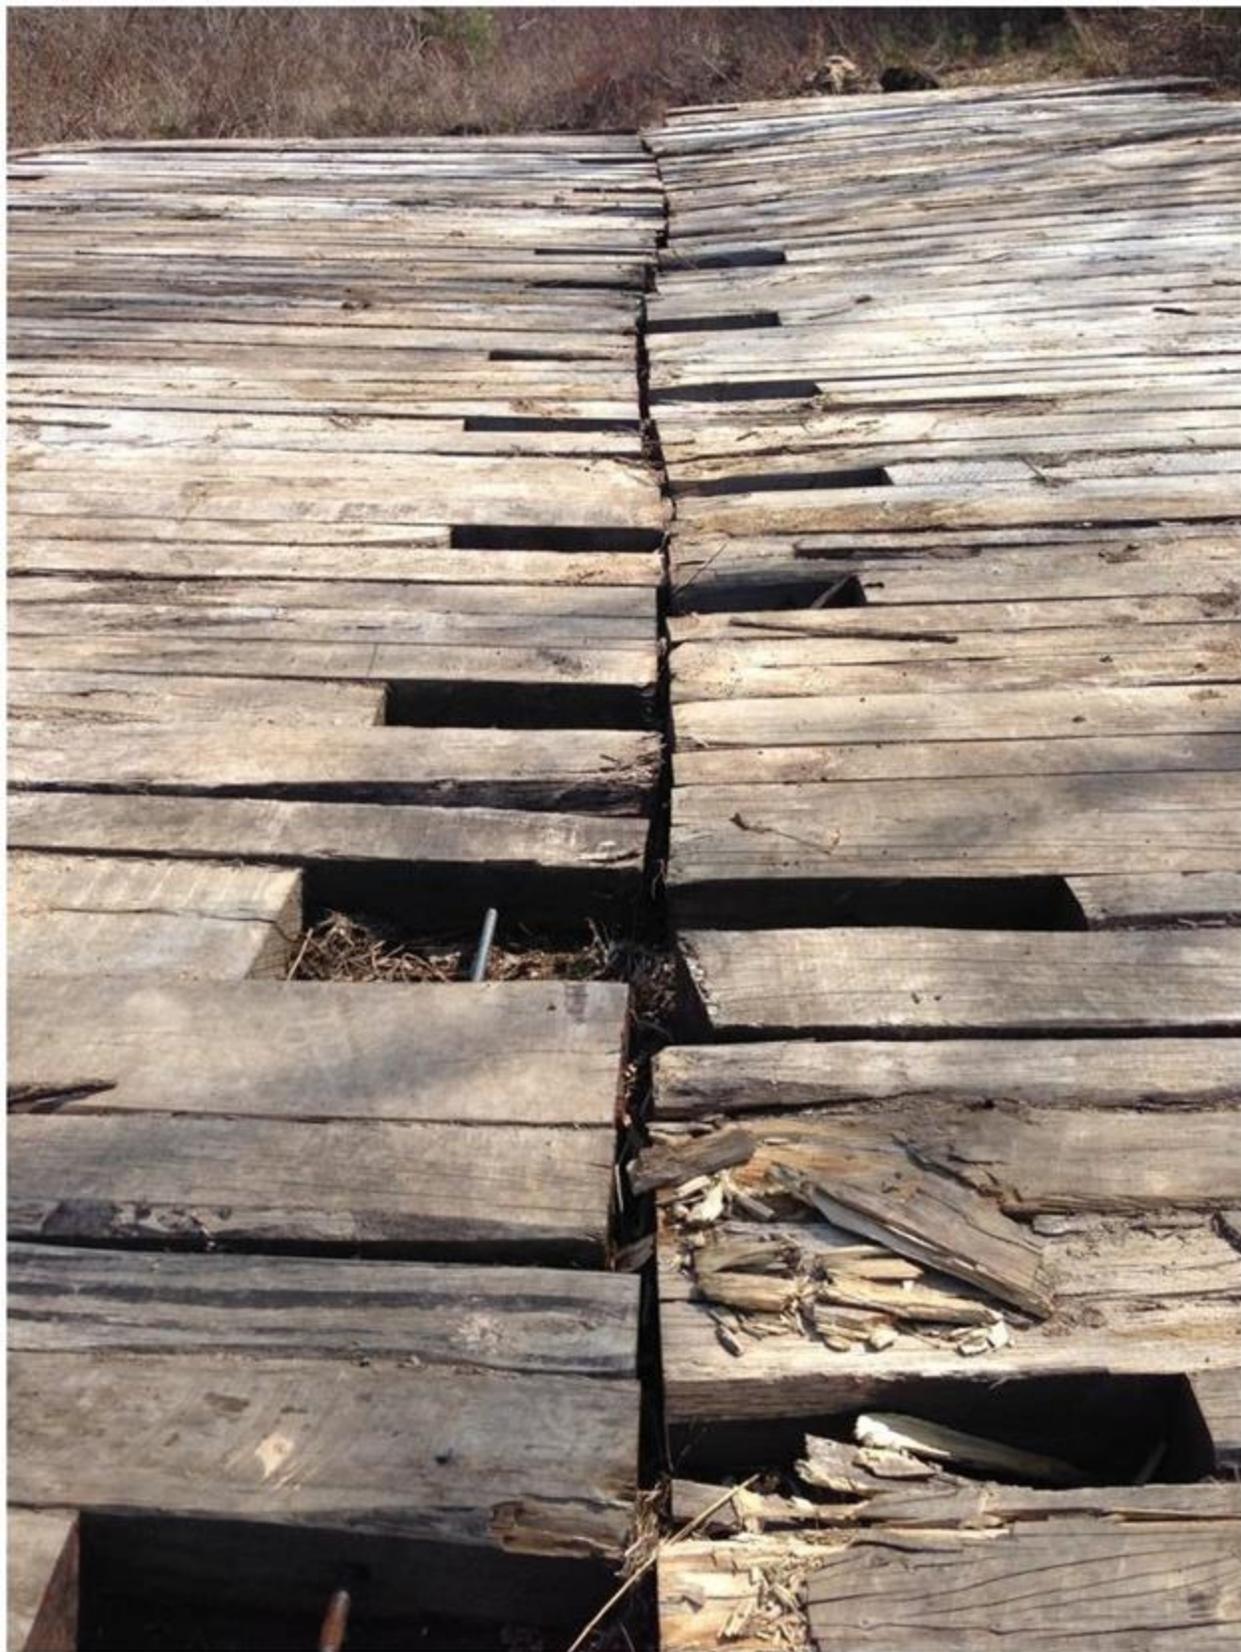
I have attached two photographs from the East Granby study to this report illustrating swamp mats *in situ*. These photographs clearly demonstrate that swamp mats have the potential to create a significant barrier to wildlife movement and cause incidental take of wildlife, especially when these mats are long (i.e., hundreds of feet). Wildlife either cannot move between habitats, or if they are able to get atop the swamp mat they risk

falling into the numerous crevices and gaps which function as death traps as the animals are unable to crawl up the 90 degree sides of these gaps. Other impacts to animals occur as illustrated by the spotted turtle that was found near death on its back, attempting to cross the swamp mat, and tipping over and are unable to right its self. Traversing swamp mats not only exposes animals to increase predatory threat, but also the threat of dying from exposure if trapped, even for a short period of time, atop or between a swamp mat on a sunny day.

Swamp mats and the heavy equipment that traverses them place a large amount of pressure on the wetland soils below these mats, killing plants and compacting soils. I would recommend that when the mats are removed that some attention be given to restoring this habitat below the mats to avoid the establishment of invasive species. I believe that swamp mats can be used effectively if the following considerations be employed.

1. Silt fence on each side of the swamp mat to stop wildlife from trying to cross the mat.
2. Bridges (box culverts) every 50 feet that will allow wildlife to pass under the swamp mat.
3. Closure (via silt fence) at each end of the swamp mat roadway to exclude animals entering the roadway.
4. A restoration and monitoring program of the area matted after work is completed to ensure that native vegetation is restored and to monitor (and remove) for invasive plants. Obviously, if the swamp mat is traversing a *Phragmites* marsh these provisions can be eliminated.
5. A protocol for cleaning swamp mats that are used in areas that are dominated by invasive plants so the mats do not become a vehicle for invasive plant establishment.
