STATE OF CONNECTICUT
CONNECTICUT SITING COUNCIL

APPLICATION OF NEW CINGULAR,
WIRELESS PCS, LLC FOR A
CERTIFICATE OF ENVIRONMENTAL
COMPATIBILITY AND PUBLIC NEED
FOR THE CONSTRUCTION,
MAINTENANCE AND OPERATION OF A
TELECOMMUNICATIONS FACILITY AT
95 BALANCE ROCK ROAD, HARTLAND,
CONNECTICUT

DOCKET NO. 408

NEW CINGULAR WIRELESS PCS, LLC ("AT&T")
RESPONSES TO INTERVENOR SIRMAN'S INTERROGATORIES (SET ONE)

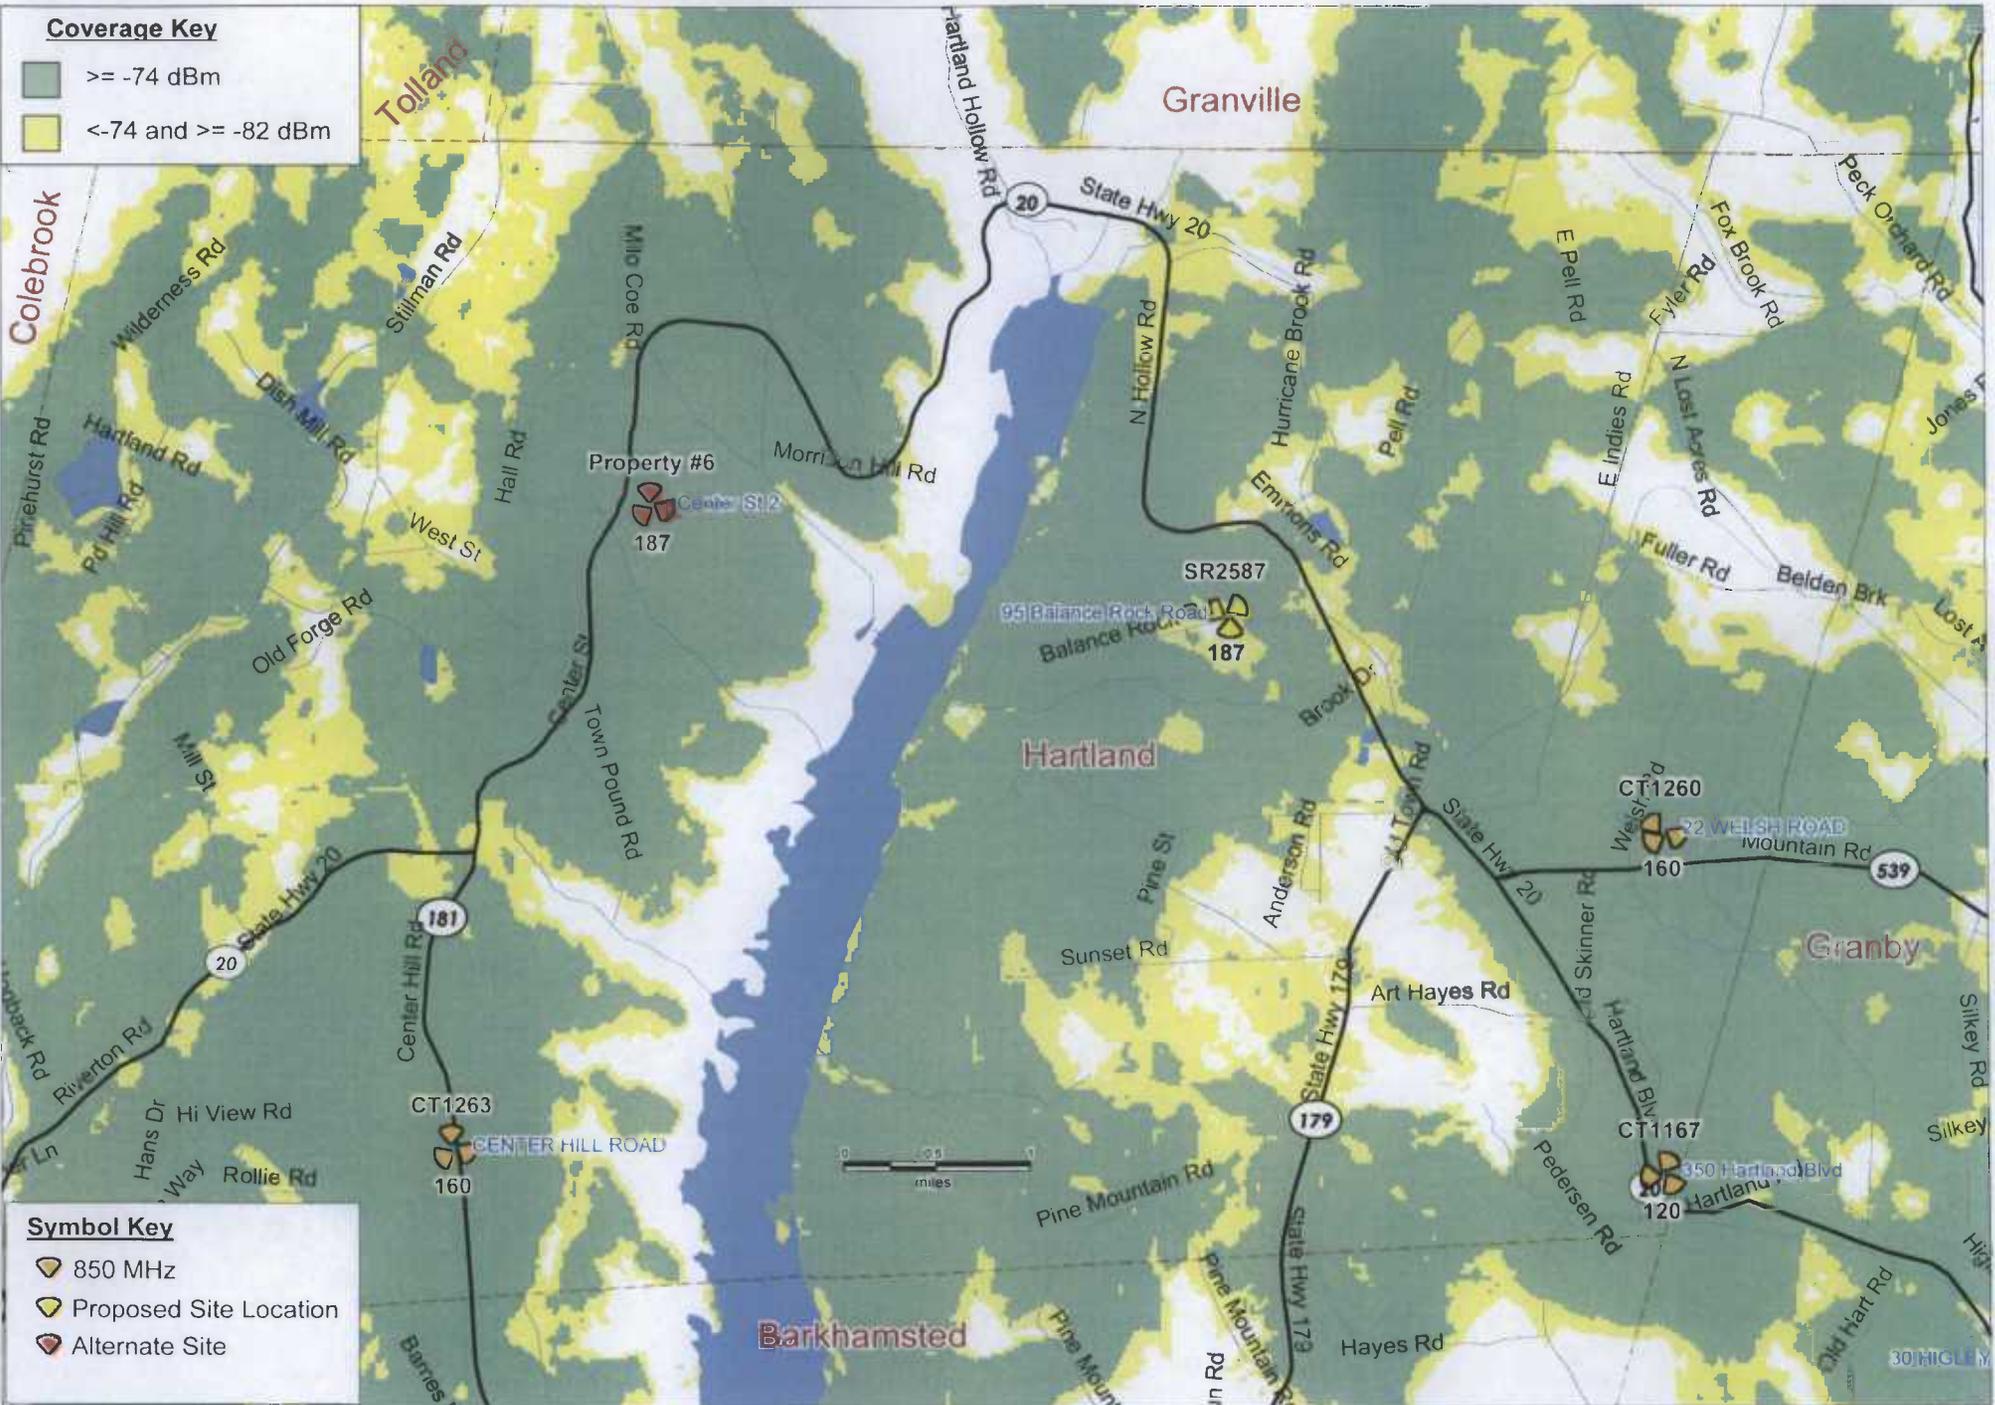
EXHIBIT A

Alternate & Existing Coverage

East Hartland, CT

propagation map included in Exhibit A demonstrates that even at 190', a tower facility at this location would not provide comparable or adequate service along Route 20.

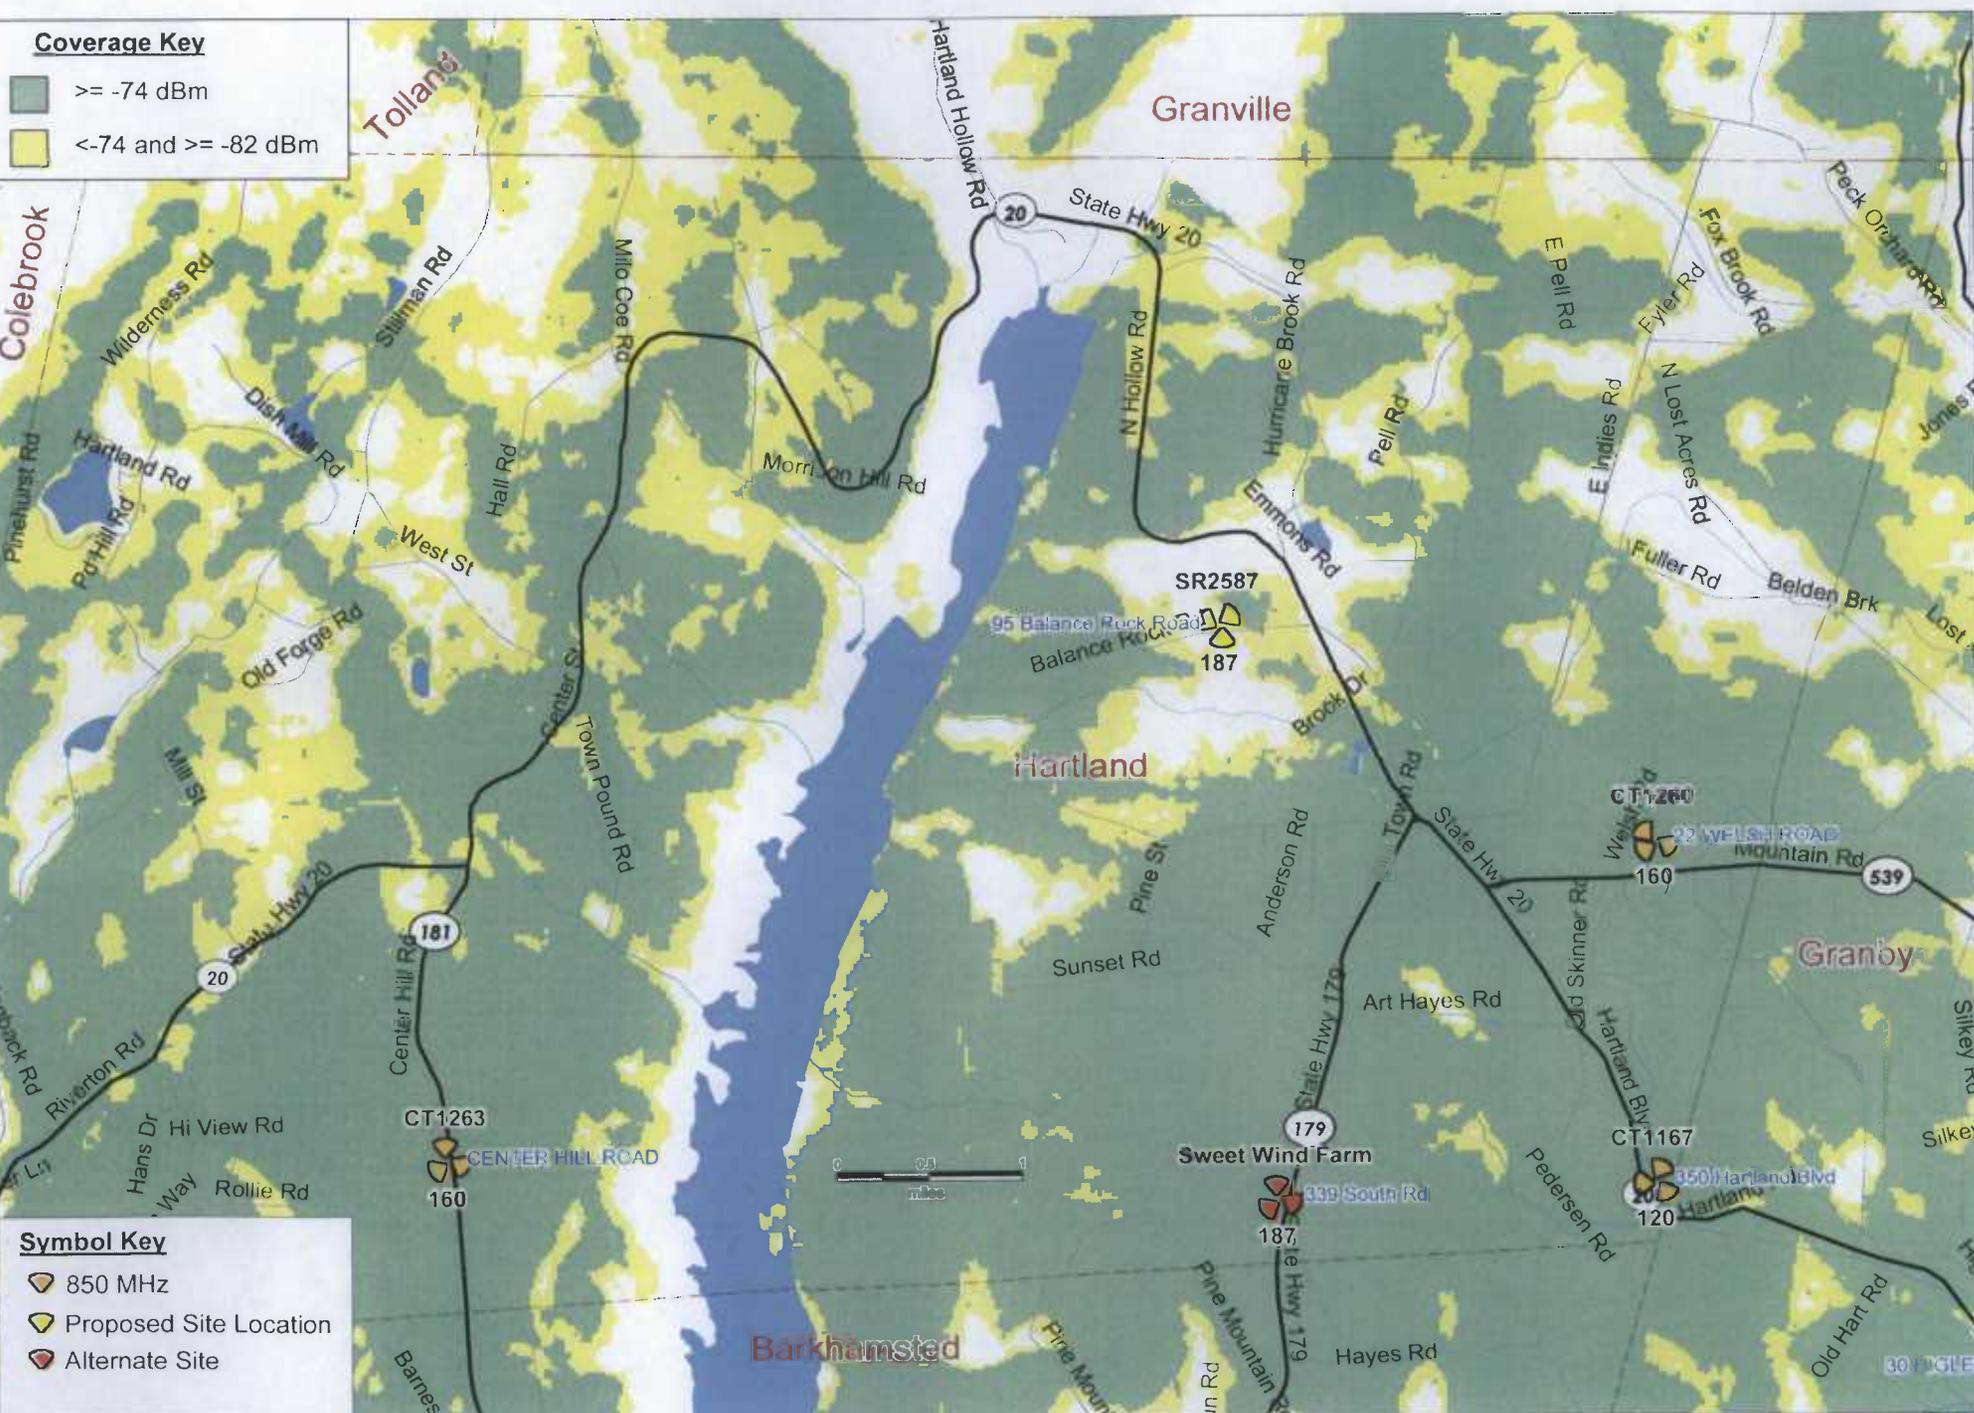
EXHIBIT B

Alternate & Existing Coverage

East Hartland, CT

A3. The property located at 339 South Road was not considered as part of AT&T's initial investigation of potential sites in this area of the State as it is located too far south of the area where service is needed. AT&T's RF engineers subsequently analyzed this location at a height of 190' and confirmed that this location is too far south to provide needed service to Route 20 as demonstrated in the propagation map provided in Exhibit B.

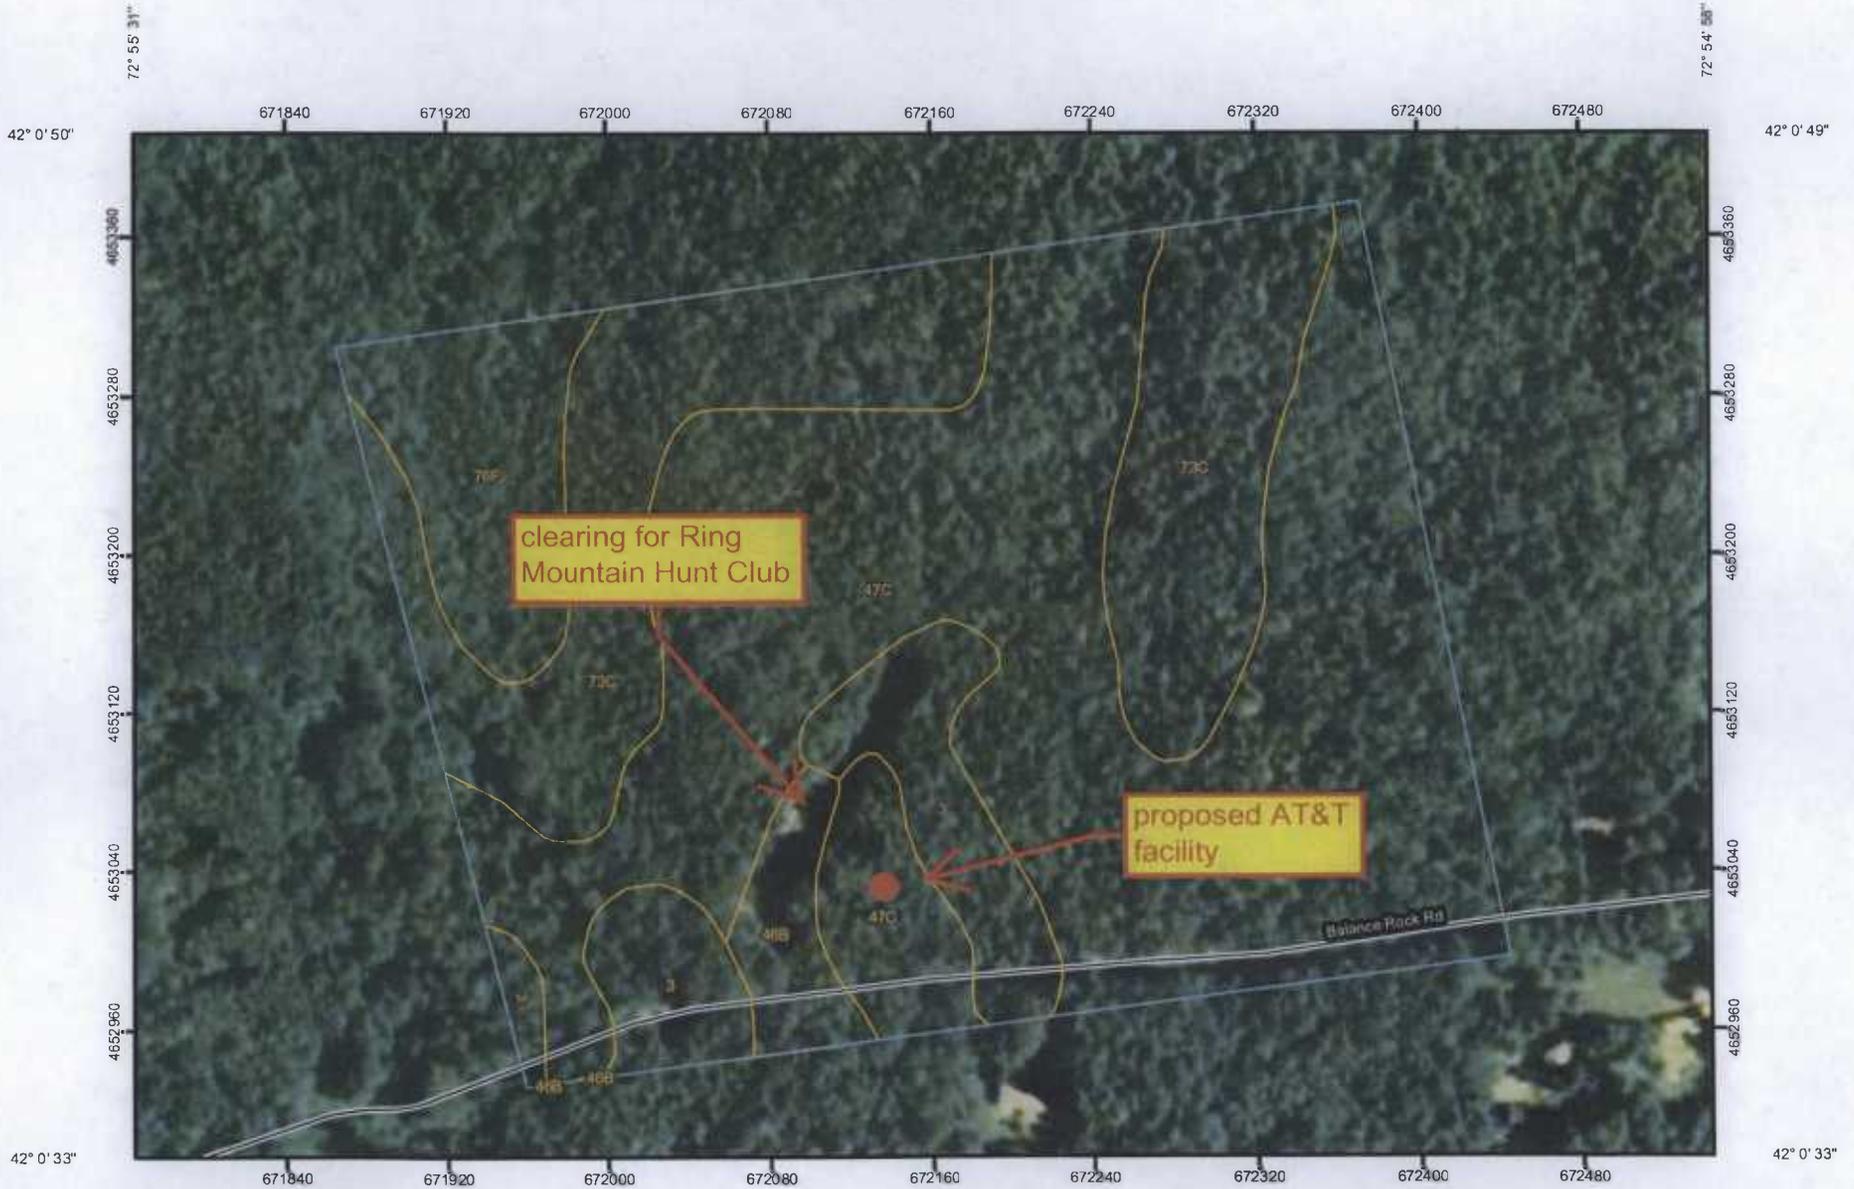
Soil Map—State of Connecticut
(95 Balance Rock Road, East Hartland, CT)

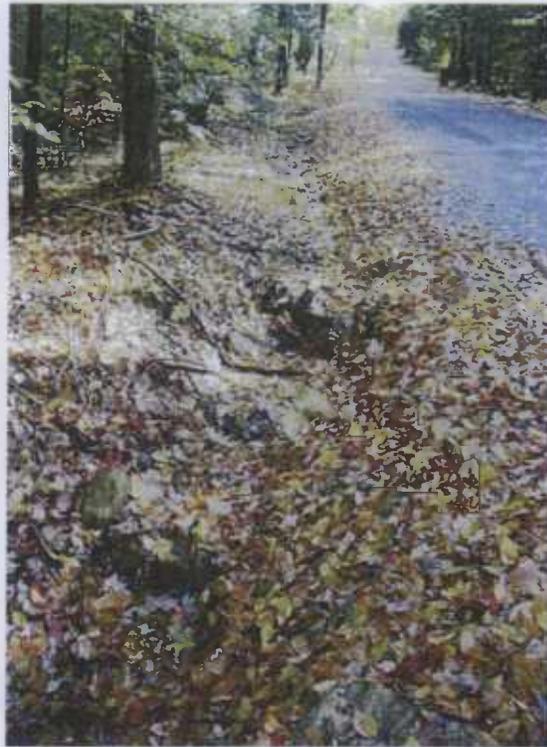
Figure 1:
View Direction: East

View of wetland drainage along road.

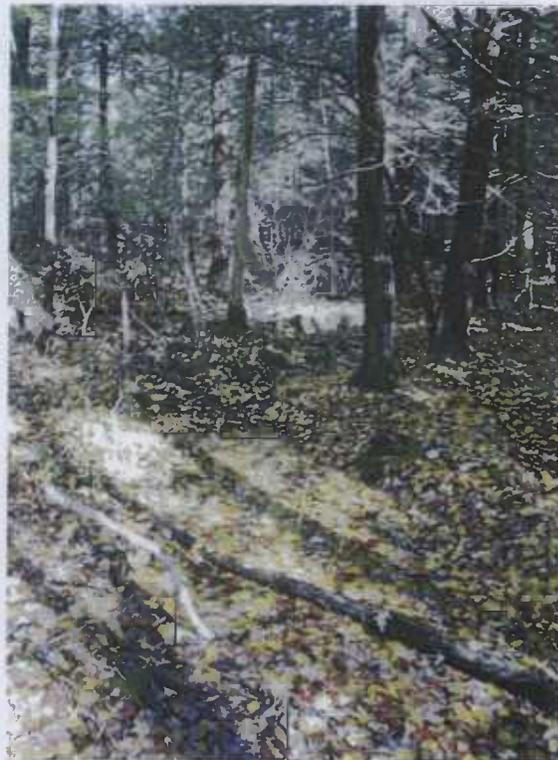
Figure 2:
View Direction: North

View of ponded area near road. Wetland continues north into forest.

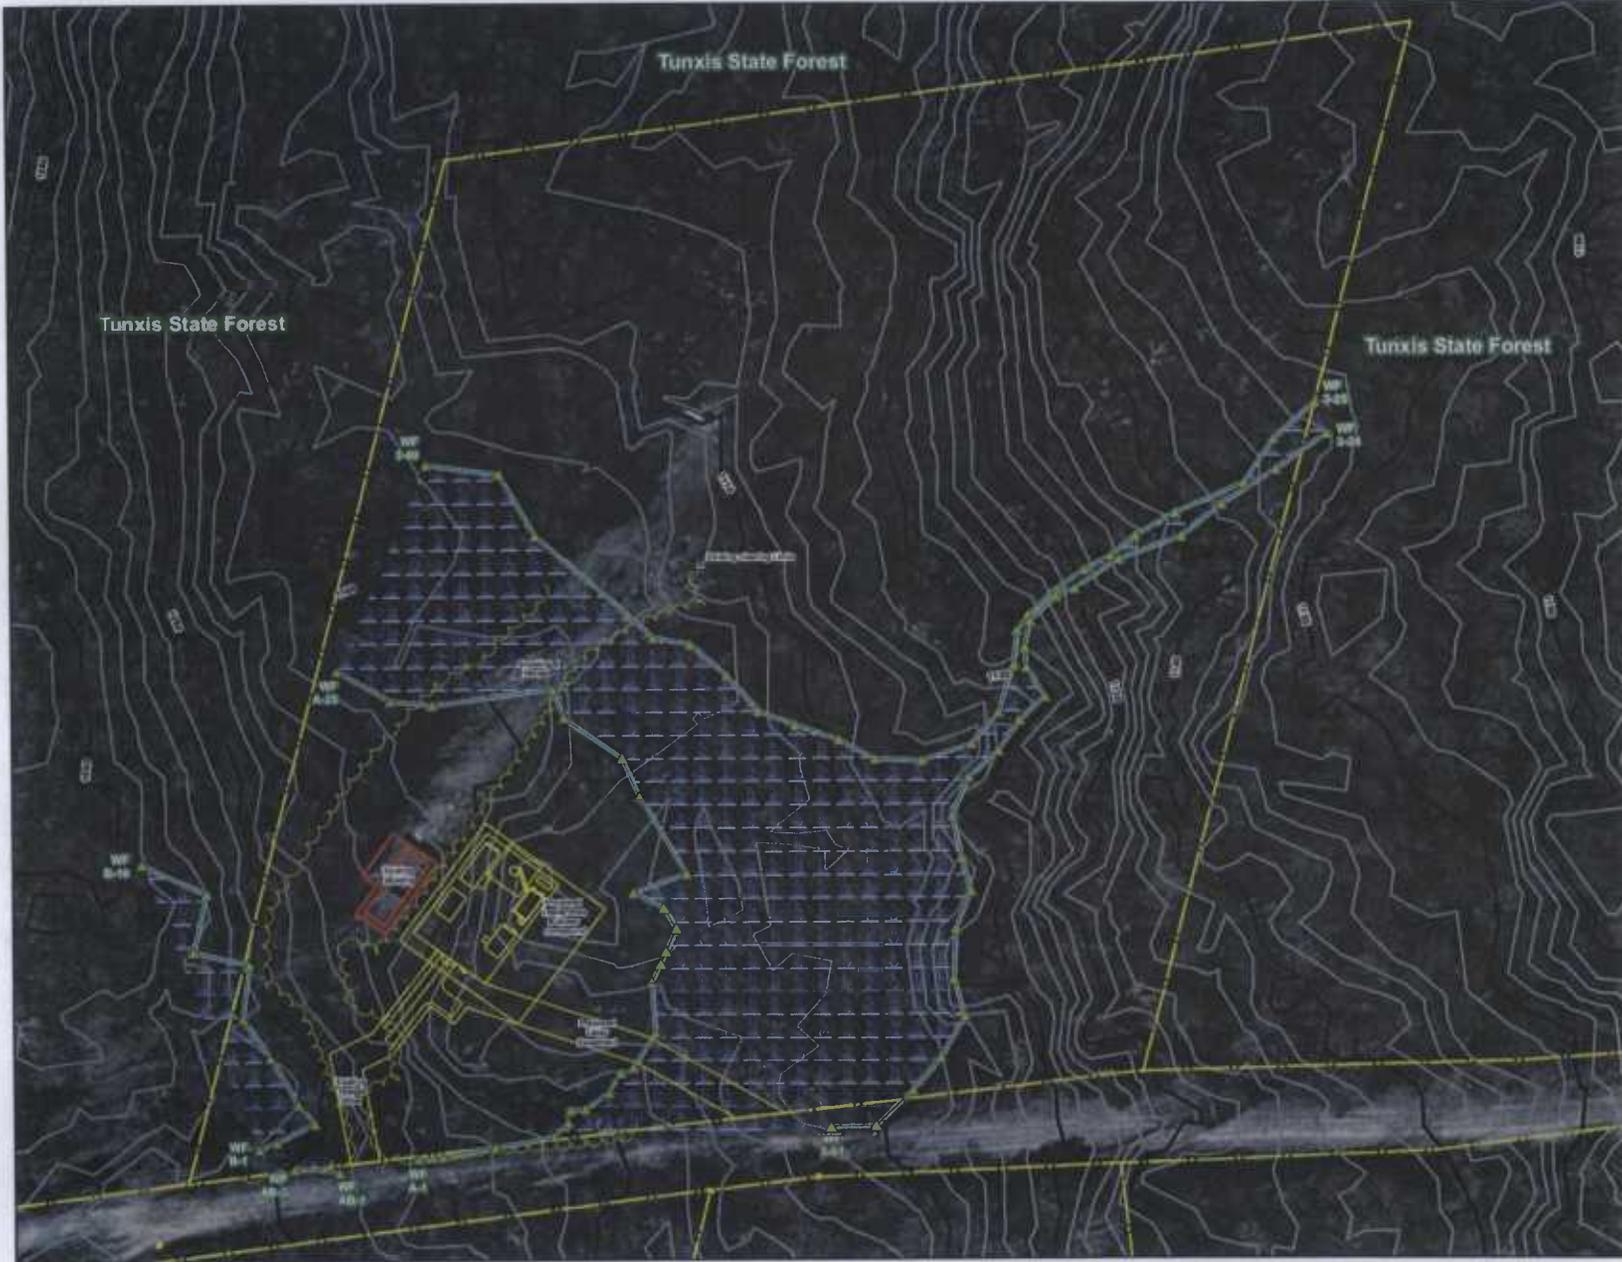
Wetland Map

Proposed AT&T Facility
 Site ID - SR2587
 West Hartland
 95 Balance Rock Road
 East Hartland, Connecticut

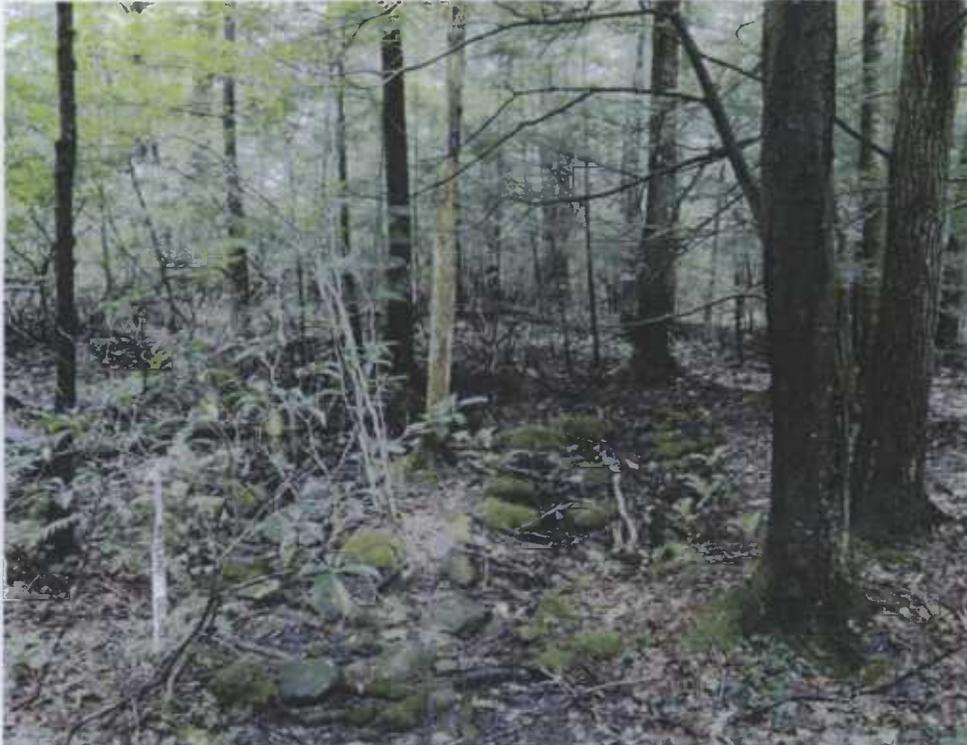
Photo 1: View of Wetland A southwestern area at start of intermittent channel, looking north.
(08/25/10)

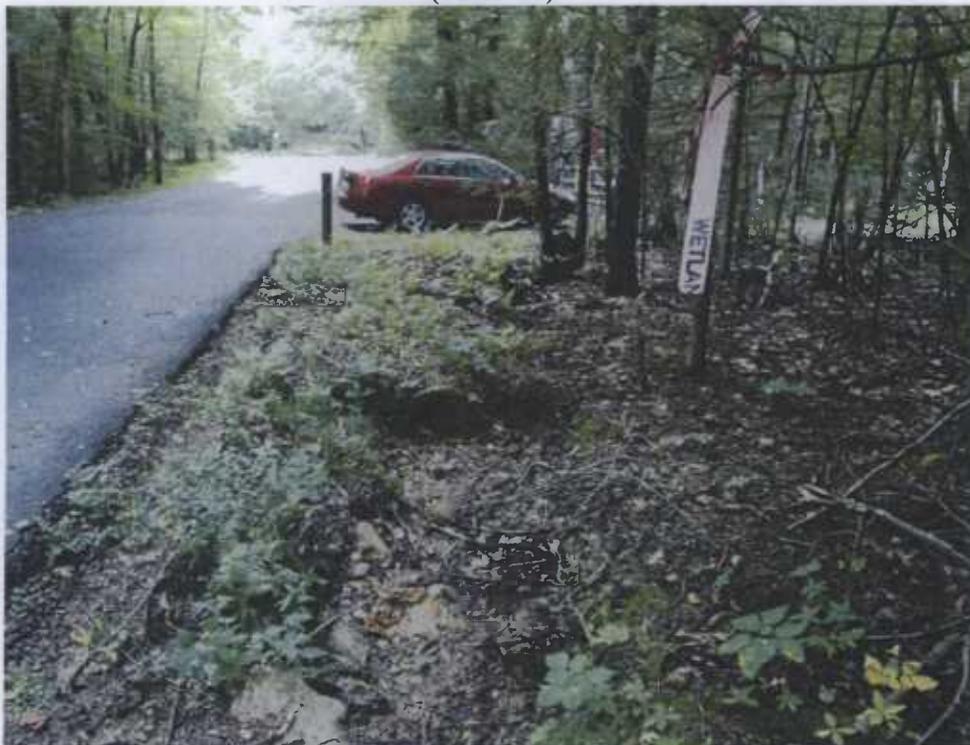
Photo 2: View of Wetland A outlet into drainage channel, looking west at existing gravel drive entrance into hunt club. (08/25/10)

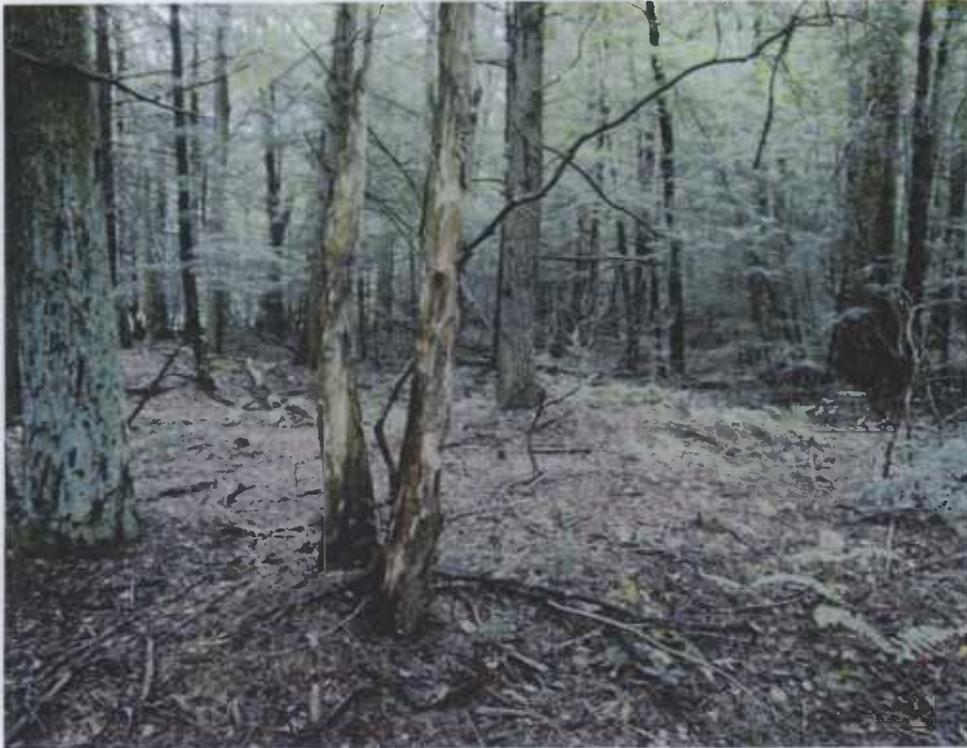
Photo 3: View of interior of Wetland A, looking north. (08/25/10)

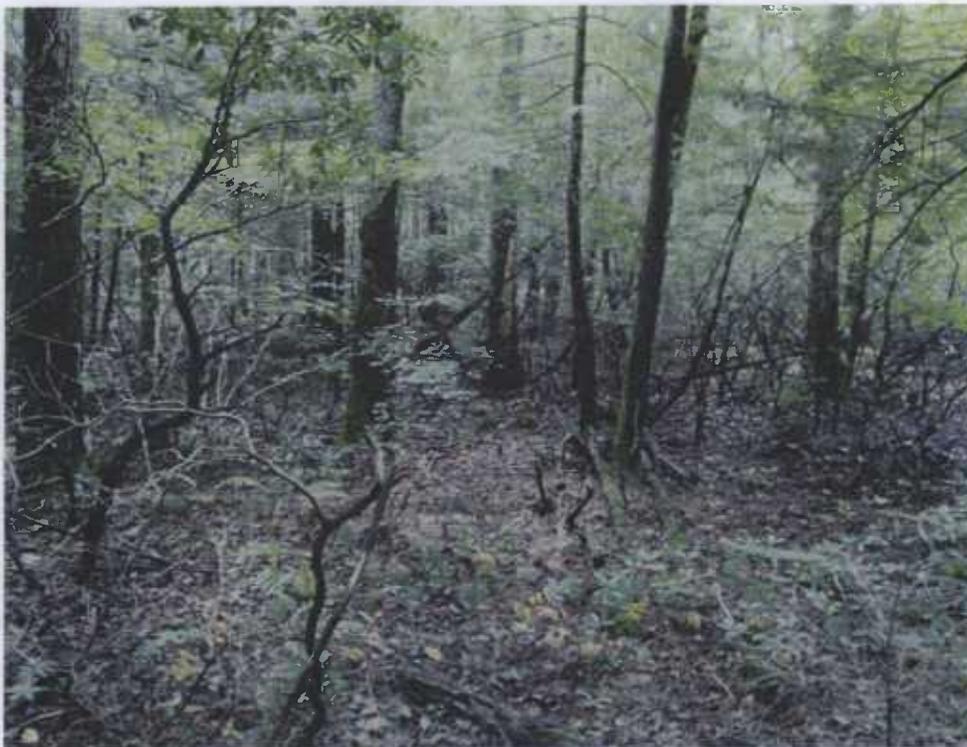
Photo 4: View of interior of Wetland A, looking east. (08/25/10)

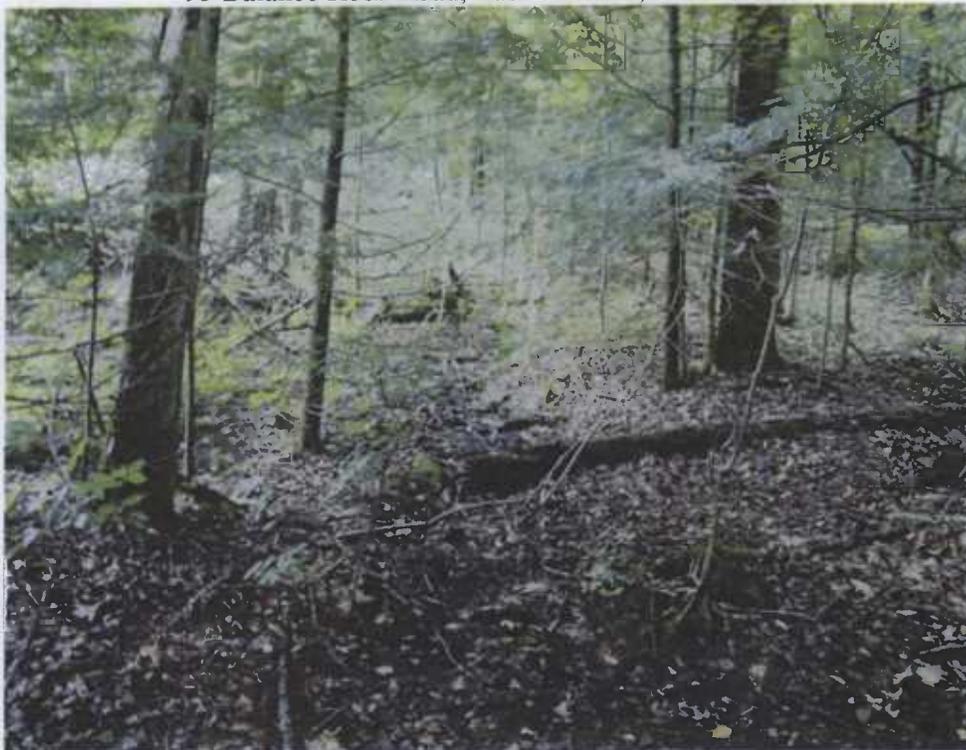
Photo 5: View of "small wet depressional area" in Wetland B identified by Kleinfelder, looking west. (08/25/10)

A12. The original wetlands report prepared by Kleinfelder delineated an area referenced as Wetland B with flag numbers B1- B4 and described it as “small wet depressional areas”, the closest being identified by flags B1-B4. Kleinfelder’s Wetland & Watercourse Delineation Report, dated December 3, 2009 is provided in Exhibit E and Attachment 4 of AT&T’s Application.

On the subject property, Wetland B appears to seasonally retain no more than 3 to 6 inches of inundation and no particular “depressional” topographic feature was observed. Refer to photo numbers 5, 6 and 10 in the Photographic Documentation provided in the updated Wetlands Delineation Report in Exhibit E.

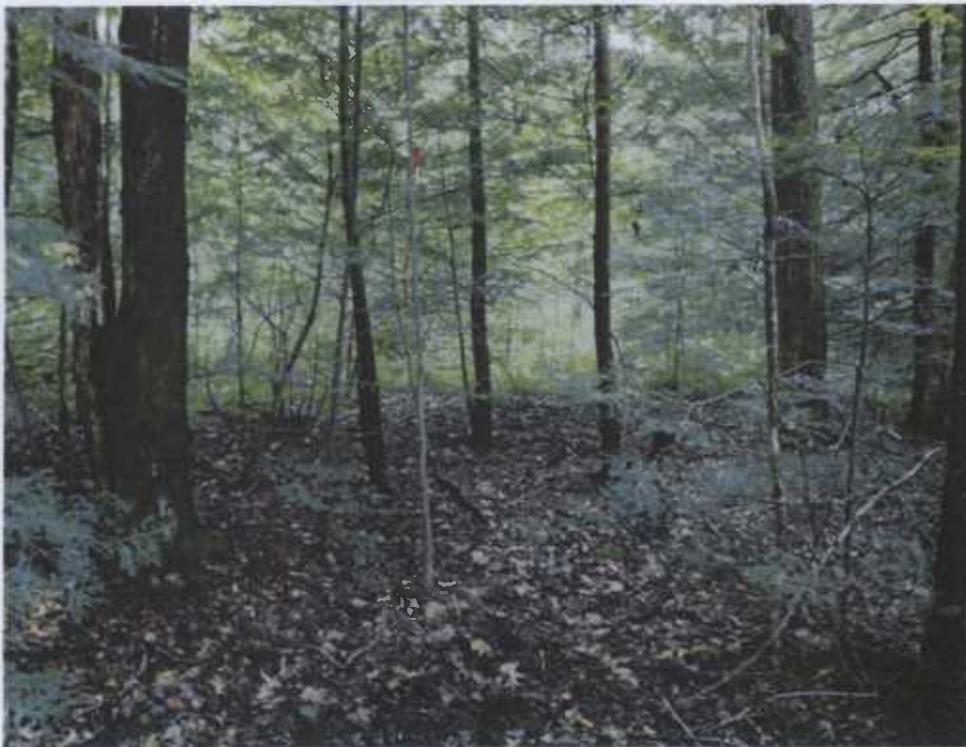
Photo 6: View of Wetland B, looking northwest. (08/25/10)

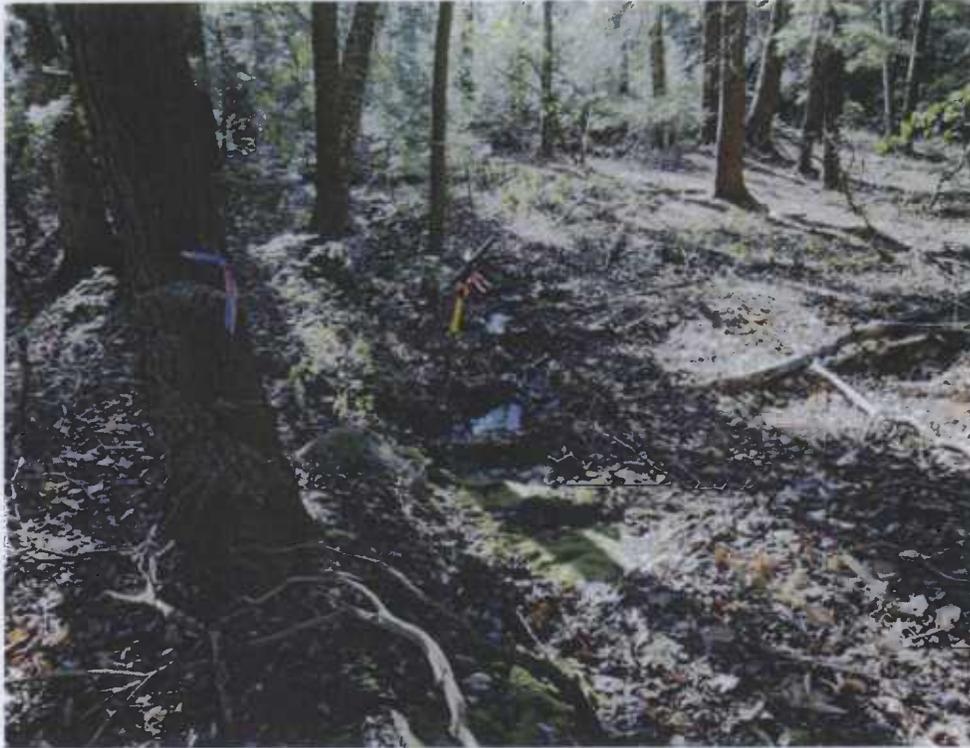
Photo 7: View of season intermittent stream in east end of Wetland A at proposed crossing (shovel), looking west. (12/09/10)

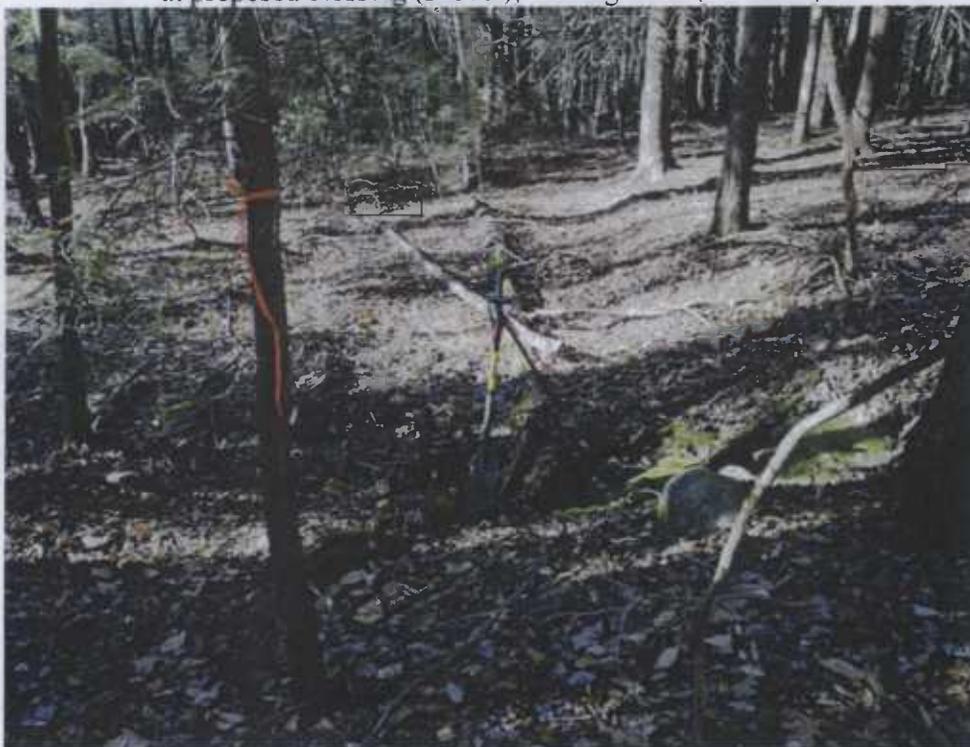
Photo 8: View of seasonal intermittent stream in Wetland A, looking north at proposed crossing (shovel). (12/09/10)

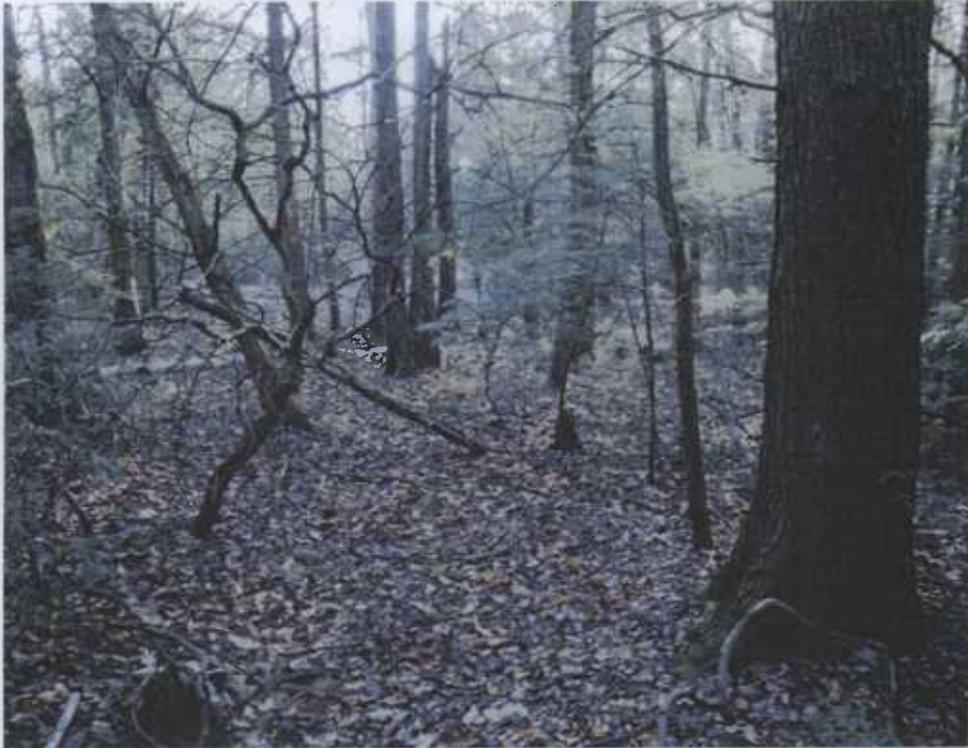
Photo 9: View of Wetland A interior, looking south (Balance Rock Road in background). (12/09/10)

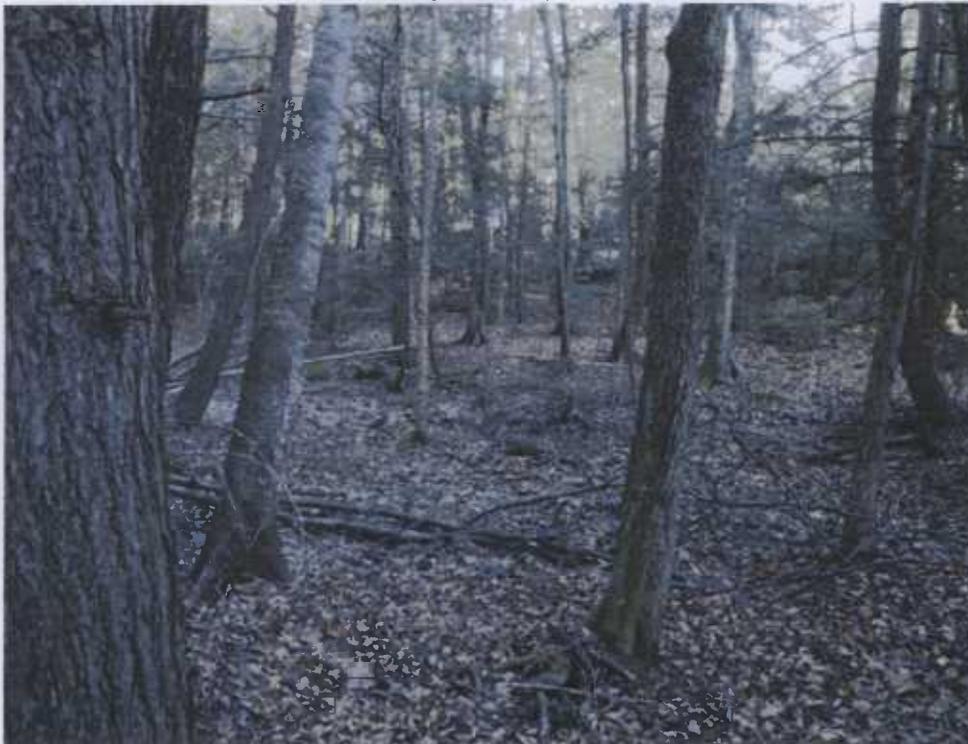
Photo 10: View of Wetland B interior on Tunxis State Forest property, looking east at subject property(hunt club in background). (12/09/10)

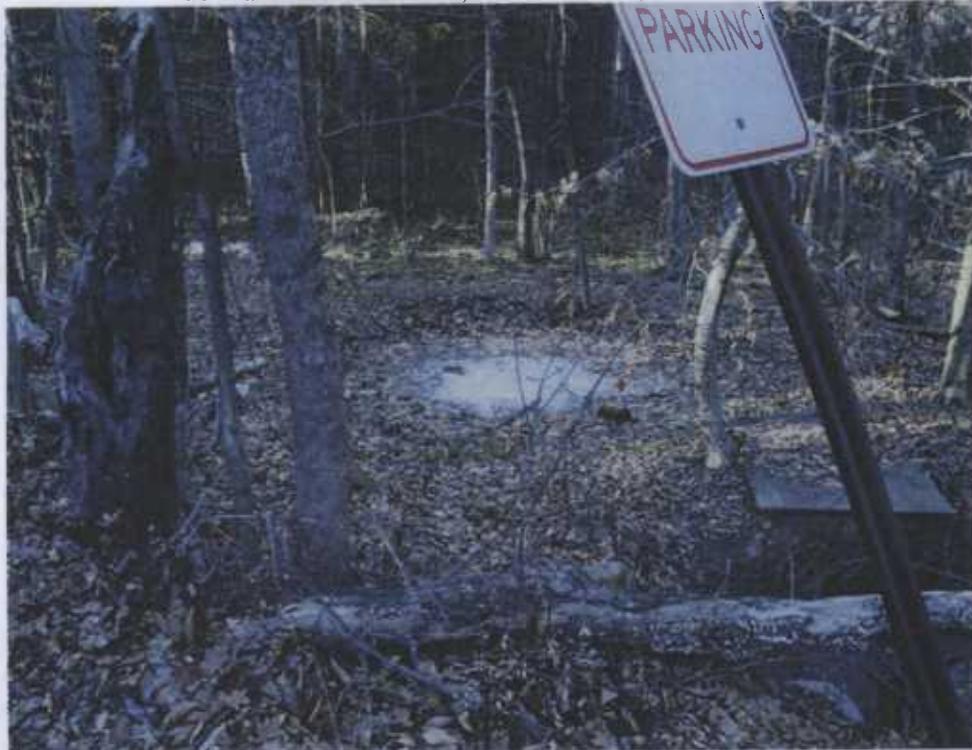
Photo 11: View of small man-made depression north of end of Balance Rock Road, looking north from road. (12/09/10)
