**BEACH EROSION CONTROL REPORT
ON COOPERATIVE STUDY
OF CONNECTICUT**

AREA 5

**PAWCATUCK RIVER
TO
THAMES RIVER**

**CORPS OF ENGINEERS, U. S. ARMY
OFFICE OF THE DIVISION ENGINEER
NEW ENGLAND DIVISION, BOSTON, MASS.**

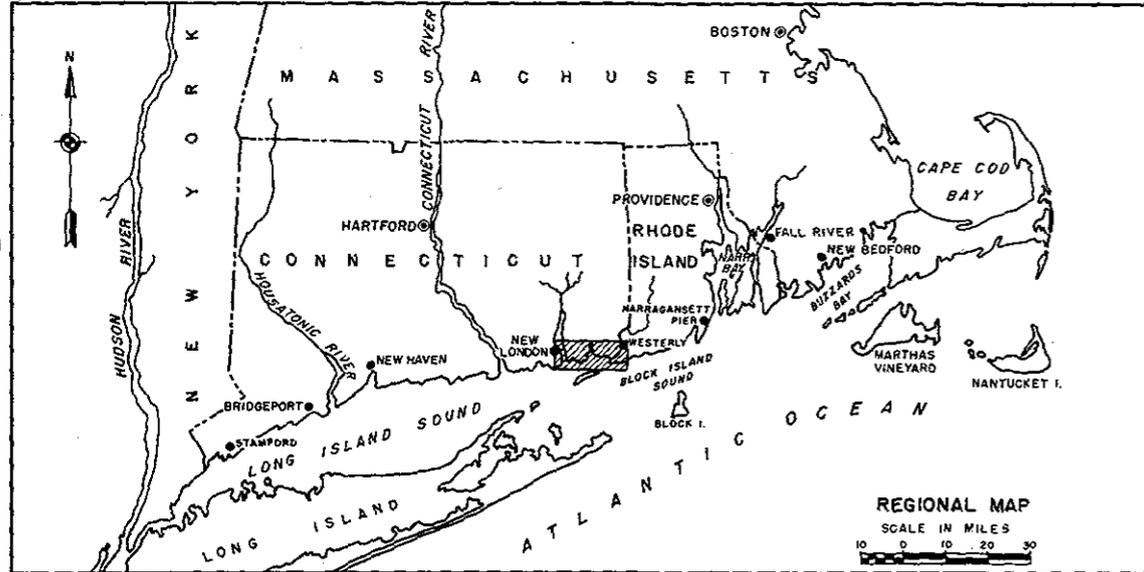
CONNECTICUT BEACH EROSION CONTROL STUDY WIND DATA NEW HAVEN, CONNECTICUT 1932 - 1942	
IN 1 SHEET NEW ENGLAND DIVISION BOSTON, MASS. JAN. 20, 1949	
APPROVAL RECOMMENDED <i>James A. Whitehead</i> CHIEF, R & M OPERATIONS DIVISION	APPROVED <i>Ed Rubin</i> LT COL, C.E., ASST. DIVISION ENGINEER
SUBMITTED <i>J. M. Rice</i> R & M PROJECTS AND REPORTS BRANCH	TRANSMITTED WITH REPORT DATED FEBRUARY 7, 1949.
DR. BY H.S.P. TR. BY S.P.D. CR. BY S.P.D.	FILE NO. B.E.C1.4

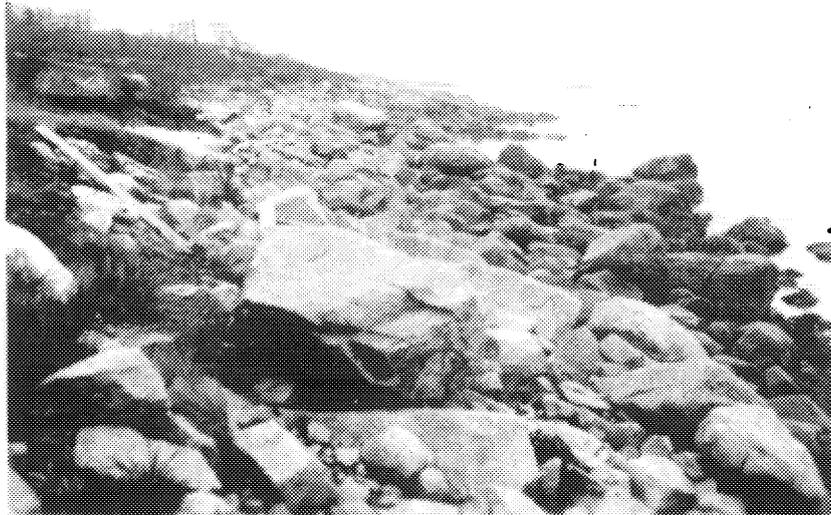
FIG. 1. PAWCATUCK POINT, STONINGTON. Jan. 13, 1950. Boulder strewn west shore.

Pawcatuck Point, Barn Island and the point at the east side of the mouth of Wequetequock Cove are strewn with boulders, apparently left as a result of removal of finer materials. The seaward shore of Elihu Island now consists largely of bare bedrock. Bedrock is exposed at points along the shore west of Elihu Island. Available data indicates that the only appreciable shore line recession during recent years has occurred along areas now composed of marsh. The area is sheltered by Napatree Beach and Sandy Point and offshore breakwaters. It is very sparsely settled. In 1950, it was noted that construction of the first two houses was underway at Pawcatuck Point. There were no buildings along the shore of the Barn Island Waterfowl Area. Elihu Island and the shore west of it known as the Stuart Estate were each occupied by one residence and some farm buildings. The only sandy beaches existed in the form of two sandy barrier bars in indentations of the marsh of the Barn Island Waterfowl Area. Due to widespread pollution from the Pawcatuck River, the area is considered unsafe for bathing although limited use is made of the shore for this purpose. No plan of improvement is considered necessary at the present time.

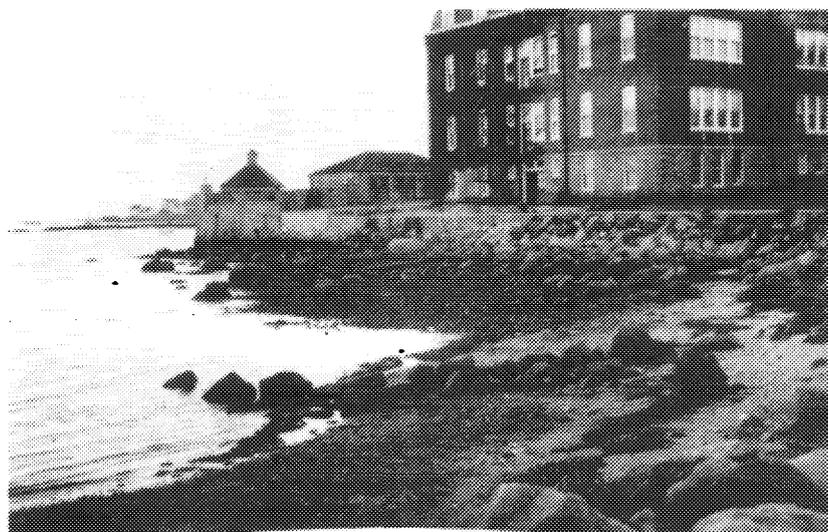
FIG. 3. BOROUGH SCHOOL, STONINGTON. Oct. 28, 1947. Coarse shore, dumped riprap revetment at sea wall.

- (8) Protective Structures: Low masonry sea wall and riprap revetment at Stonington Borough School, high masonry walls south of school, loose stone wall and riprap breakwater north and east of sandy pocket beach, masonry walls and riprap along portions of sandy pocket, masonry walls south of sandy pocket.

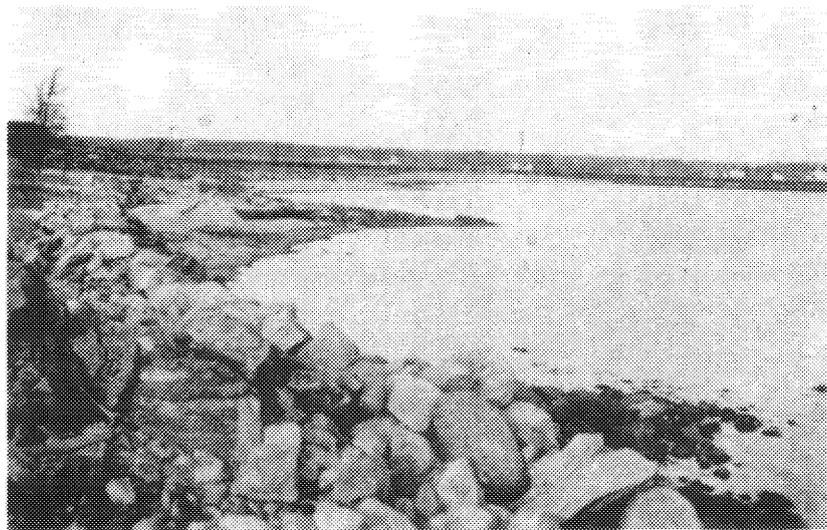
FIG. 2. WAMPHASSUCK NECK, STONINGTON. Jan. 12, 1950. Sand held on south side of groins and railroad embankment.

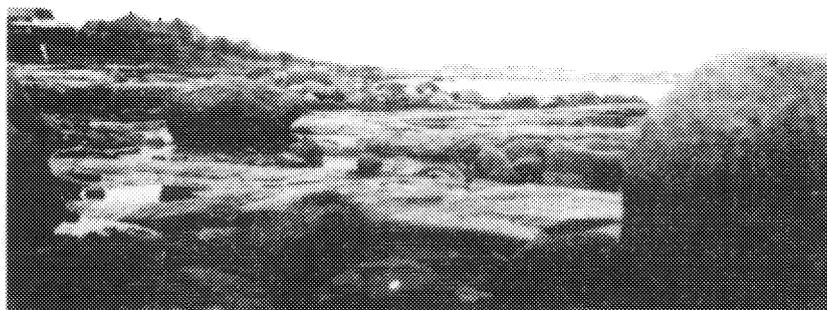
FIG. 3. WAMPHASSUCK POINT, STONINGTON. Oct. 29, 1947. Boulders and bedrock at south tip of point.

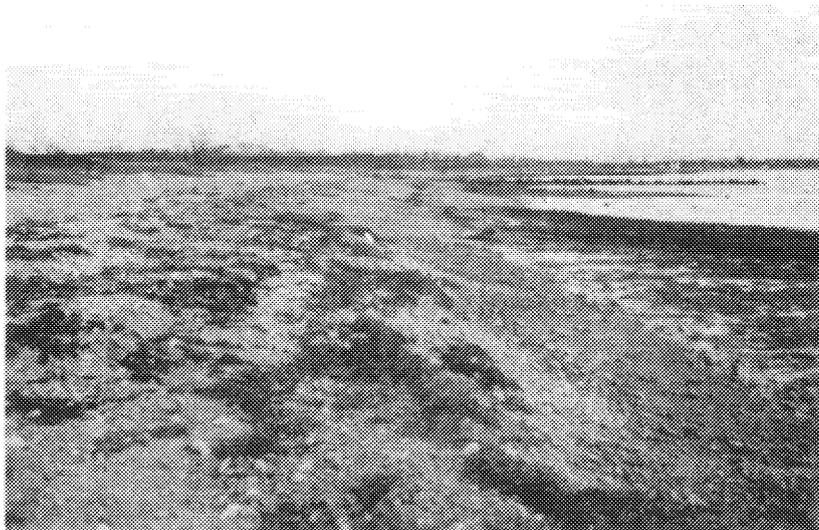
FIG. 3. BAR WEST OF QUAMBAUG COVE. Jan. 12, 1950. Bar retreating landward over marsh.

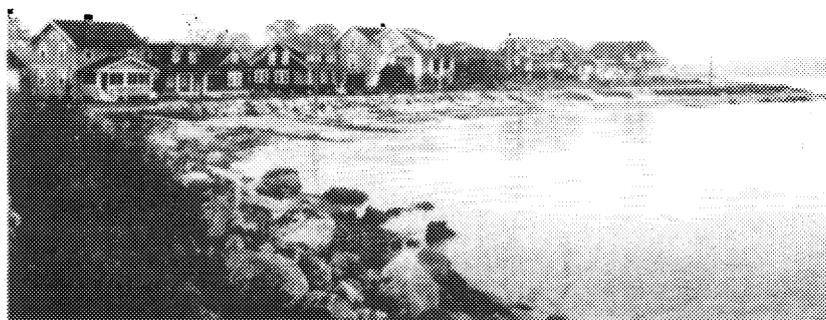
FIG. 3. EAST SHORE GROTON LONG POINT, GROTON. Oct. 27, 1947. Low shore area subject to flooding during storms.

of this road are low in elevation and subject to flooding. Cottages have been built along the landward side of the road at these low-lying areas. Dumped riprap has been placed along the edge of the road, but this form of protection is inadequate to prevent flooding. Complete protection requires the construction of some form of water-tight barrier. The flooding of this area is regarded as creating a temporary inconvenience and nuisance. So far as is known, there are no costly damages resulting which would justify the expenditure needed for the type of protection required. No definite plan of protection has been considered. Construction of groins along the shore in an effort to build up sandy beaches has not achieved the desired result, except along the northerly end of the area. This is due to lack of available sources of supply of littoral drift material. Improvement of the composition of the shore would require direct placement of sand and the construction of groins at the north limit of fill areas to retard the movement of sand northward by littoral currents. Since sufficient recreational area is available for residents at the nearby main bathing beach, no consideration has been given to development of additional areas.

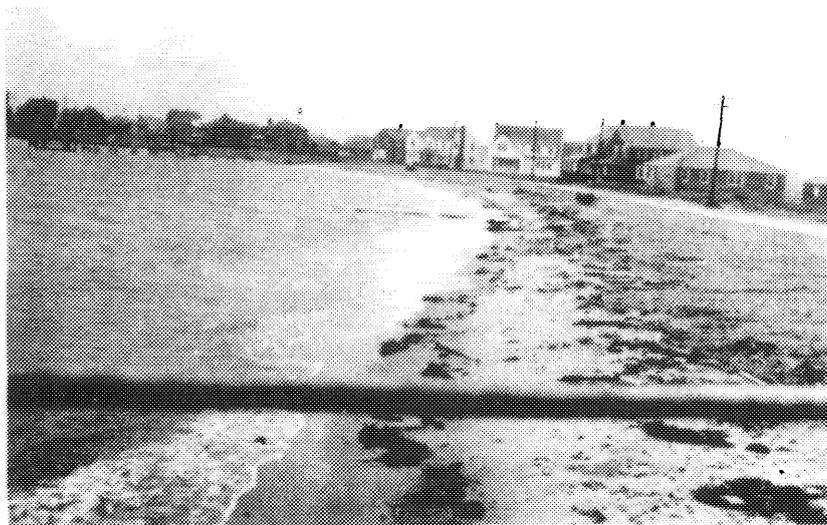
FIG. 1. SOUTH BEACH, GROTON LONG POINT, GROTON. Jan. 10, 1950. Newly built sea wall protects road and low cottage area.

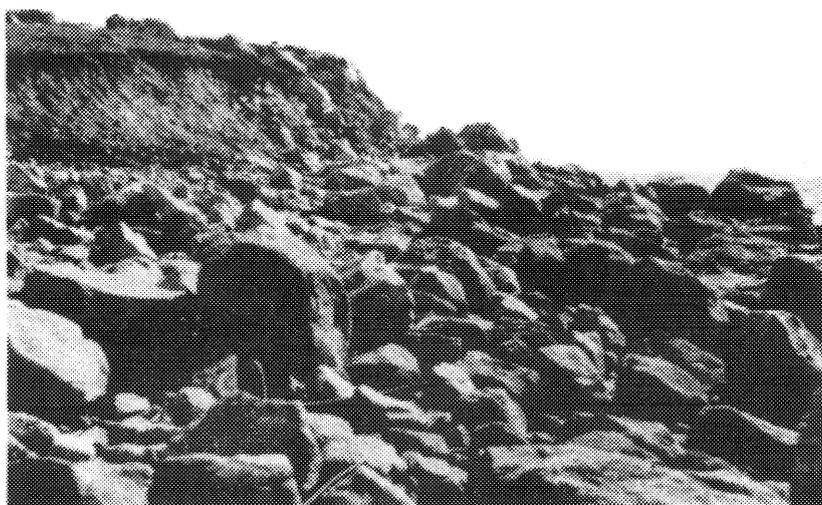
FIG. 3. BLUFF POINT, GROTON. Oct. 15, 1947. Boulders left along shore from erosion of bluff.

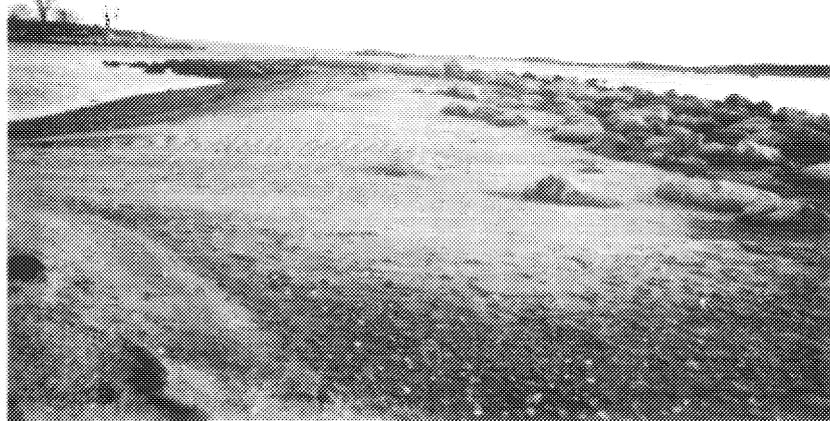
FIG. 2. JUPITER POINT, GROTON. Nov. 17, 1947. Low outer tip of point used as bathing beach.

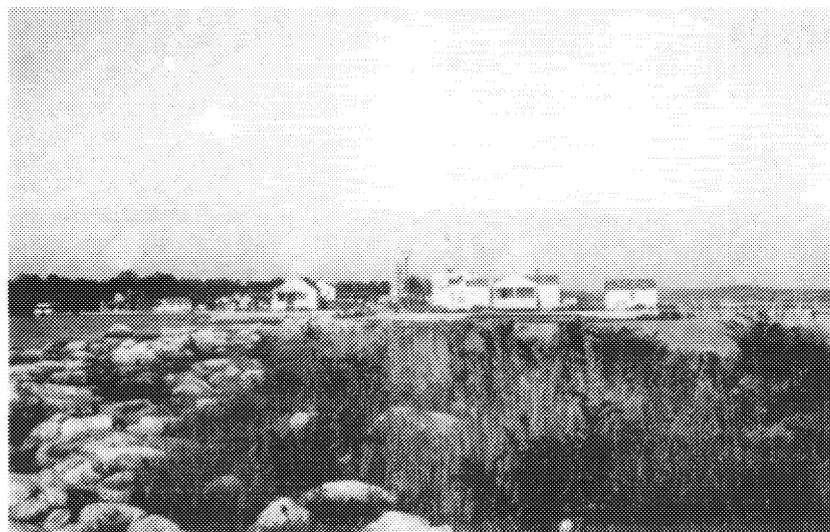
FIG. 3. JUPITER POINT, GROTON. Oct. 15, 1947. Low cottage area viewed from south tip of point.

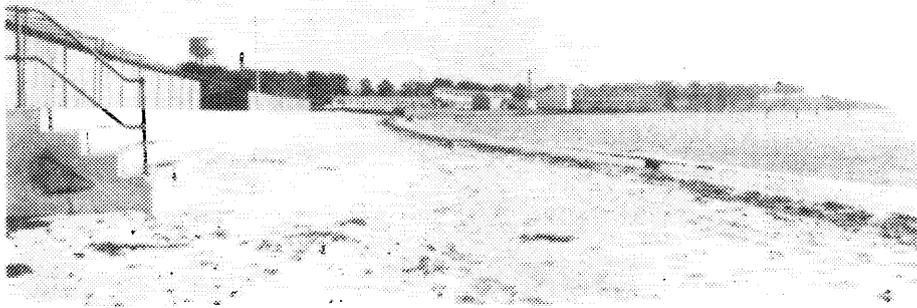
FIG. 1. SHENECOSSETT BEACH AND AVERY POINT, GROTON. Oct. 15, 1947. Sandy private bathing beach in foreground. Avery Point in background.

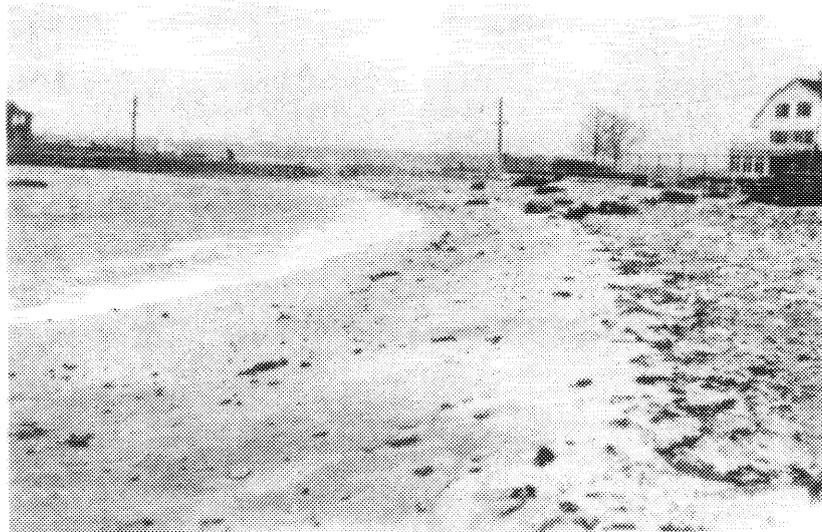
FIG. 2. EASTERN POINT BEACH PARK, GROTON. Jan. 9, 1950. Sandy public bathing beach at Eastern Point.

55. Eastern Point Beach Park. - The plan considered consists of direct placement of sand to widen the narrow west end of the bathing beach and enlargement of an impermeable groin at the east boundary of the park. The bathing beach is the south shore of the park extending 400 feet eastward from Eastern Point. The west end of the beach is subject to erosion by eastward drifting of sand, necessitating annual replacement of losses by artificial means. Beach losses are also effected by waves washing sand over the narrow beach and low wall and road behind it. The amount of beach area available for recreational use is small. This area is further limited by the existence of boulders and other coarse material in the fore-

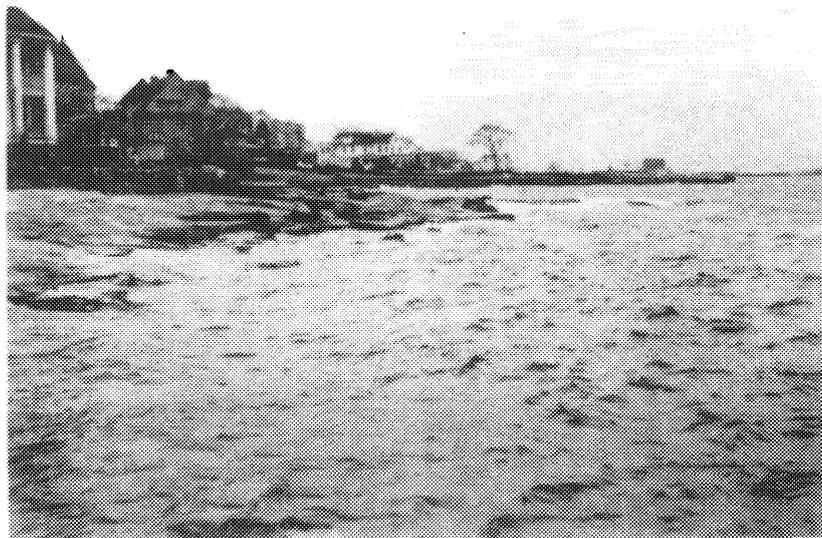
FIG. 3. EAST SHORE NEW LONDON HARBOR, GROTON. Jan. 9, 1950. Irregular bedrock shore.
