REPORT
ARCHAEOLOGICAL AND HISTORICAL RESOURCES ASSESSMENT
CEPA EVALUATION

HAMMONASSET BEACH STATE PARK
MADISON, CONNECTICUT

Prepared for Fuss and O'Neill, Inc.

March 2008

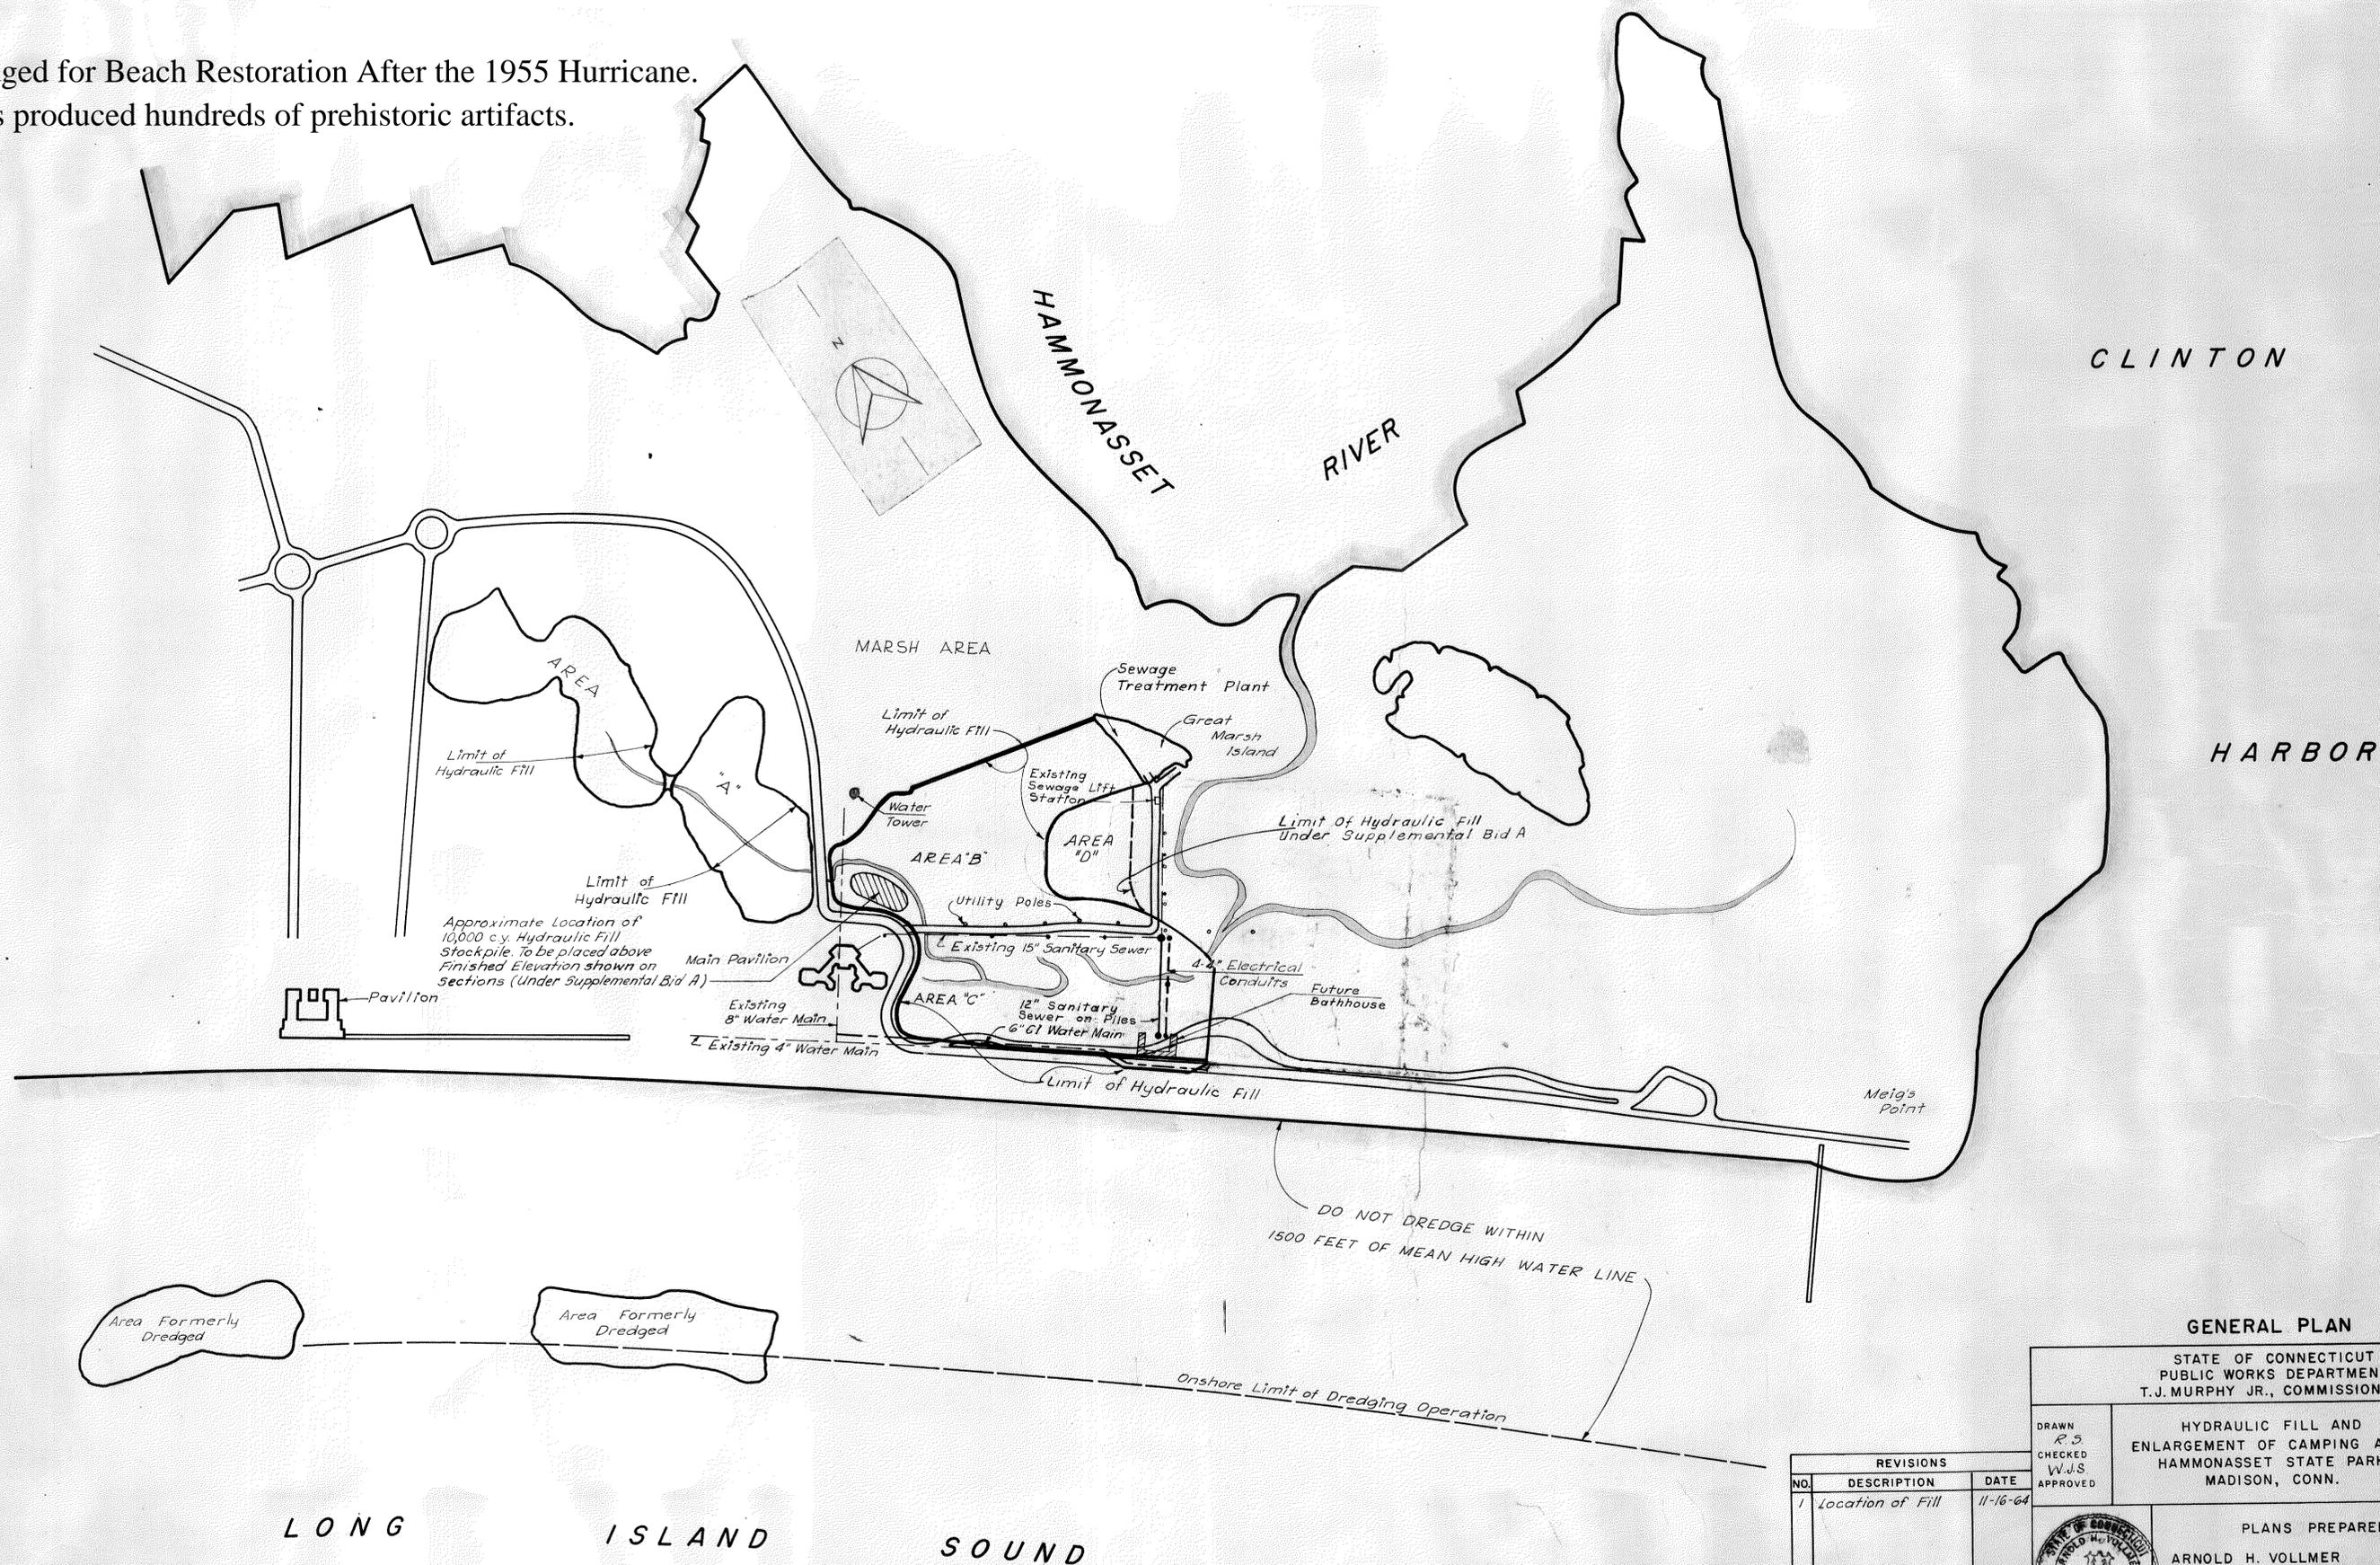
Figure 3:
 Areas Dredged for Beach Restoration After the 1955 Hurricane.
 These areas produced hundreds of prehistoric artifacts.

Dredging work in the offshore area of Hammonasset Beach in the 1950s resulted in the discovery of the richest known inundated prehistoric site in the Northeast because the deposition of offshore sands on the beach resulted in the identification of prehistoric sites in the sands. In addition, the state site files list numerous prehistoric sites in the coastal and near-coastal areas in the HBSP vicinity, attesting to the attraction of the area for prehistoric peoples. The Hammonasset Beach and Clinton Harbor areas should be considered highly sensitive cultural landscapes. The following recommendations apply to potential prehistoric-period archaeological remains within the HBSP project area:

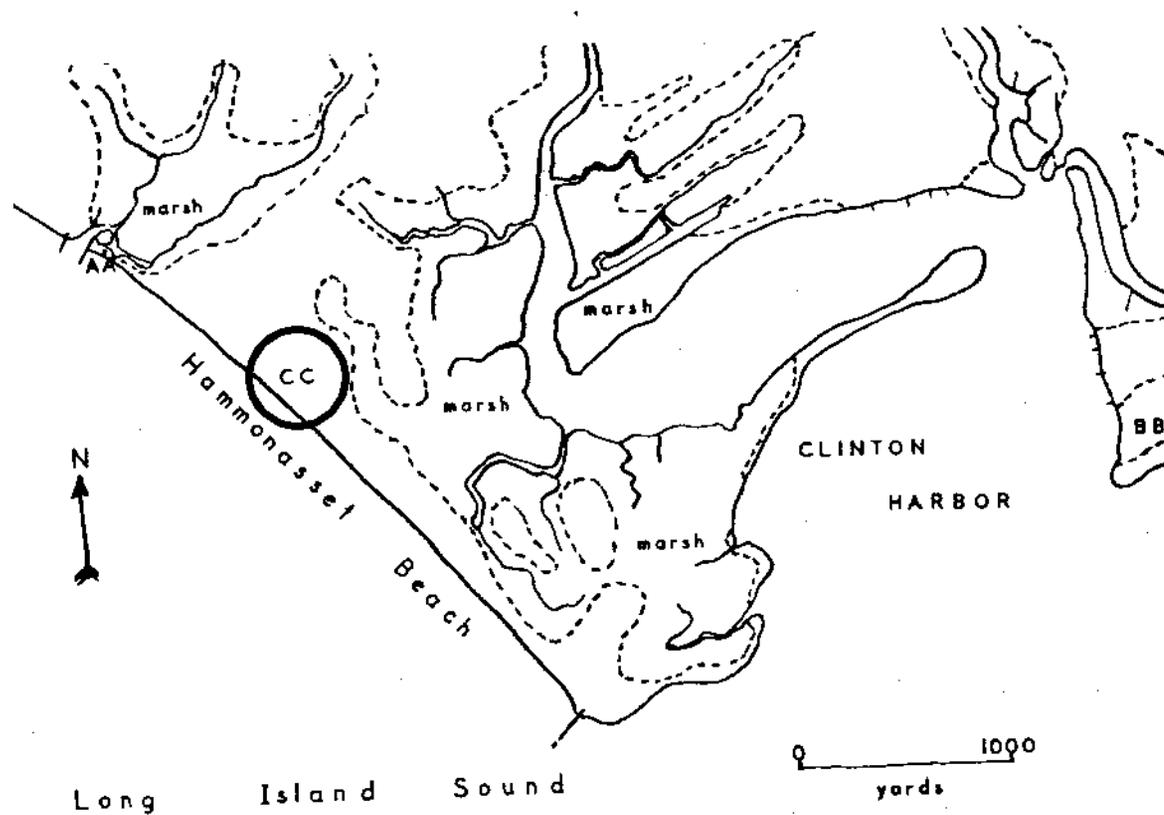
Figure 5. Location of Artifacts recovered from the Plowed Field

Area 'CC' represents the approximate location of artifacts found in a plowed field in the park.
 Areas 'AA' and 'BB' represent peat exposures (Bourne 1977).

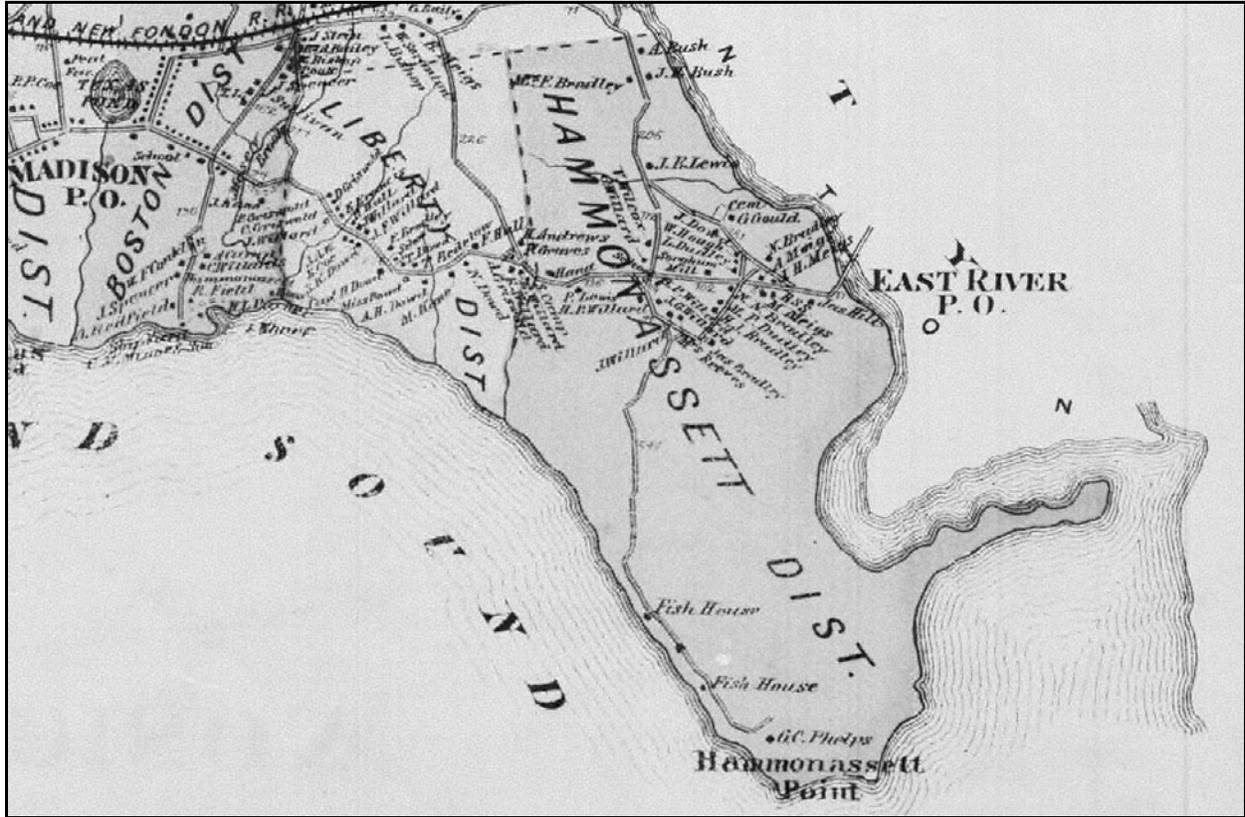
Figure 11: Hammonasset Point as shown on the 1868 Beers atlas map. The Nature Center farmhouse is shown as the property of G. C. Phelps, and two “fish houses” are shown along the road.

No evidence of earlier park buildings or structures was observed during the walkover, nor could anything be discerned of the Winchester Repeating Arms Company target butt cited by Dunn (1973) or of the two "fish houses" shown on the 1868 map (Figure 11). However, the back side of the dune is heavily overgrown with roses, cattails, and tall grasses, and it may be that the vegetation obscured evidence of these structures (Photograph 11). It is also possible that natural and human-initiated dune-building actions have buried remains in sand to the point that they are no longer readily visible.

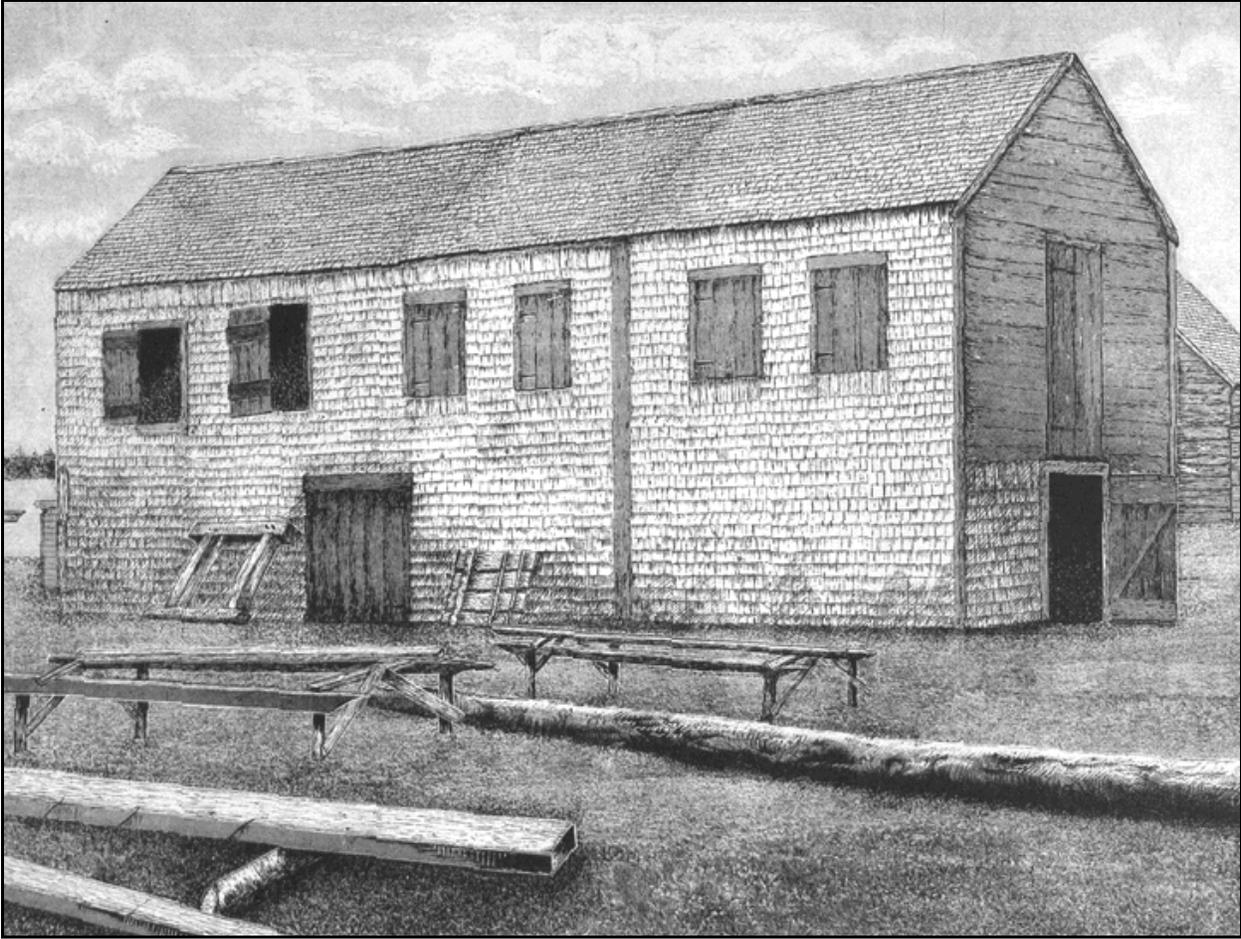
Figure 12: Traditional New England fish house for preparing dried or smoked fish (from Goode 1887).

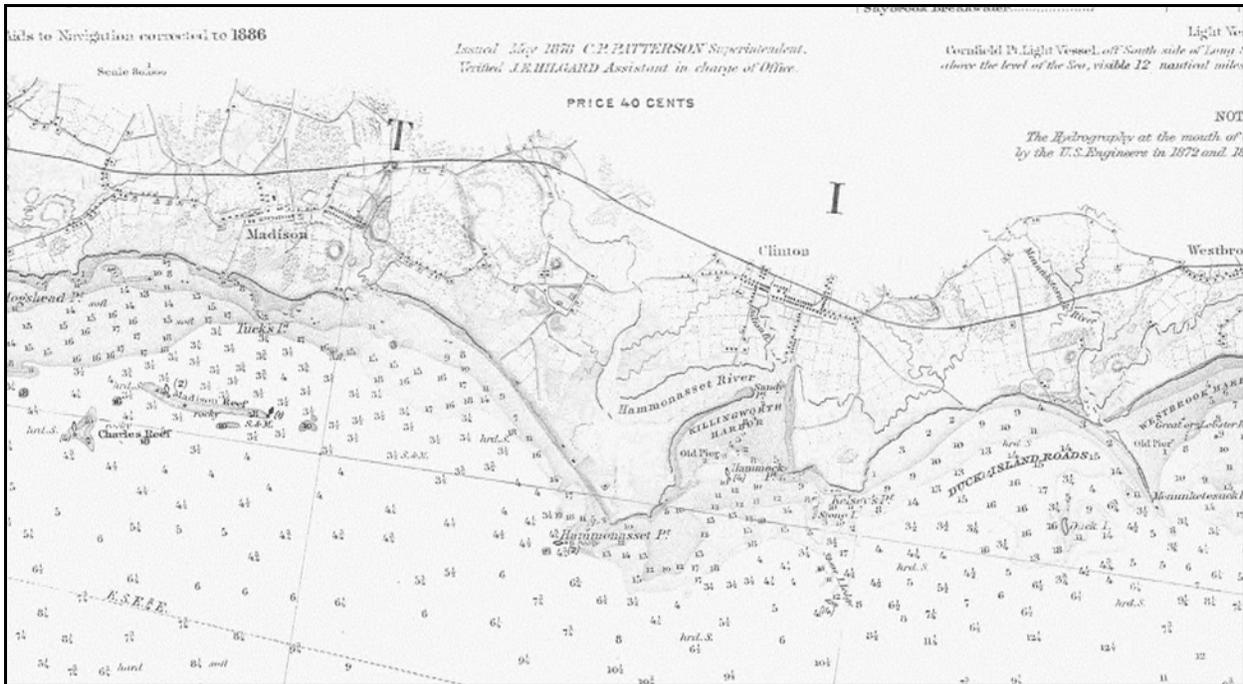
Figure 13: Hammonasset Point as shown on Chart 115 (1886). Three buildings, probably the farm house and fish houses, are shown just back from the beach.

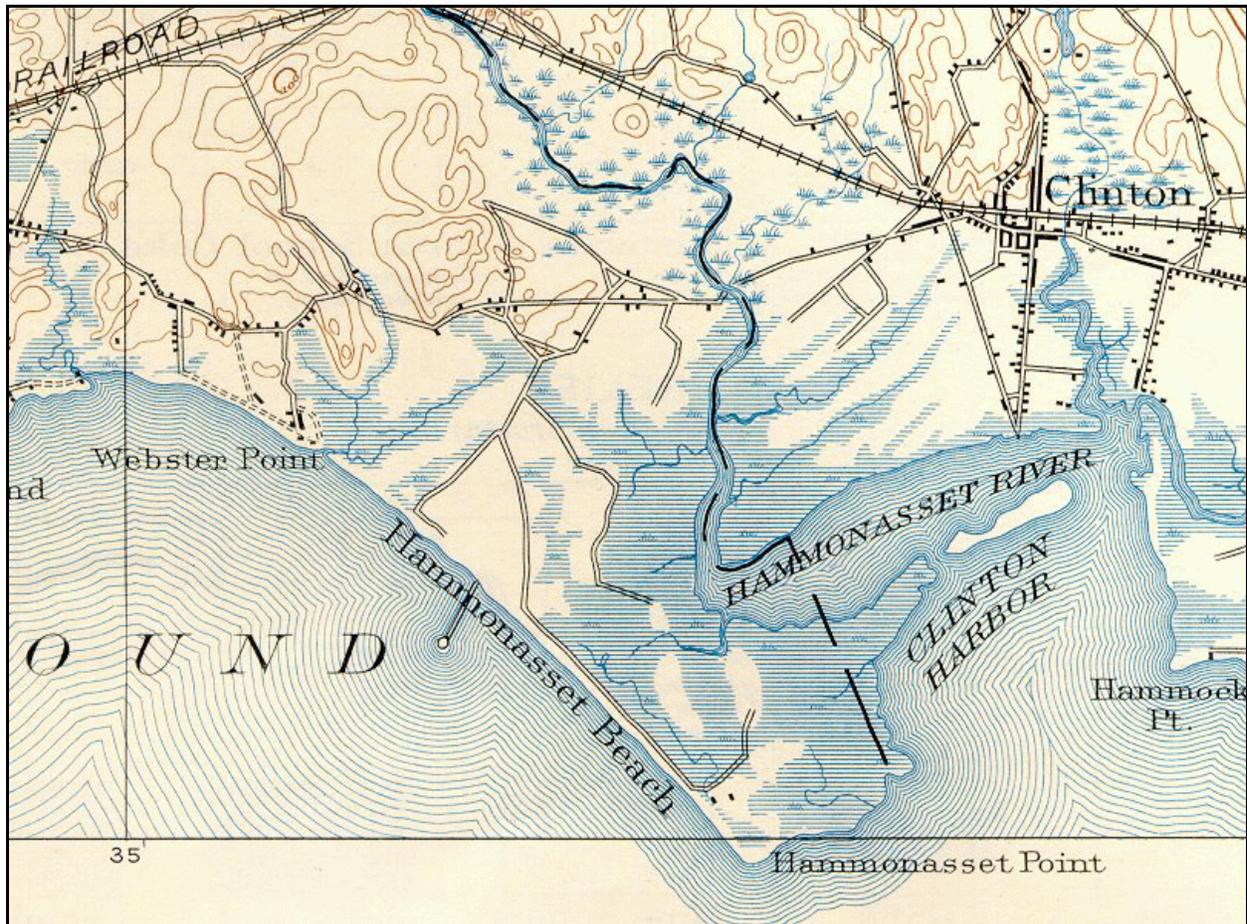
Figure 14: Hammonasset Point as shown on the 1893 U.S.G.S. Guilford Quadrangle, surveyed in 1890. Only two buildings are shown, both at the Meigs Point farm. The structure shown extending into the Sound from the north end of the beach does not appear on any other maps or charts.

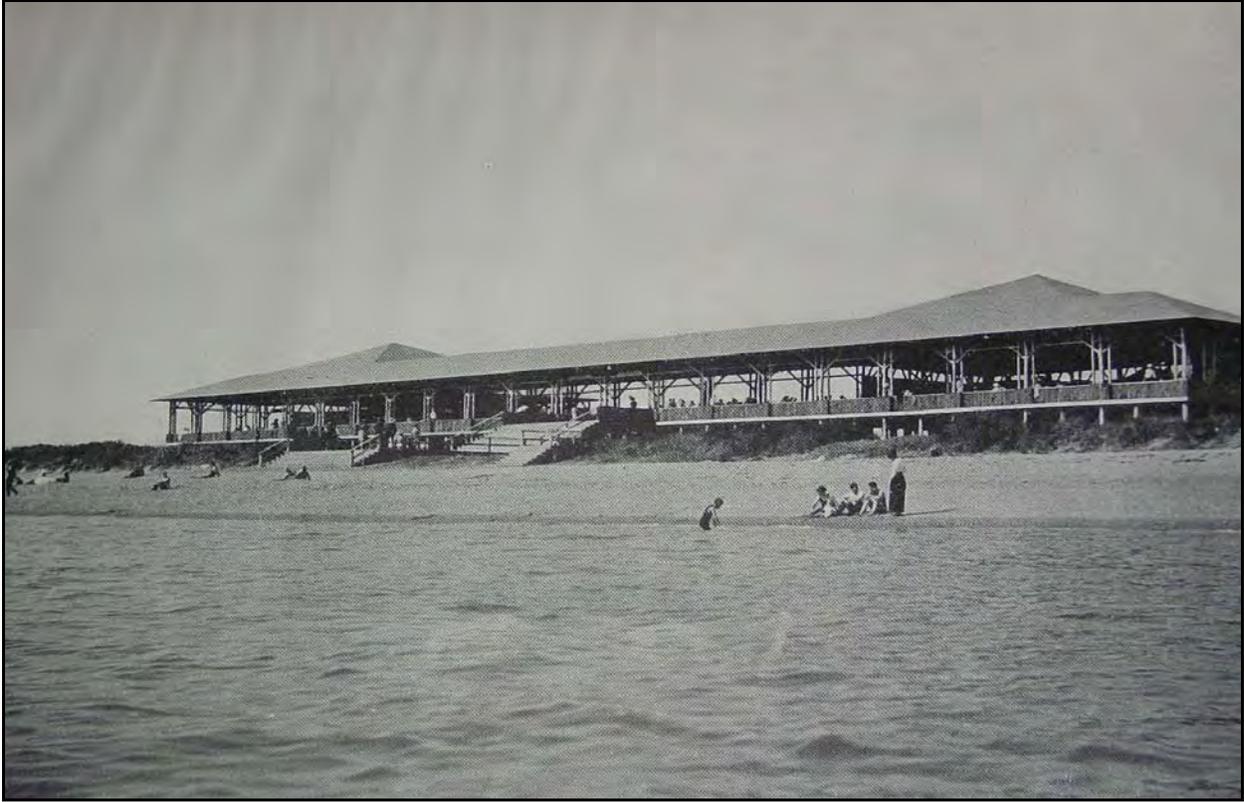
Figure 16: Pavilion at Hammonasset Beach shortly after construction, from State Parks and Forests Commission, *Annual Report*, 1920.

Hammonasset was identified as a priority acquisition by the newly created Connecticut State Parks and Forests Commission in 1914, but it was not until 1919 that funds became available to actually purchase the land. The state lost no time in creating camps sites, parking areas, roads, and a large pavilion that accommodated changing rooms and toilets; that pavilion (Figure 16) lasted until 1967. The park was first opened to the public on July 18, 1920. The next season, a restaurant called the Clam Shed was erected some 600 feet east of the Grand Pavilion, to which it was connected by a boardwalk. In 1923 additional purchases of land almost doubled the park's size; that year, 228,700 visitors enjoyed the park. Some time around 1900, at least four families had built beach-side cottages at Hammonasset; these pre-existing cottages were re-located, along with a newly built cottage, to the Cedar Knoll area for use as rentals.

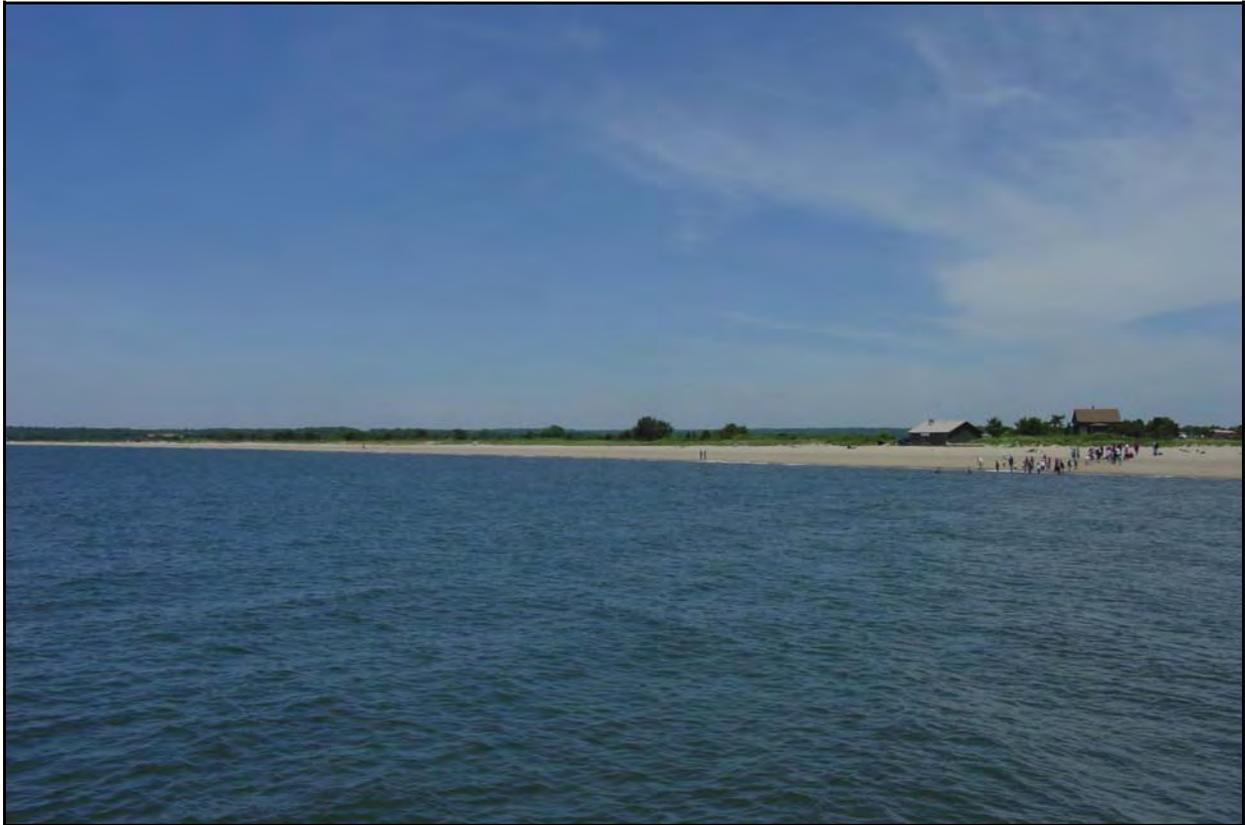
Photograph 1: Overview of Hammonasset Beach from the east breakwater, Nature Center at right, camera facing northeast.

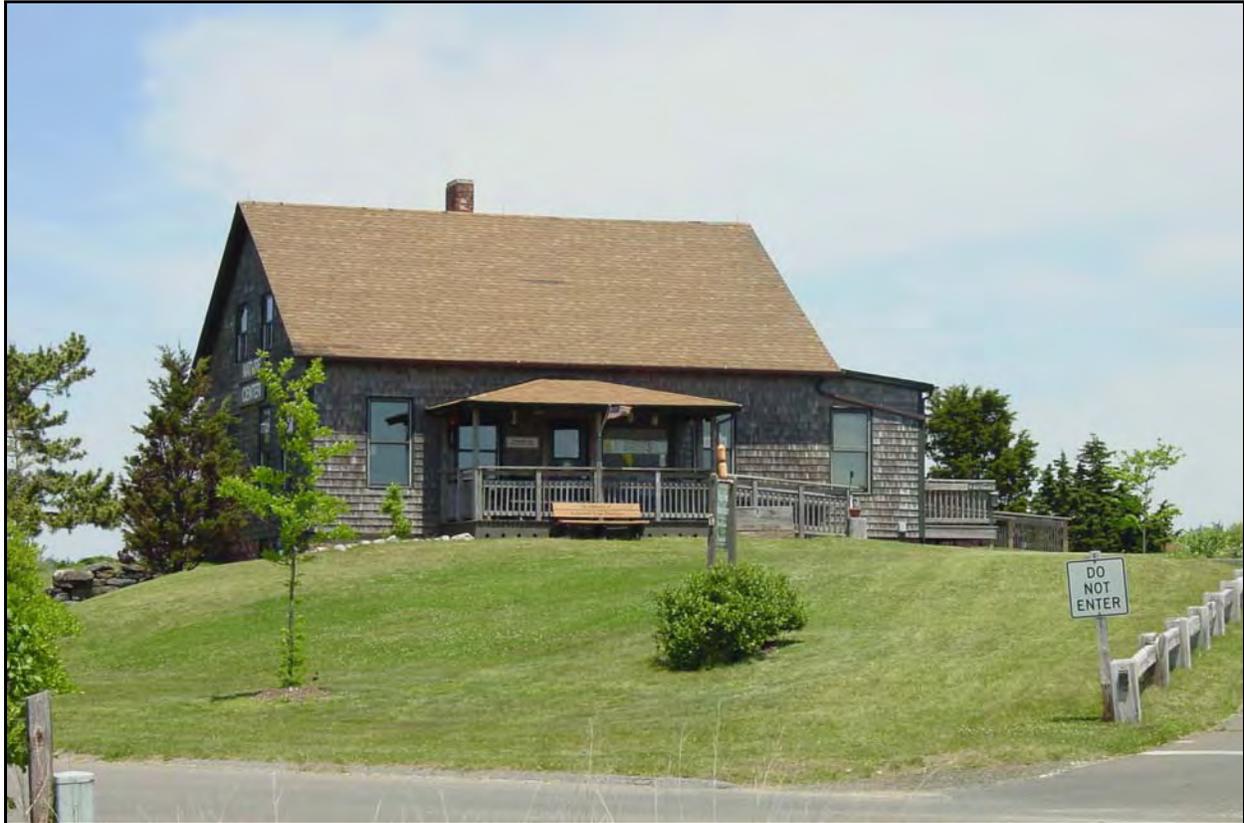
Photograph 2: Hammonasset Beach Nature Center, remodeled from a 19th-century farmhouse, camera facing northeast.

recommended as eligible for listing on the National Register of Historic Places because of the numerous changes that have affected its integrity: added dormer on the back slope of the roof, modern windows, and complete removal of all interior finishes for the installation of nature exhibits. However, undisturbed areas surrounding the 19th-century farmhouse may contain subsurface artifacts and/or features that might be significant in illuminating lifeways at a modest 19th-century saltwater farm.

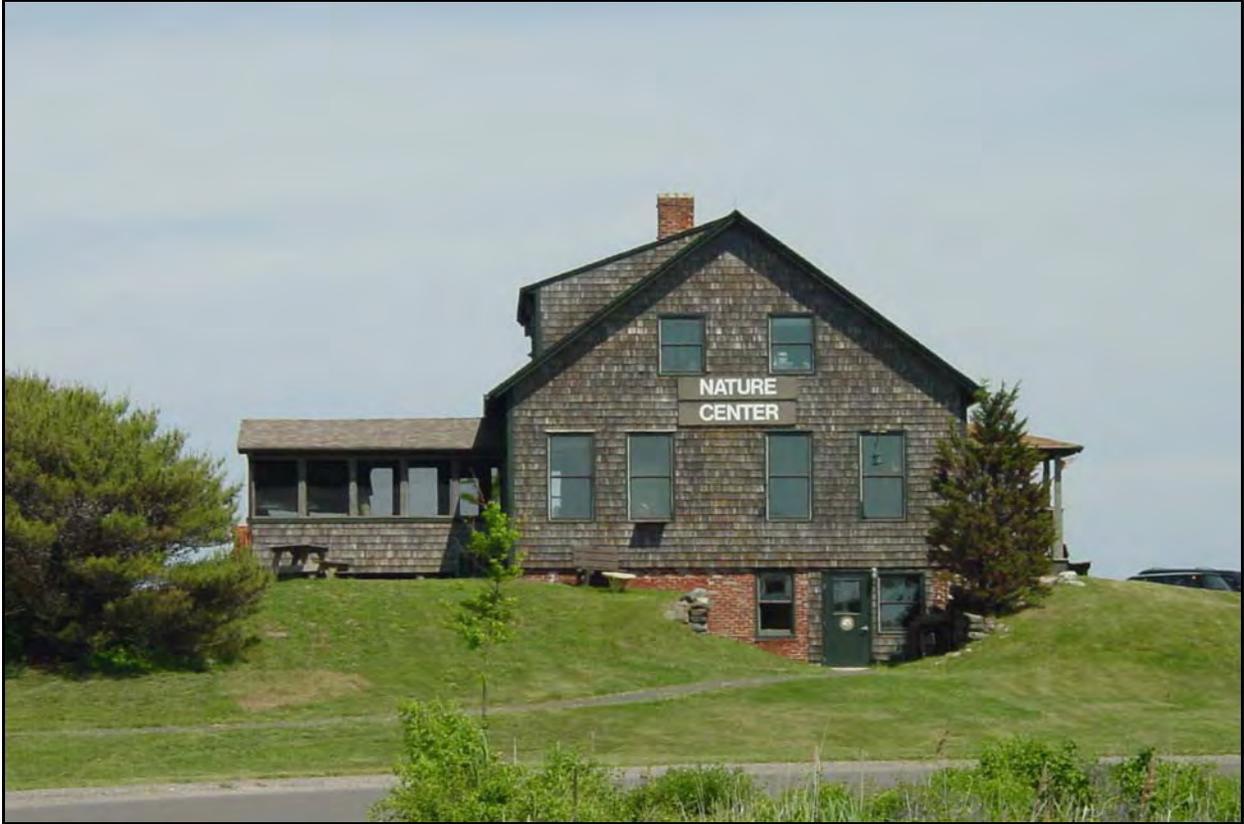
Photograph 3: Hammonasset Beach Nature Center, remodeled from a 19th-century farmhouse, camera facing southeast.

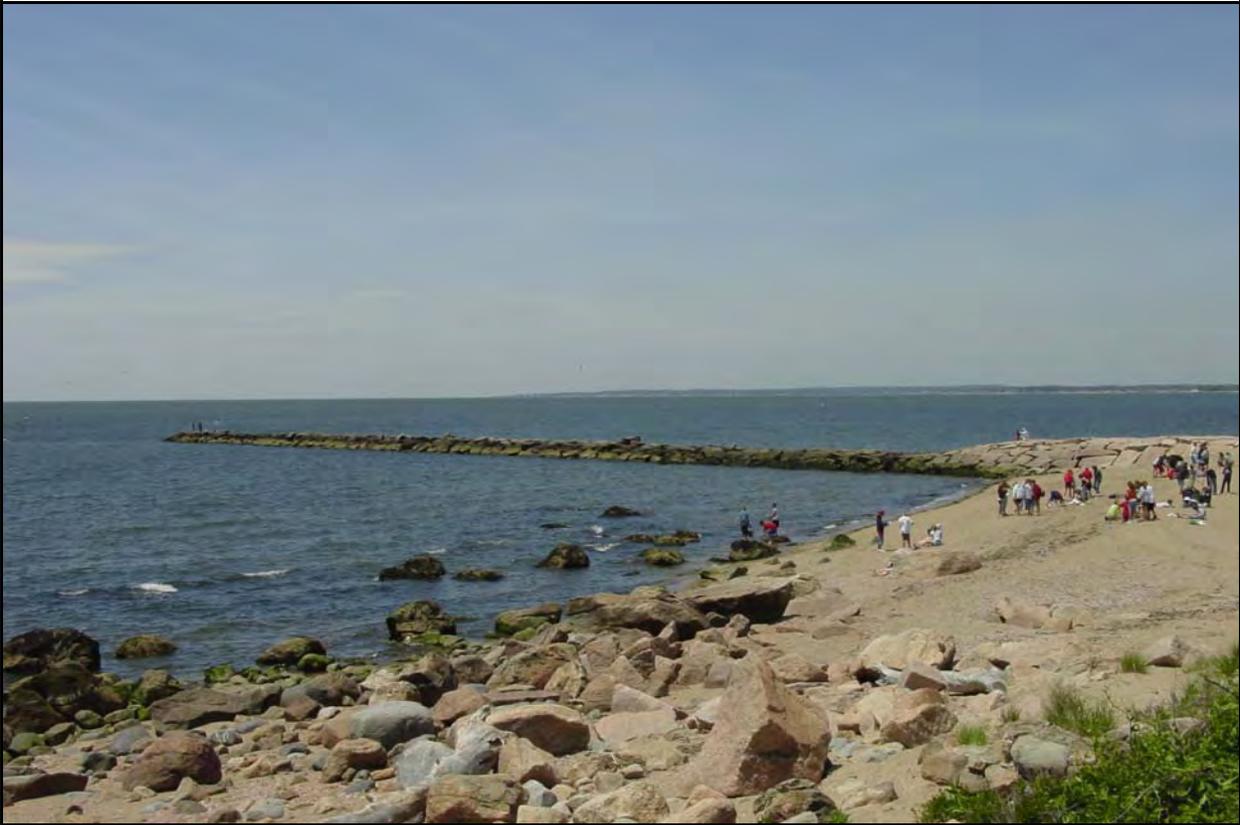
Photograph 4: Breakwater at east end of beach, camera facing northwest.

There are two mid-20th-century stone breakwaters, the larger of which is at the east end of the beach (Photographs 4 and 5). Both are built of huge irregular pieces of granite, with more rectangular slabs set on top to create a flat-topped, approximately trapezoidal section. The east breakwater was built following the hurricanes of the mid 1950s, at which time steel sheet-piling was installed to prevent erosion at the west end of the beach at the outflow of Tom's Brook. The west-end breakwater was built in the 1970s. Although the east breakwater is now 50 years old, it is not recommended as eligible for listing on the National Register of Historic Places because it is a commonplace structure with little claim to exceptional engineering significance.

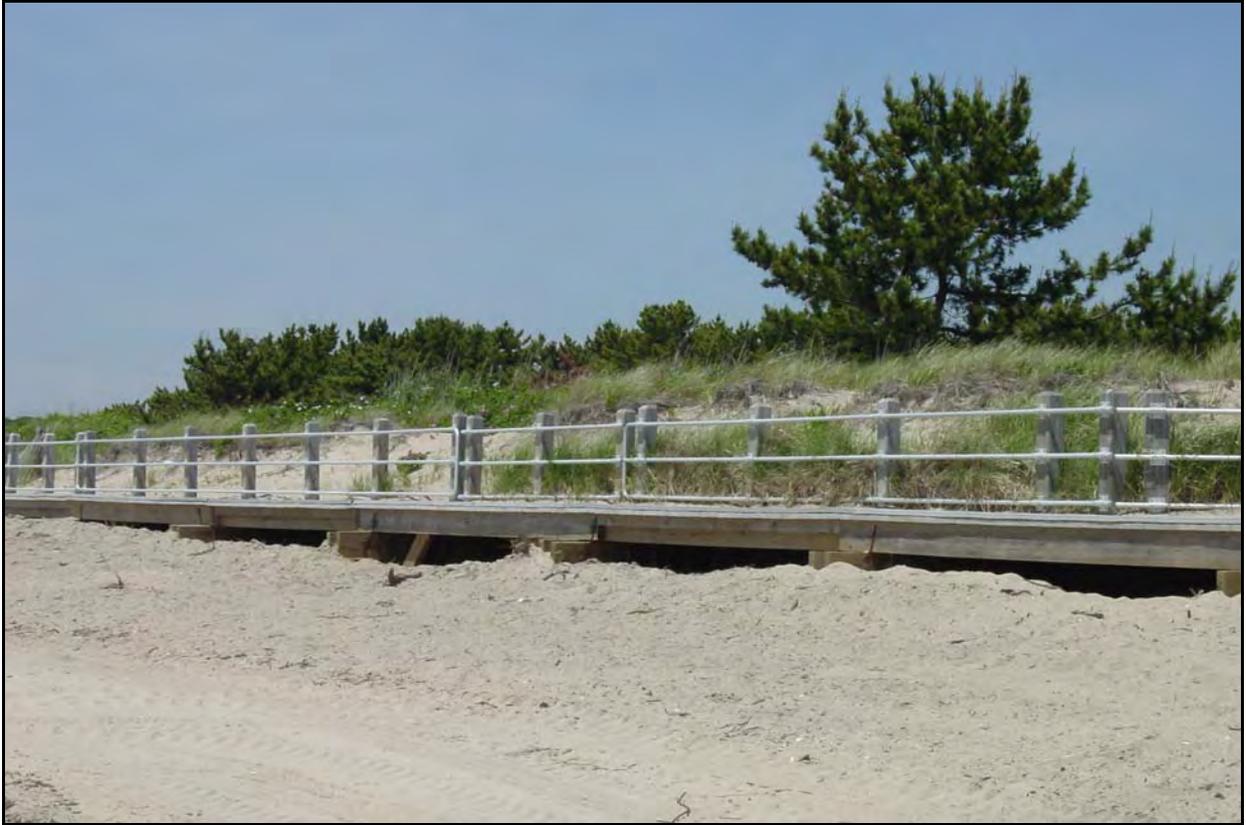
Photograph 10: Modern boardwalk along dune at west end of beach, camera facing northeast.

Infrastructure at the park includes a two-lane paved road leading from the entrance to the point parking area, a stone-dust walking/bicycle trail paralleling the back of the dune, and a short section of modern boardwalk at the west end of the beach (Photograph 10).

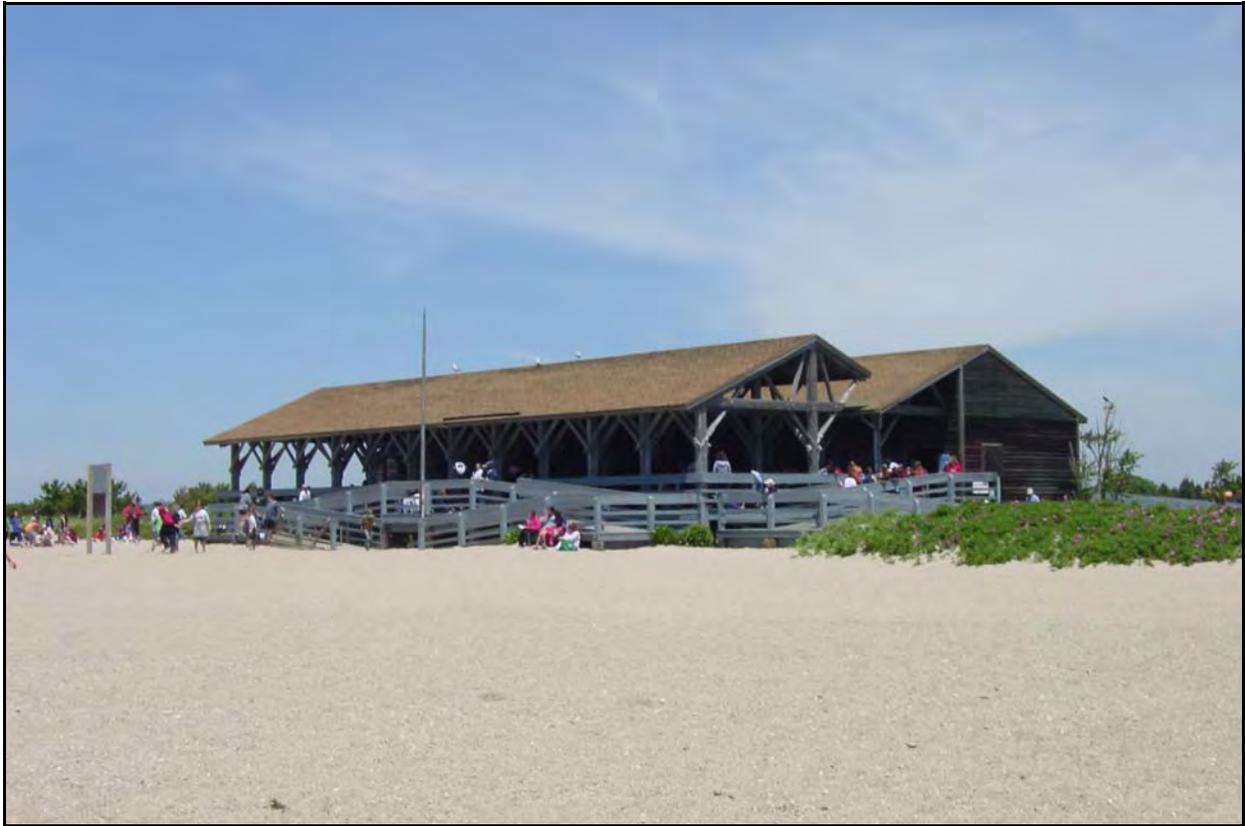
Photograph 6: Modern changing rooms/toilets structure, east end of beach, camera facing northeast. One three such structures on the beach, all modern.

The rest of the park's buildings appear to be of relatively recent origin and are wood-frame construction set on timber or concrete piles or concrete-slab foundations. The buildings' clapboard or board-pattern plywood exteriors are stained a natural dark brown. Directly fronting on the beach are three large toilet and changing room structures (Photograph 6) and two snack bars (Photograph 7). The Camp Store (Photograph 8) is located at the west end of the beach between the dune and the camping area. There are also four open picnic pavilions (Photograph 9), three near the beach's dune and the fourth northeast of the nature center.

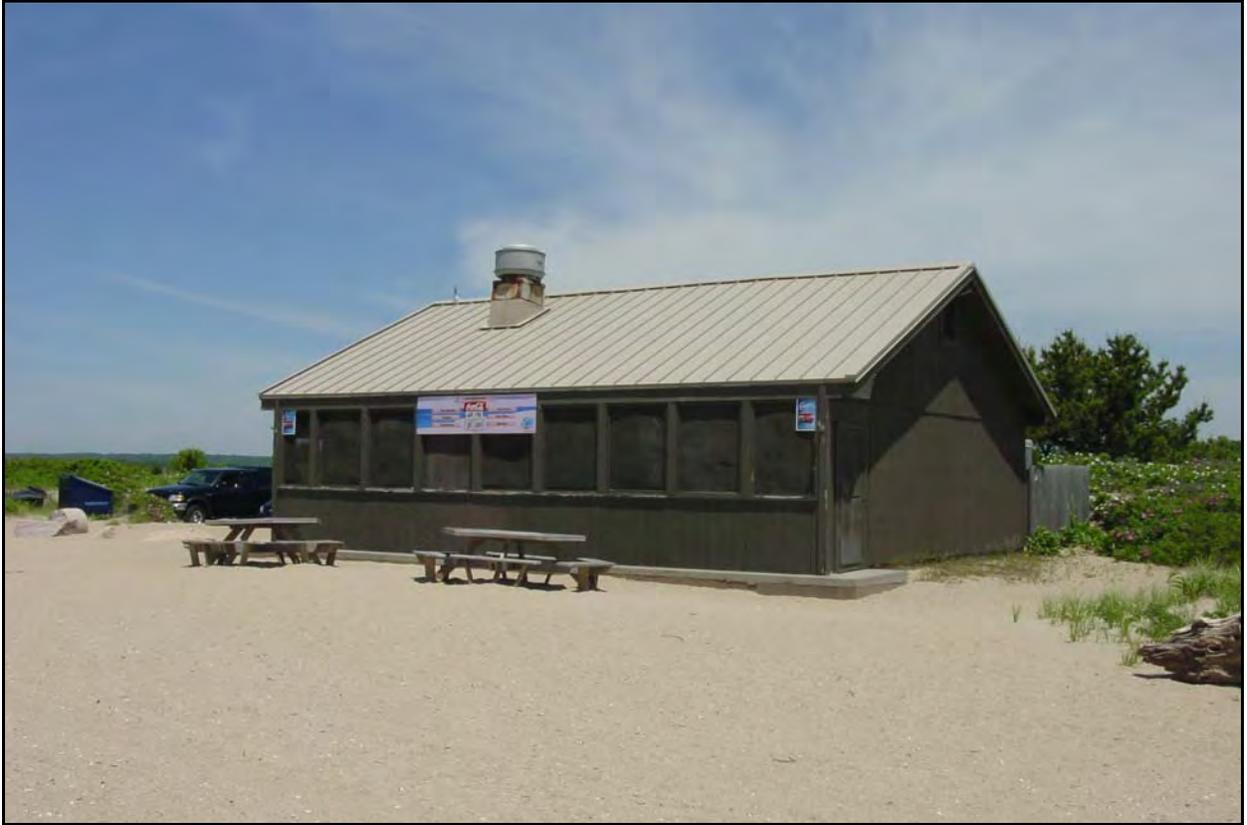
Photograph 7: One of two identical (modern) snack bars, camera facing northeast.

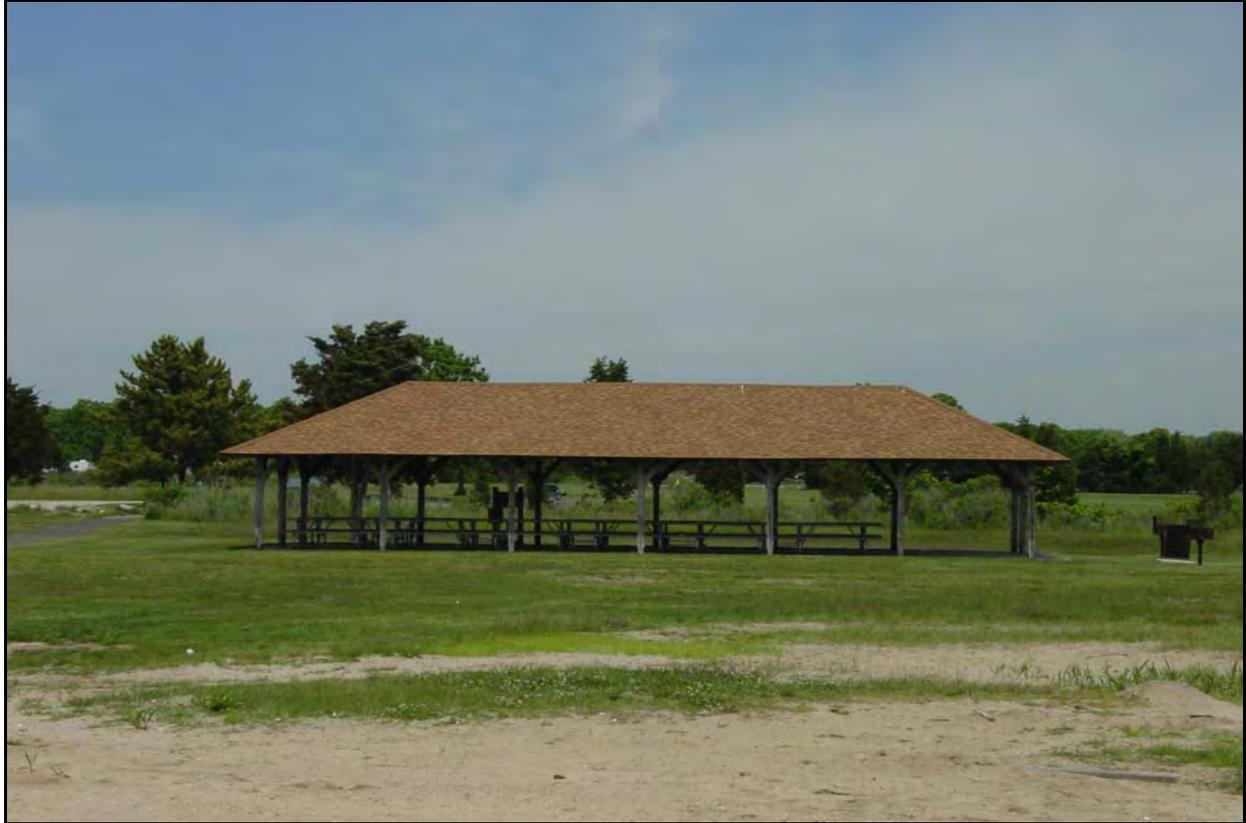
Photograph 9: Typical picnic pavilion, camera facing north. There are three other picnic pavilions similar to this one at the west end of the beach.

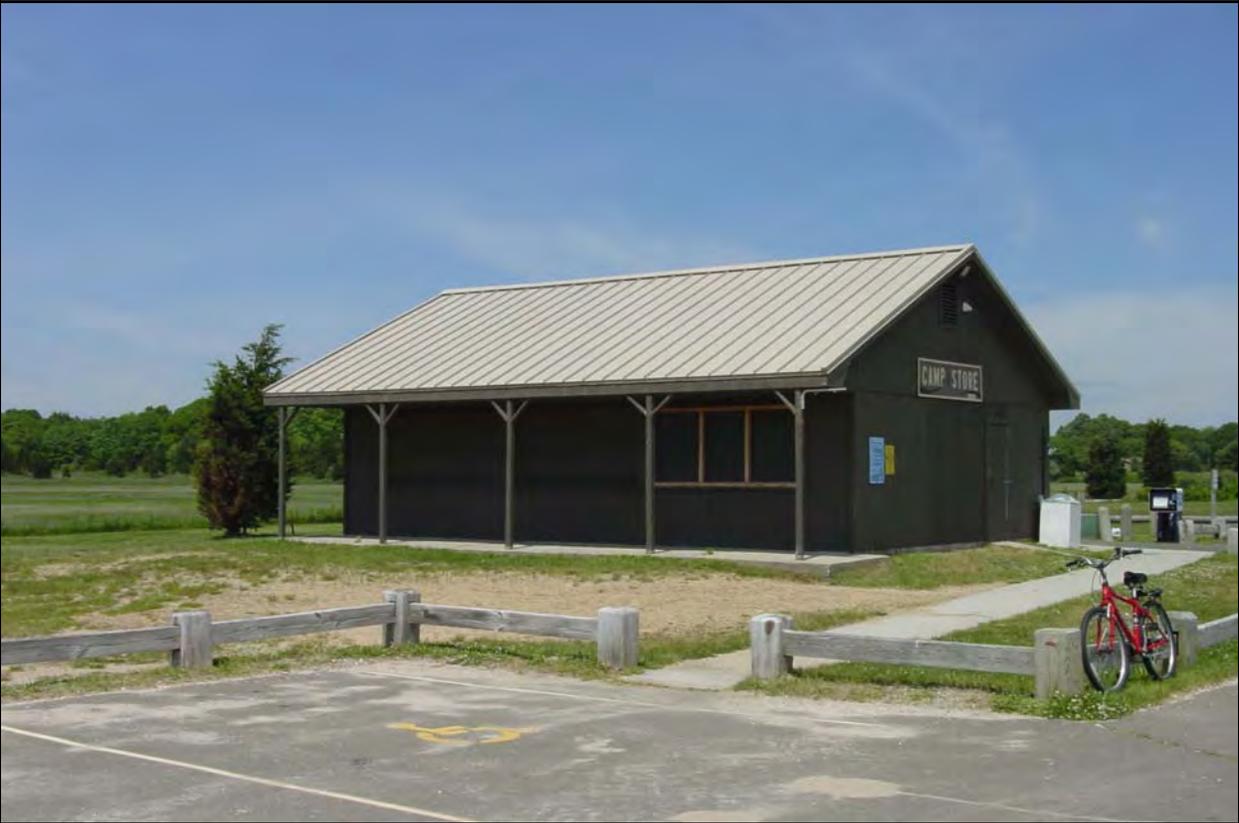
Photograph 8: Camp Store, camera facing northeast.

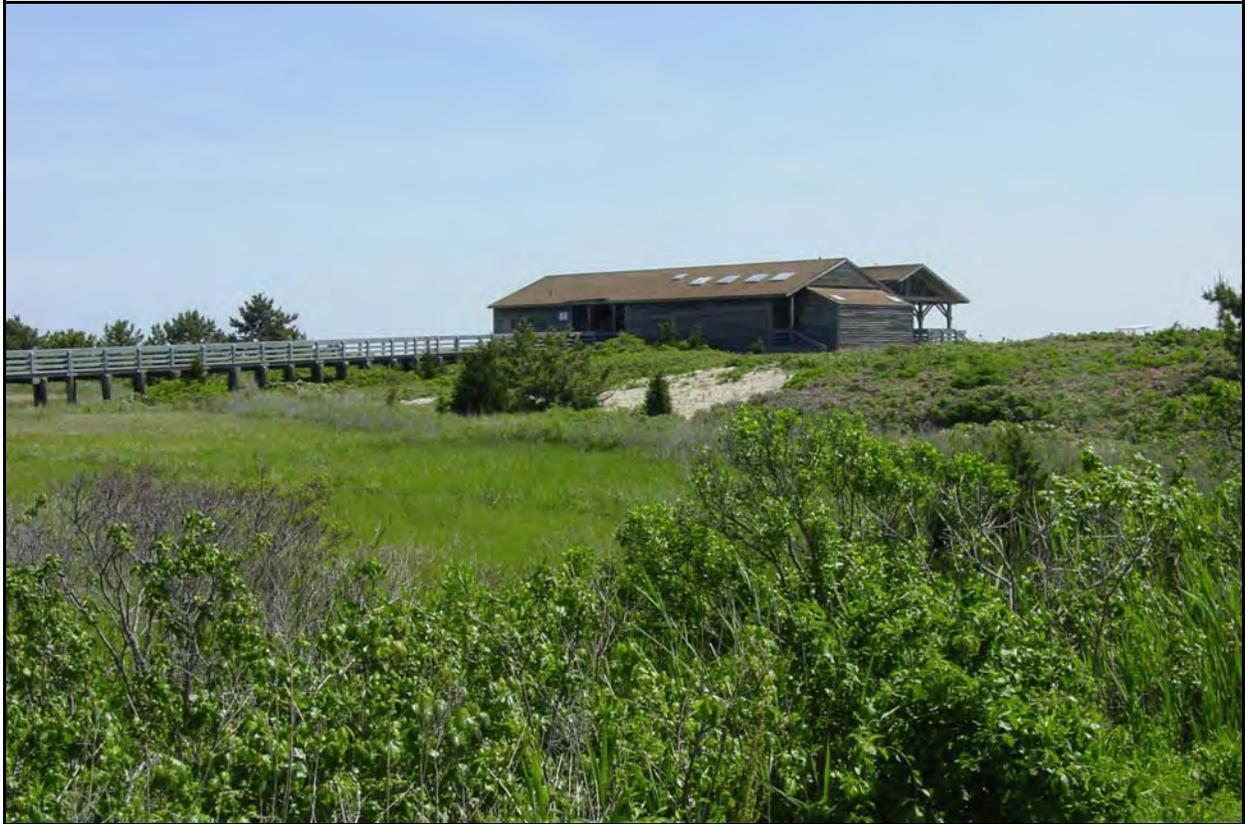
Photograph 11: Typical dune backside vegetation, east end of beach, camera facing southwest.
