**CT DEPARTMENT OF ENERGY AND ENVIRONMENTAL PROTECTION**

# **CT Pawcatuck River Watershed Bacteria TMDL**

**FB Environmental and CT DEEP**

**9/18/2014**

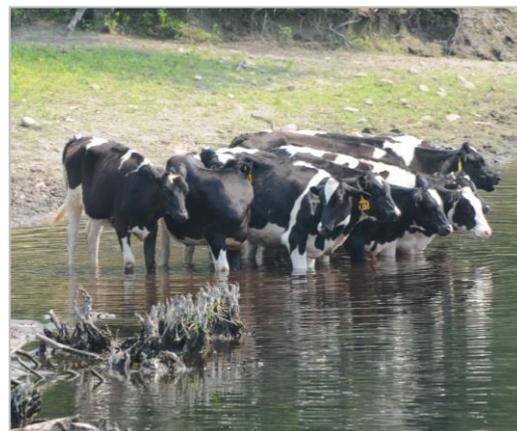
Figure 18. Cattle in Pawcatuck River at Boom Bridge Road Station 17620

There is a very large agricultural area off Anthony Road and Boom Bridge Road in North Stonington. As shown in Figure 12, this area is adjacent to the Pawcatuck River and has between 1-500 head of cattle as delineated in ARCGIS. This area has also been identified in Figure 12 as a potential source of bacterial contamination from agricultural wastewaters and contaminated stormwater runoff. Figure 18 shows evidence that agriculture is likely creating some inputs of bacteria loading to the river.

Agricultural operations are an important economic activity and landscape feature in many areas of Connecticut. Runoff from agricultural fields may contain pollutants such as bacteria and nutrients (USEPA, 2011a). This runoff can include pollutants from farm practices such as storing manure, landing application of manure, livestock holding and feeding areas, allowing livestock to wade in nearby waterbodies, applying fertilizer, and reducing the width of a vegetated buffer along the shoreline. Agricultural land use makes up 6% of the Pawcatuck River watershed. There are several areas where agricultural lands are adjacent to the impaired segment of the Pawcatuck River and its tributaries.
