**Environmental Review Record
and
Statutory Checklist**

**Residence of Janelle Imperato
50 Vista Drive
East Haven, CT**

**NEPA Compliance Document
Prepared Pursuant to 24 CFR Part 58**

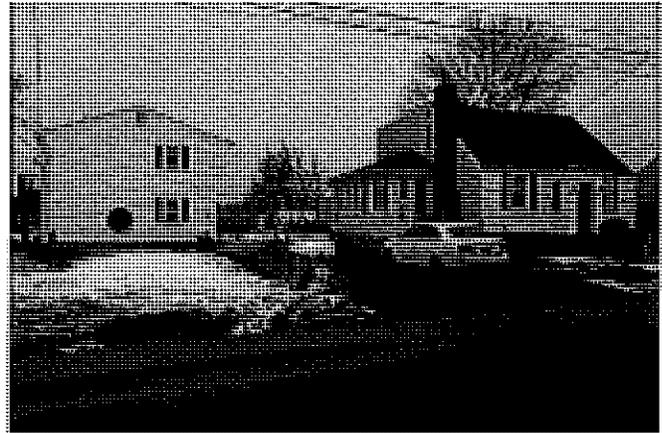
Note: This site has two buildings with one address. For purposes of this report the single family dwelling occupied by the owner will be called Building "A". This building is a frame "Cape" style with a basement (no basement under a rear addition). The other building will be called Building "B". This is a two story frame building on a slab on grade. This building has 4 rental units.

Damage compliant by owner	Inspection observation <i>Recommendation (Mitigation comments in bold)</i>	Rehabilitation Cost projection	Mitigation cost projection
The property is in an AE Flood Zone 12' above datum zero: If the dwelling is remediated and raised above the flood zone a new structure with new footings will be designed and constructed to elevate the living space of the building. The existing foundation walls and footings shall be removed with this new construction included in this item cost projection.			\$160,000 For both buildings \$80,000 EA
Floor, interior partitions and interior items for first level, Building B. This structure is built with a slab on grade first floor. It may be less expensive to demo the interior completely and rebuild on a new raised floor under the lifted second floor then to try to raise the interior partitions with the building. This is what is proposed here.			\$150,000

Flood in basement: Owner states flood water entered the basement of building A damaging the boiler. Owner states FEMA fixed the boiler.	As the owner stated the damage was fixed the boiler was not inspected. <i>Recommendation: Protect from damage during other operations. If Building A is mitigated and raised above the flood plain, the boiler will have to be located to within the house in a location yet to be determined.</i>	NA	NA

<p>Rear window: Owner states a tree fell on building A damaging a rear window and adjacent wall. Owner replaced the window unit but did not yet replace the adjacent siding and weather barrier. Owners representative expressed he would like to replace the sheathing as it has started to stain due to weathering.</p>	<p>The window in question is in place. There is no siding or weather barrier on the adjacent wall. See figure 1</p> <p><i>Recommendation: install new siding to match existing over new weather barrier.</i></p>	<p>\$750</p>	<p>\$750</p>
<p>Rear deck: Owner states the same tree and flooding damaged the rear deck attached to building A. The owner started rebuilding the deck but did not yet install railings.</p>	<p>There is a deck present and looks complete except for the lack of guard rails. See figure 2</p> <p><i>Recommendation: install new guard railing on deck and stair and new hand rail at stair.</i></p>	<p>\$1,000</p>	<p>\$1,000</p>

<p>Siding on Building B: Owner states a second tree fell onto building B damaging the siding.</p>	<p>Some siding at the rear of the building is damaged. The trail of damage is in an arc shape consistent with a tree falling and scraping the siding. See figure 3</p> <p><i>Recommendation: Replace the siding to match existing. Patch the weather barrier if and as required.</i></p>	<p>\$3,000 Entire wall</p>	<p>\$3,000 Entire wall</p>
<p>Damage to shed: Owner states the siding on the shed was blown off.</p>	<p><i>A metal shed on the site has no siding. The shed is covered with a non woven synthetic material weather barrier.</i></p> <p><i>Recommendation: Take no action, shed is not covered by CDBG-DR program.</i></p>	<p>NA</p>	<p>NA</p>
<p>Total Cost Projection</p>		<p>\$4,750 Both buildings A & B</p>	<p>\$314,750 Both buildings A & B</p>
		<p>\$1,750 Building A only</p>	<p>\$84,750 Building A only</p>
