Environmental Review Record
and
Statutory Checklist

Residence of Sammy Sosa
20 Atwater Street
East Haven, CT

NEPA Compliance Document
Prepared Pursuant to 24 CFR Part 58

November 13, 2014

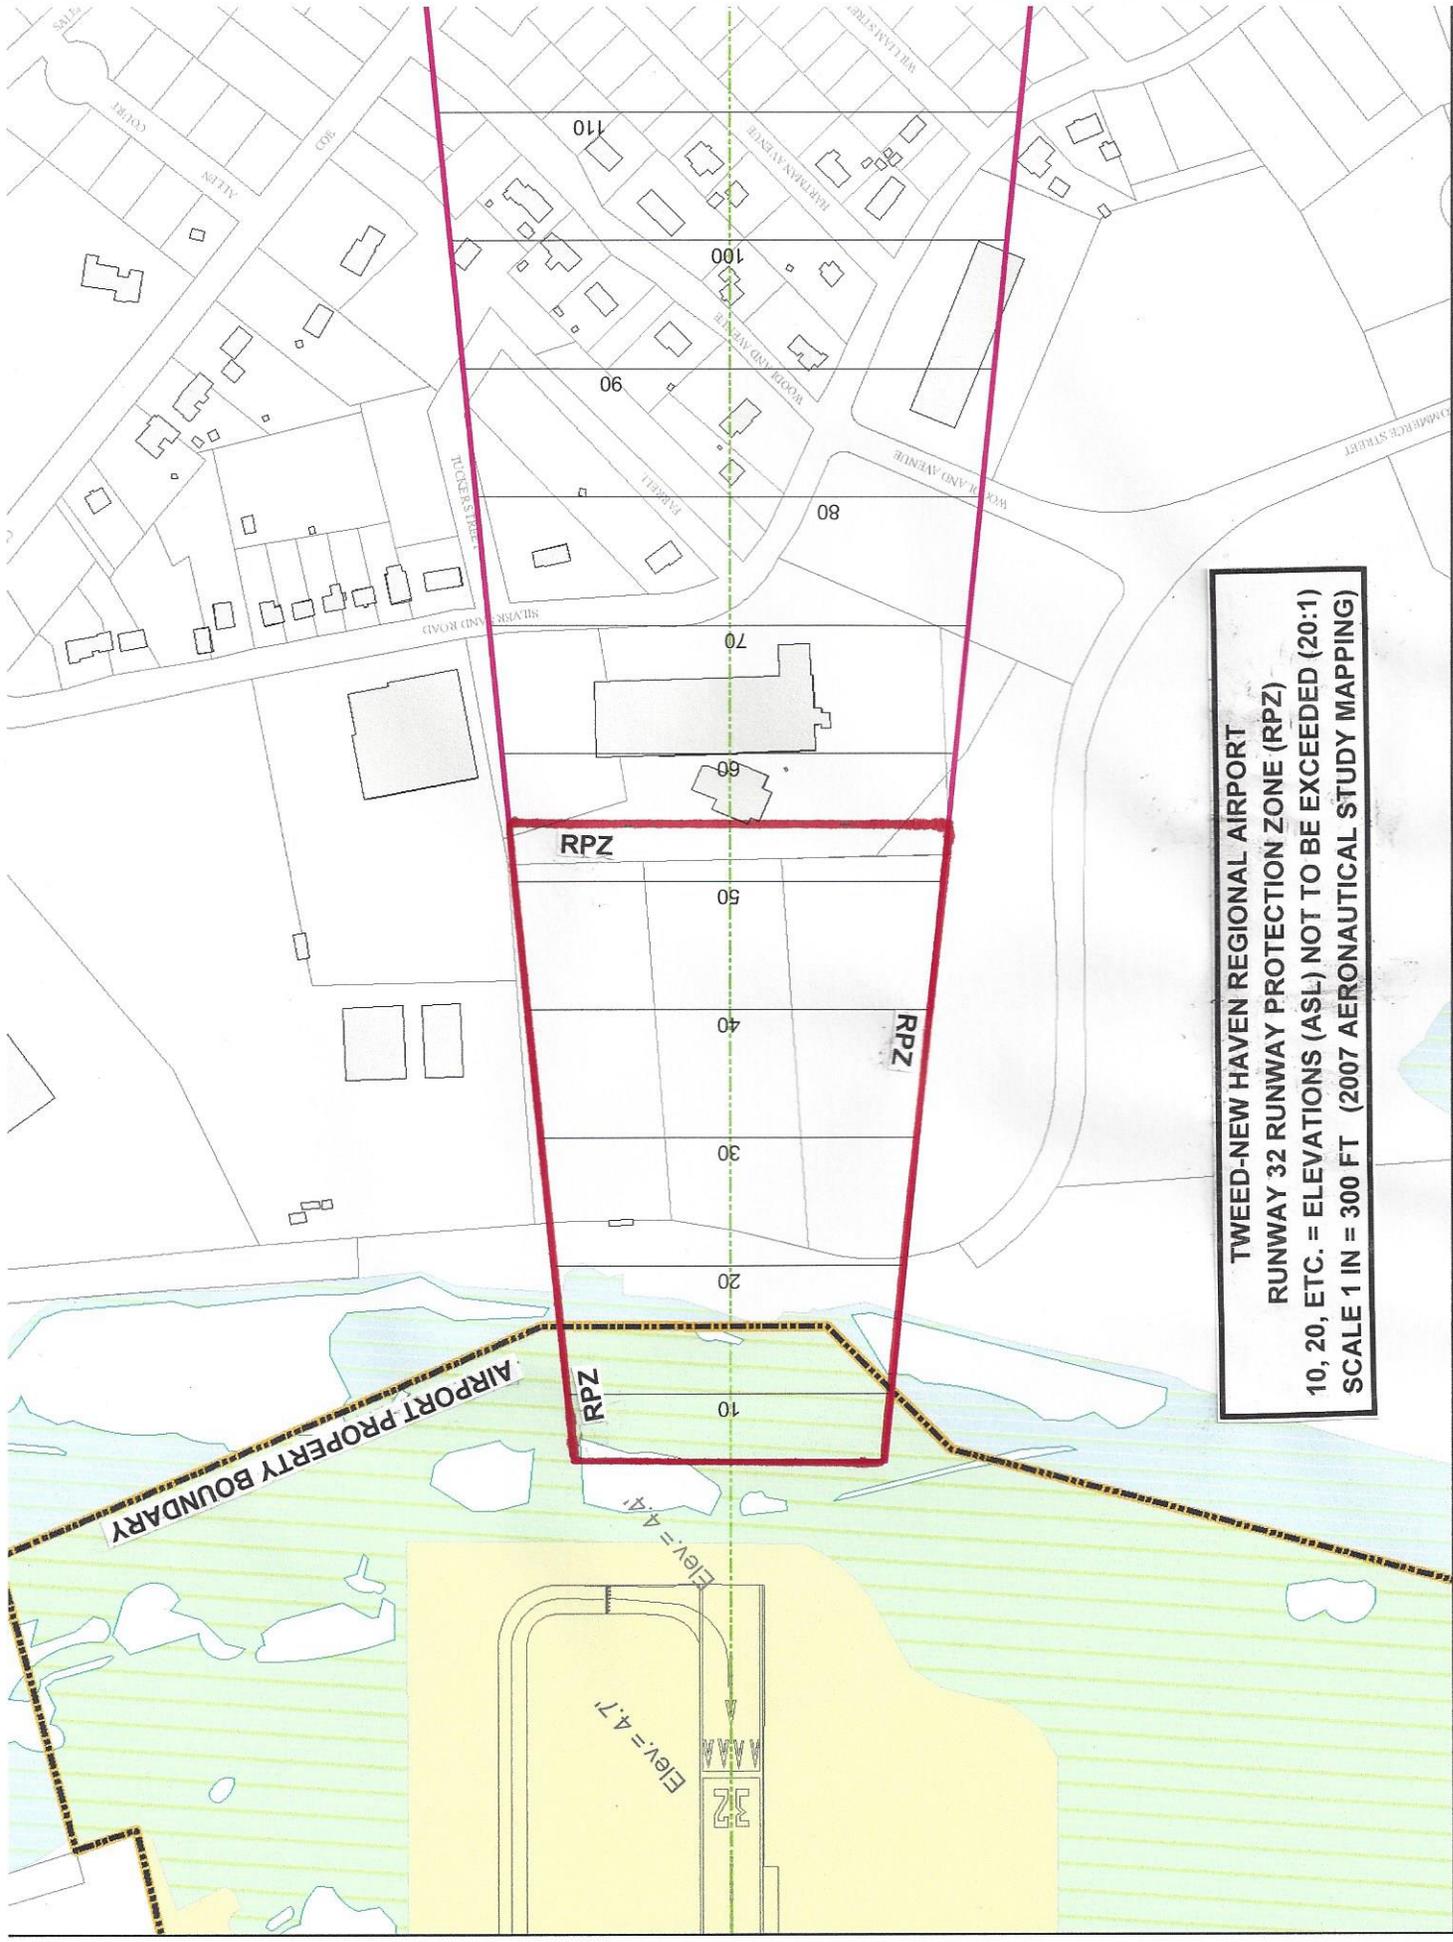
TWEED-NEW HAVEN REGIONAL AIRPORT
RUNWAY 32 RUNWAY PROTECTION ZONE (RPZ)
 10, 20, ETC. = ELEVATIONS (ASL) NOT TO BE EXCEEDED (20:1)
 SCALE 1 IN = 300 FT (2007 AERONAUTICAL STUDY MAPPING)

Runway 32 Approach Surface - 20:1 Obstacle Clearance

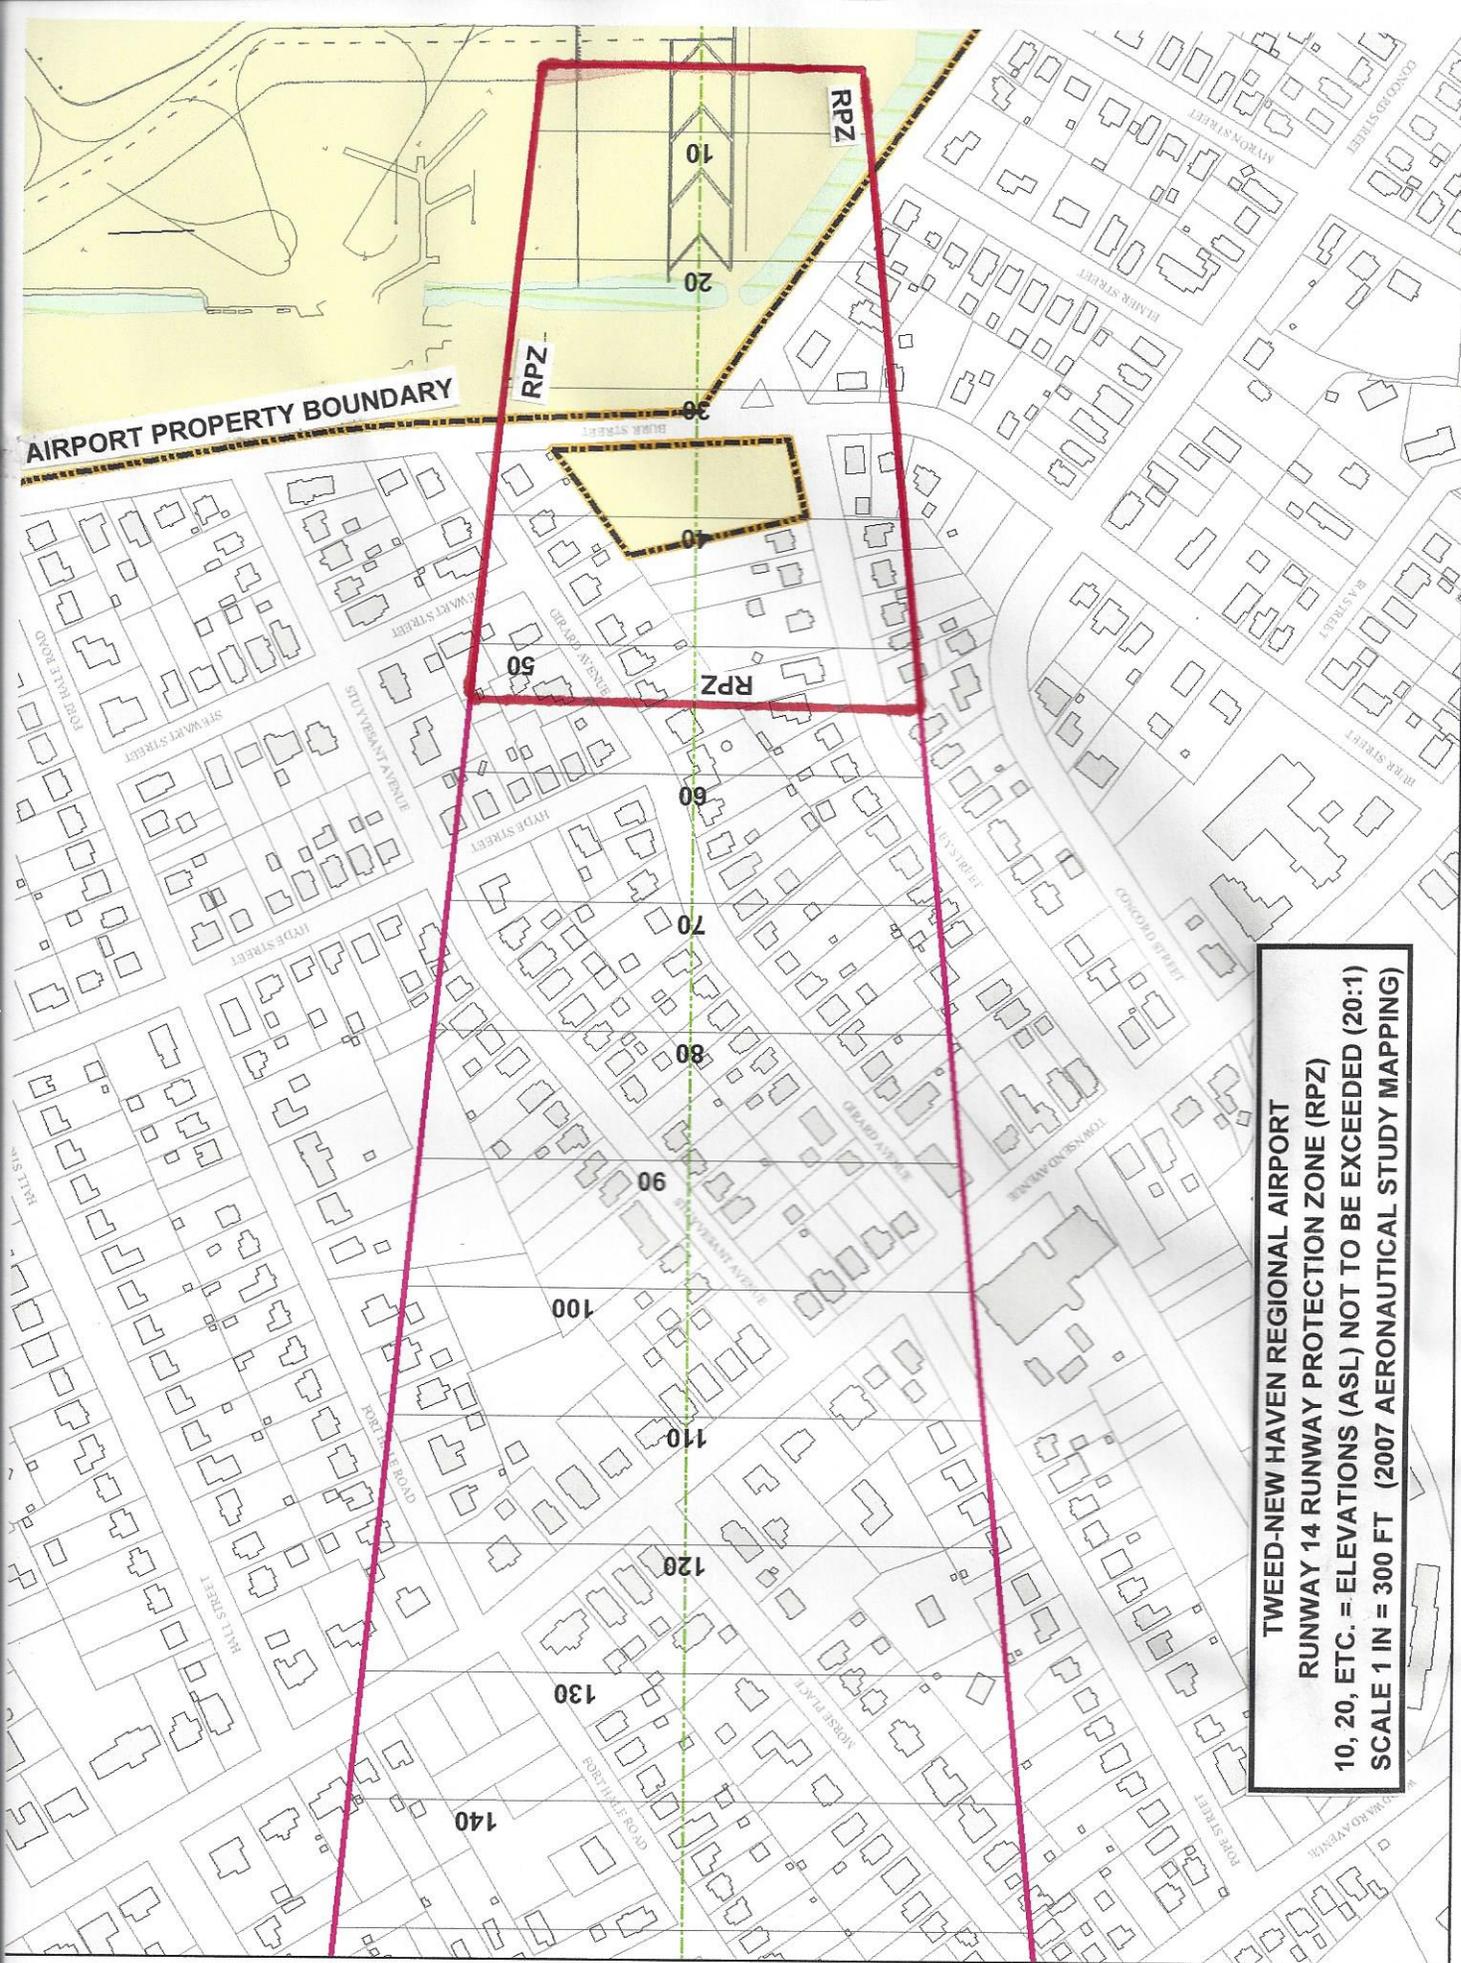
**TWEED-NEW HAVEN REGIONAL AIRPORT
 RUNWAY 14 RUNWAY PROTECTION ZONE (RPZ)
 10, 20, ETC. = ELEVATIONS (ASL) NOT TO BE EXCEEDED (20:1)
 SCALE 1 IN = 300 FT (2007 AERONAUTICAL STUDY MAPPING)**

Runway 14 Approach Surface - 20:1 Obstacle Clearance Surface

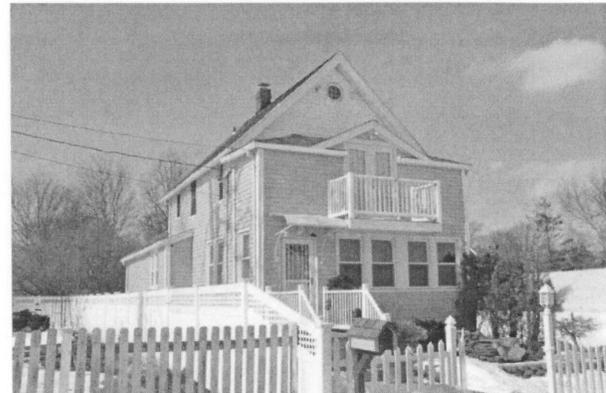
Present at inspection:
 Sammy Sosa, Homeowner
 Arthur J. Seckler, III, Senior Associate, Lothrop Associates LLP
 Thomas Streicher, AIA, Lothrop Associates LLP
 Maurizio Huaylla, Lothrop Associates LLP

Damage compliant by owner	Inspection observation <i>Recommendation</i>	Rehabilitation Cost projection	Mitigation cost projection
	<p><i>The property is in an AE Flood Zone 12' above datum zero:</i> If the dwelling is remediated and raised above the flood zone a new post and beam structure with new footings will be designed and constructed. The existing foundation walls and footings shall be removed with this new construction included in the cost of this item estimate. Modification of existing and/or construction of new exterior stairs to accommodate the new elevation are included in this item cost.</p>		\$100,000
<p>Basement hatch entry: Owner states storm surge moved and misaligned the basement access hatch doors</p>	<p>Observing the owner operate the door it seemed to open and close properly. The door appears slightly misaligned but is installed in an old stone and concrete wall. See figure 1</p> <p><i>Recommendation: Adjust alignment.</i></p> <p><i>If the dwelling is to be raised above the flood zone: This door will be removed with the foundation wall</i></p>	\$100	NA
